**COMPARATIVE ANALYSIS OF DURABILITY AND
RANKING OF CONCRETE BRIDGES IN HOT
CLIMATES**

DOCTORAL THESIS

Novi Sad, 2022.

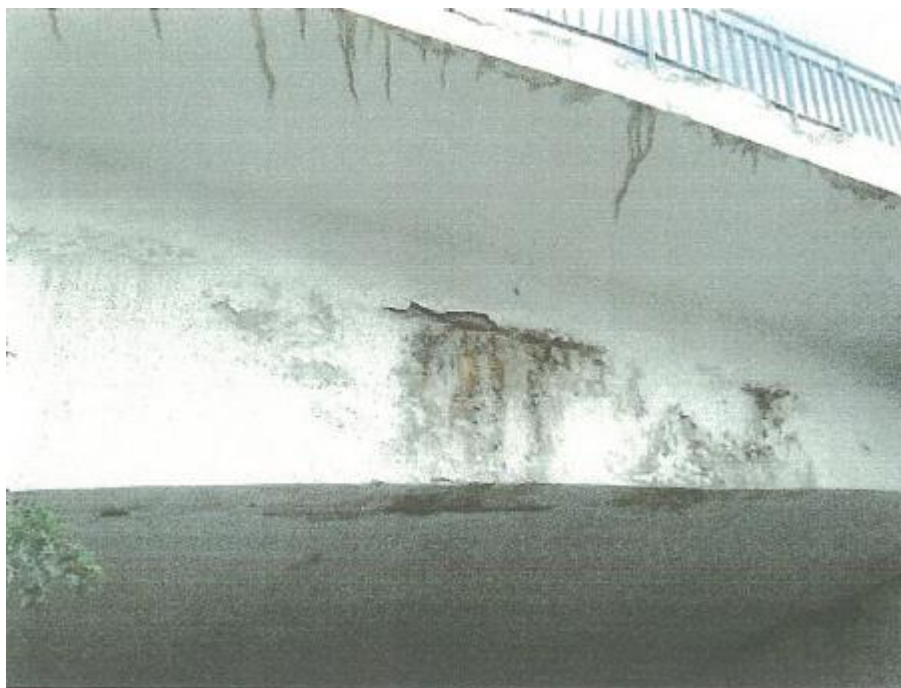
Figure VI-109. Spalling of plaster on deep supporting element

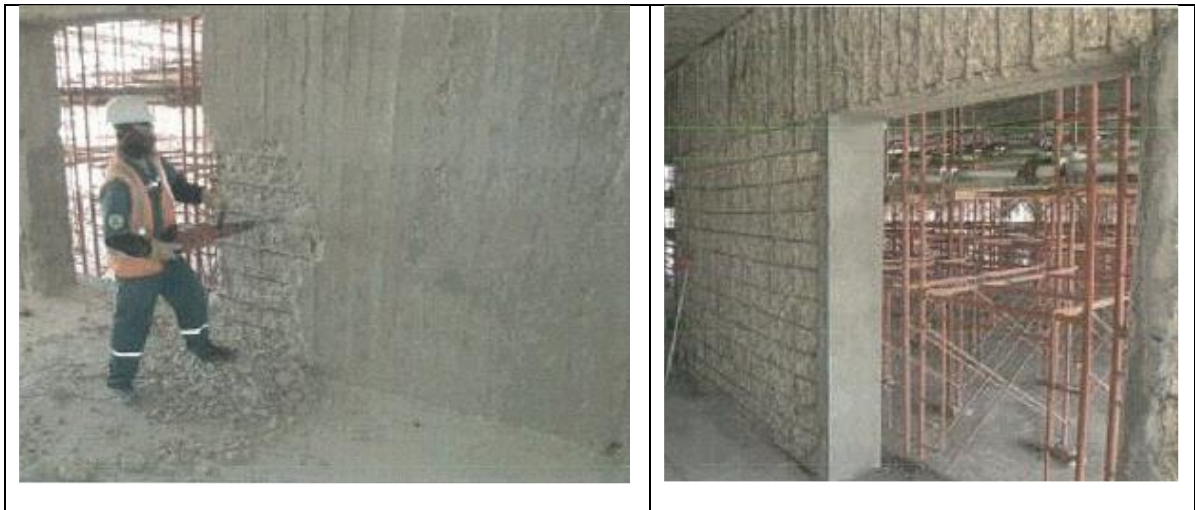
Figure (VIII-2) Damaged concrete removal from exterior walls

The removal of old carbonated concrete cover from exterior wall and ceiling beam is shown on the next two pictures.

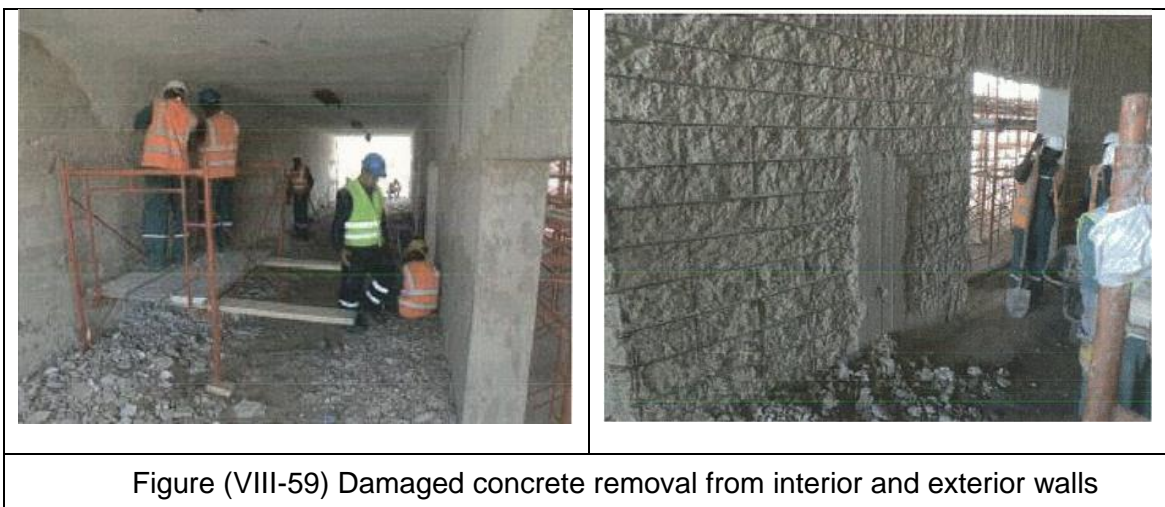
Figure (VIII-59) Damaged concrete removal from interior and exterior walls

The removal of old carbonated concrete cover from interior and exterior walls, and tunnel ceiling is shown on the next three pictures.

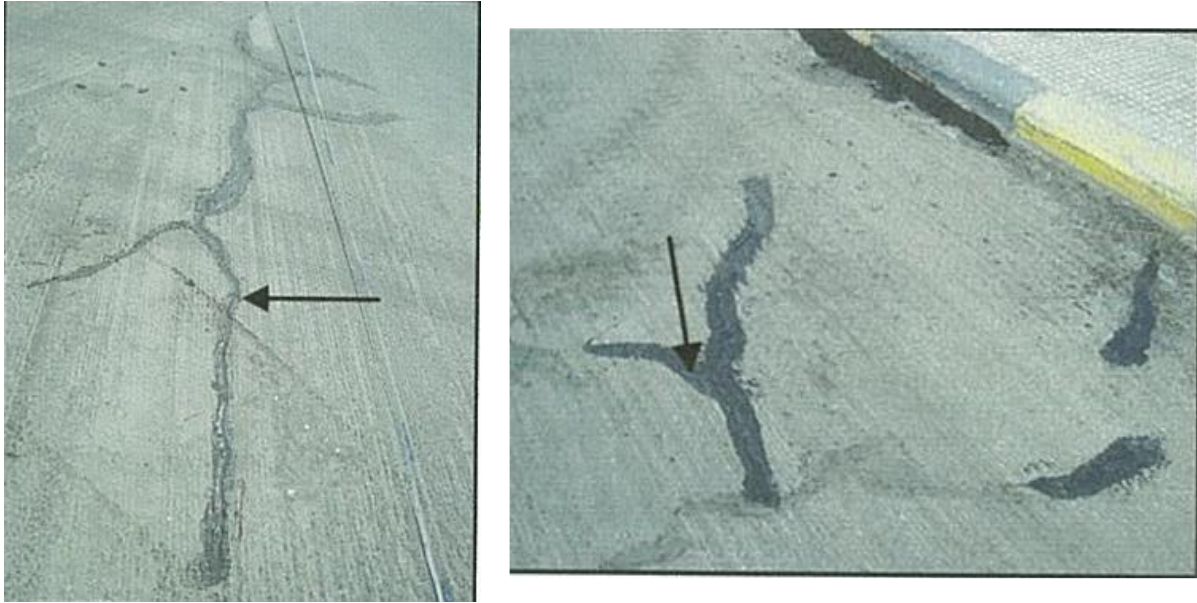
Figure (VIII-93). Cracks after injection

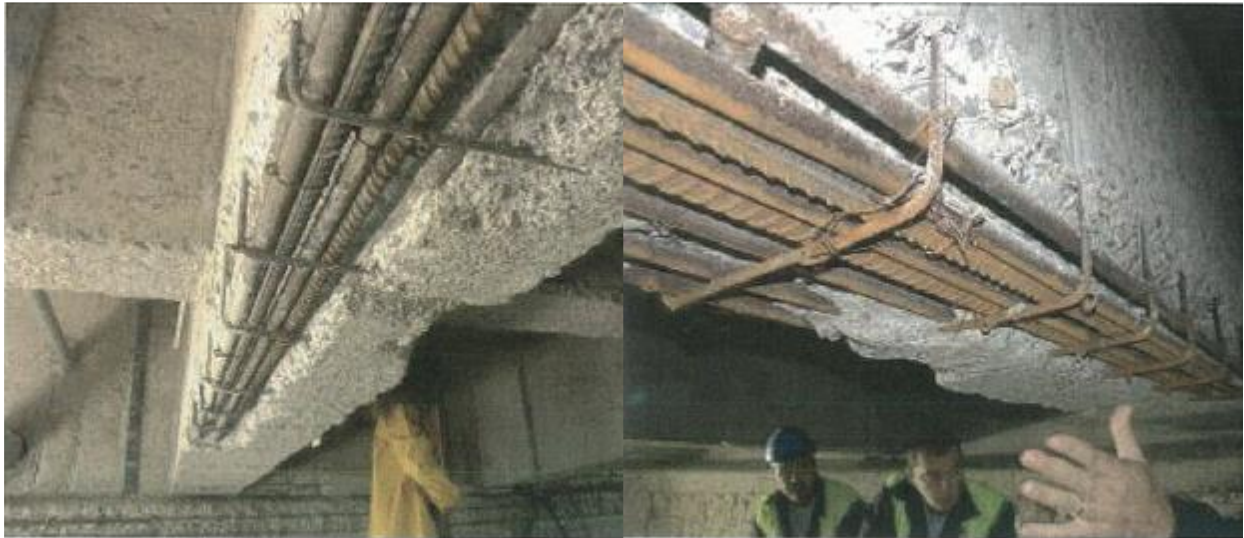
Twisted, deformed and broken reinforcing bars in longitudinal slab beams were replaced with new rebars (Fig VIII-144 & VIII-145).

Figure.VIII-144 & VIII-145. Rebar replacement on the damaged longitudinal slab beams

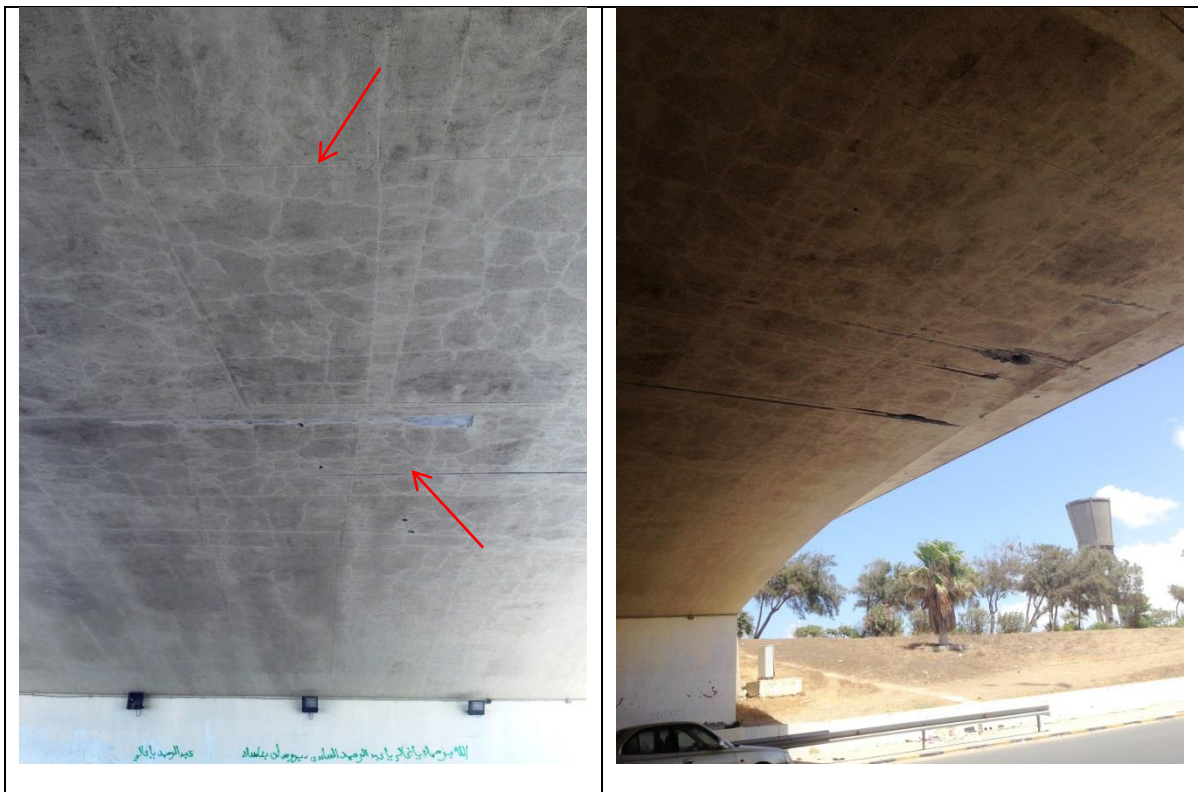
On the place of connection between cantilever arch slabs and simple beam slab the “channel” was formed by cutting of repair mortar due to release of surface stresses and because of different moving of these elements, also (Fig IX-8).

Figure (IX-9) Net like cracks, local spalling off of repair mortar (cover) and shallow cut “channels” on down side of bridge deck slab.

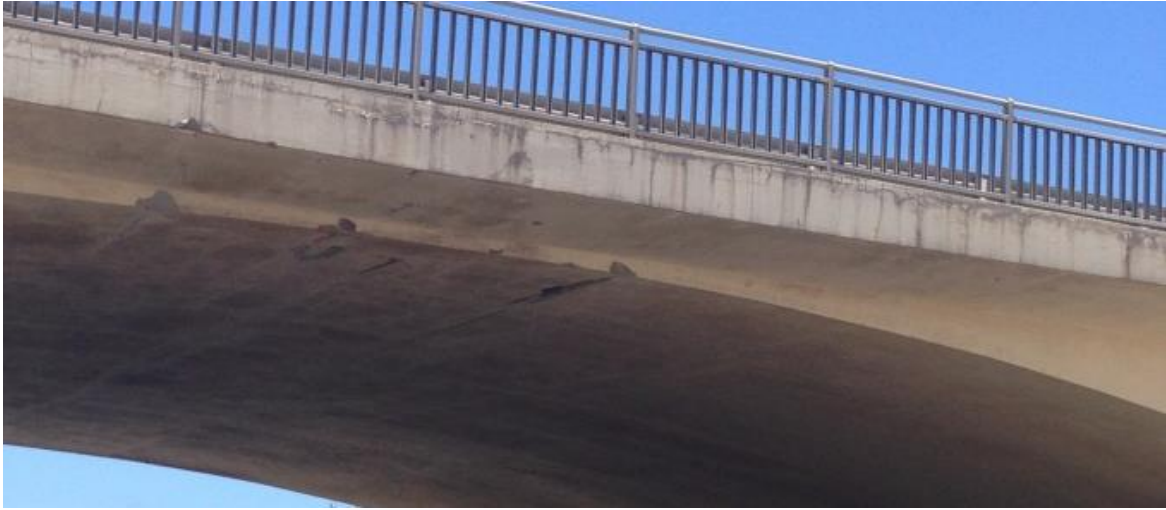
Figure (IX-11) The characteristic damages on side surface of cantilever slab

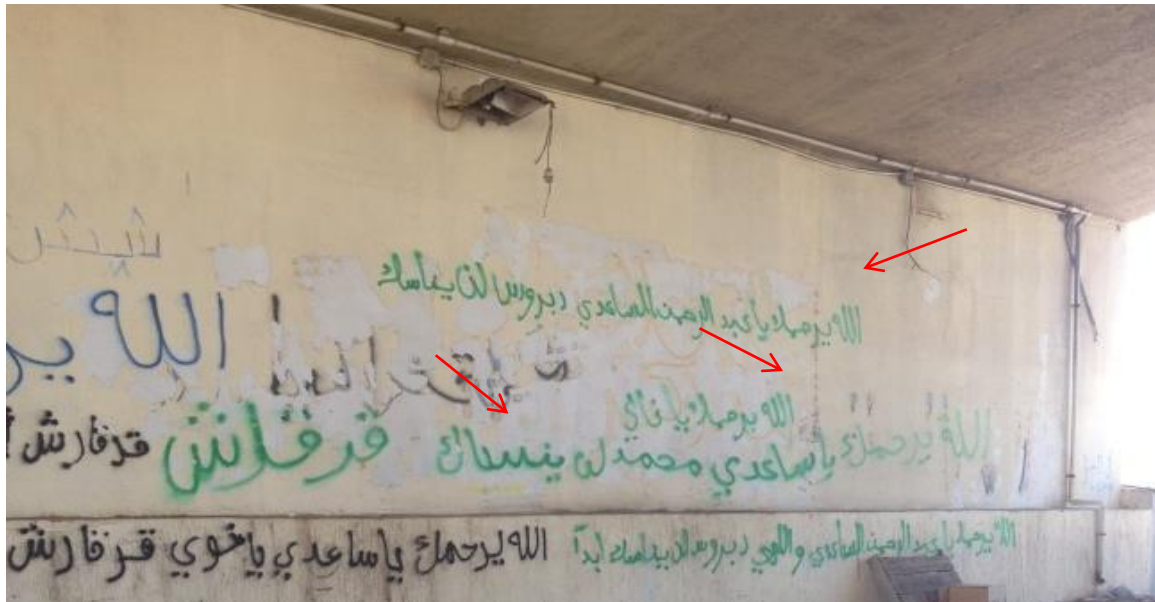
Figure (IX-14) Cracks in supporting wall

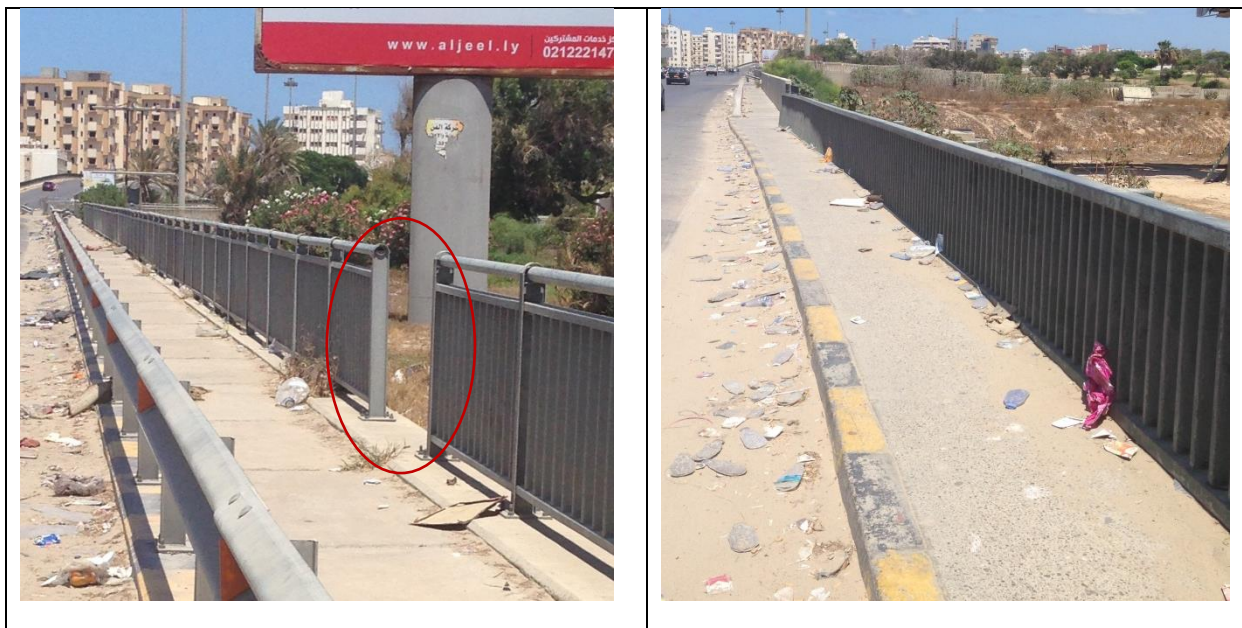
Figure (IX-17) A general view of fences on the bridge, with missing part

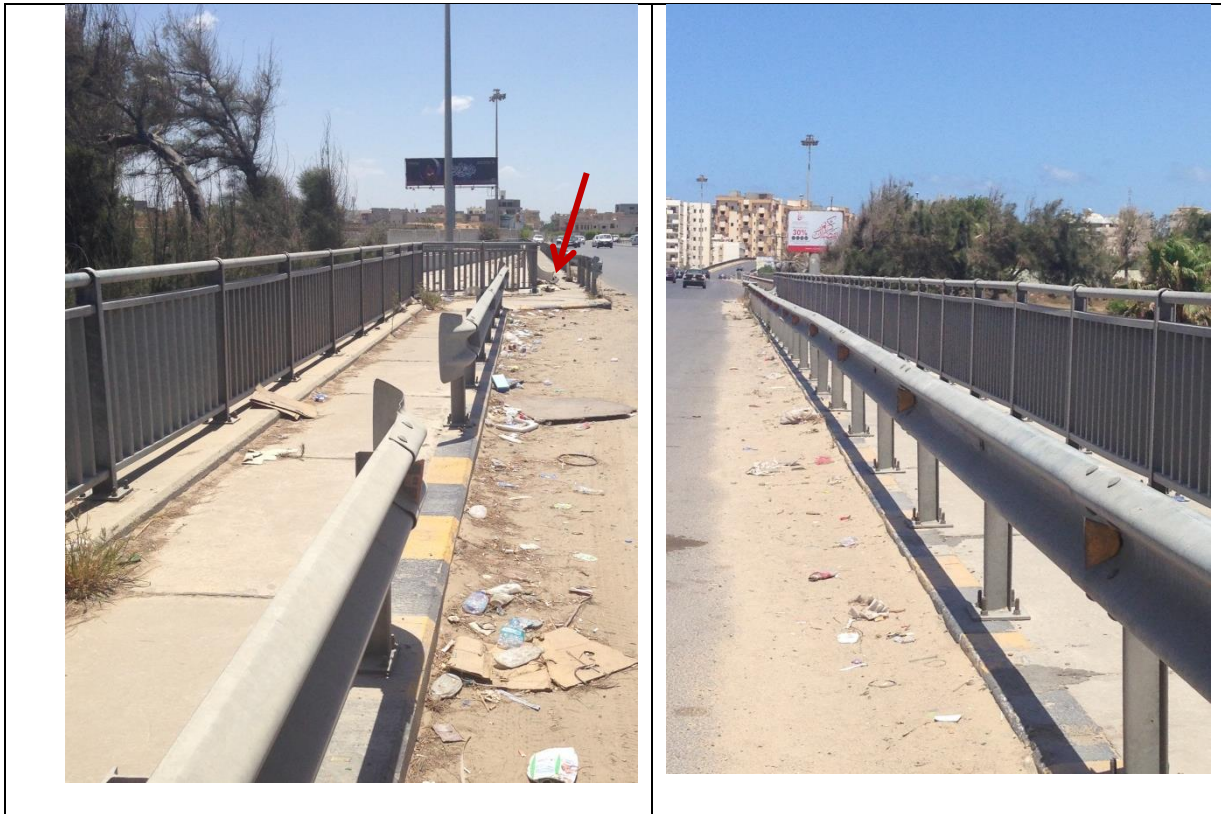
Figure (IX-19) General view of the guardrail on the bridge with the missing of part of it

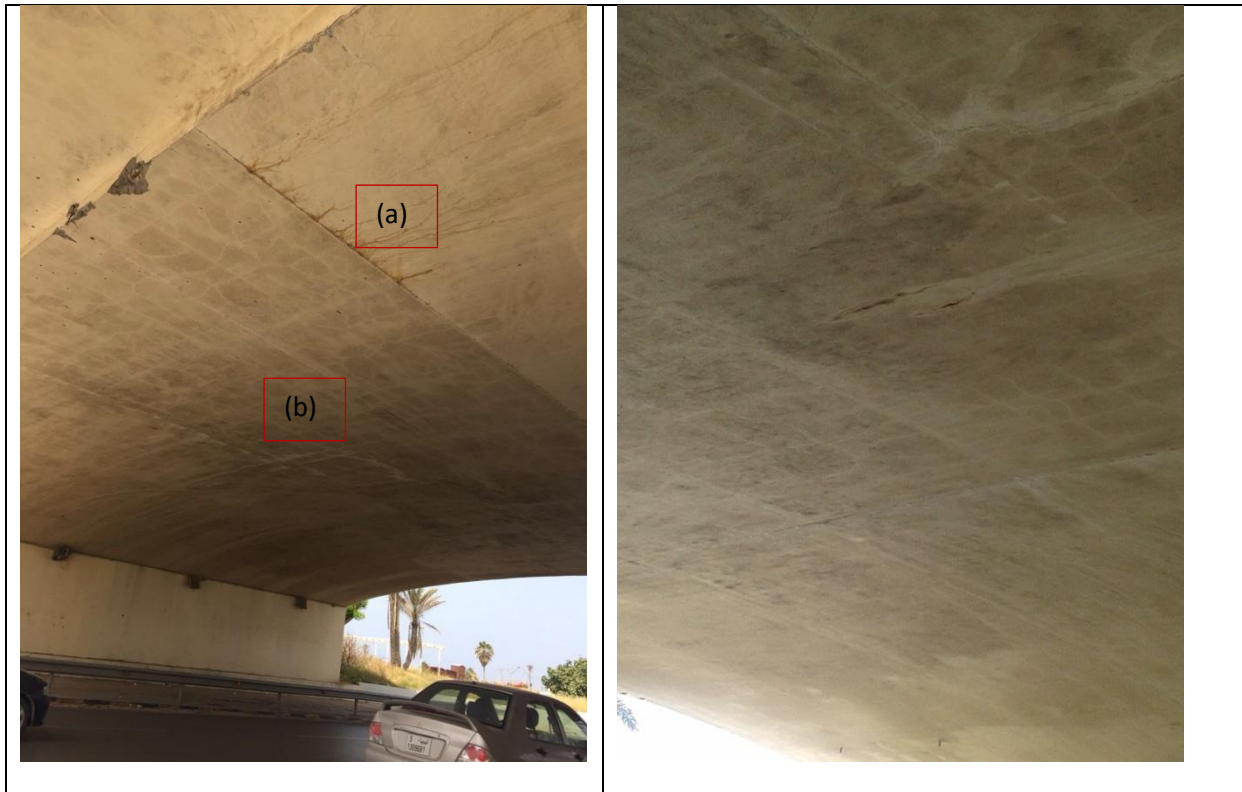
Figure (IX-27): View of deck slab with abutment, (a) rust stains, (b) white stains

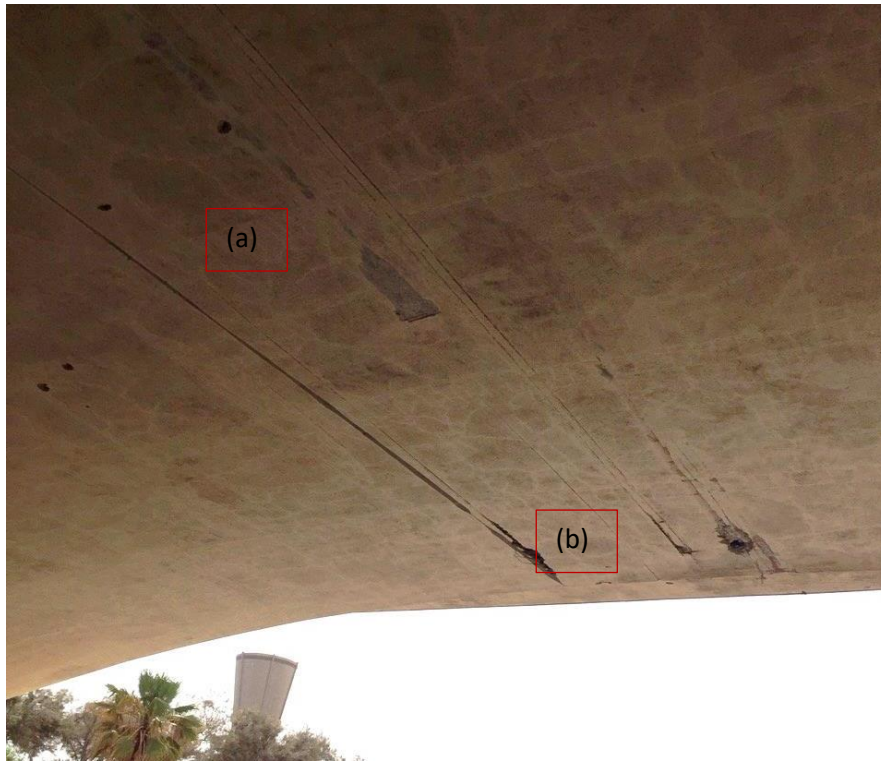
The characteristic damage of the down side of deck slab is net like cracks caused by drying shrinkage of repair mortar. Described damage is noticed on the whole down side of deck slab (Fig IX-27-IX-29).

Figure (IX-29): Local shallow (a) and deep (b) spalling off of repair mortar, bridge deck ceiling slab

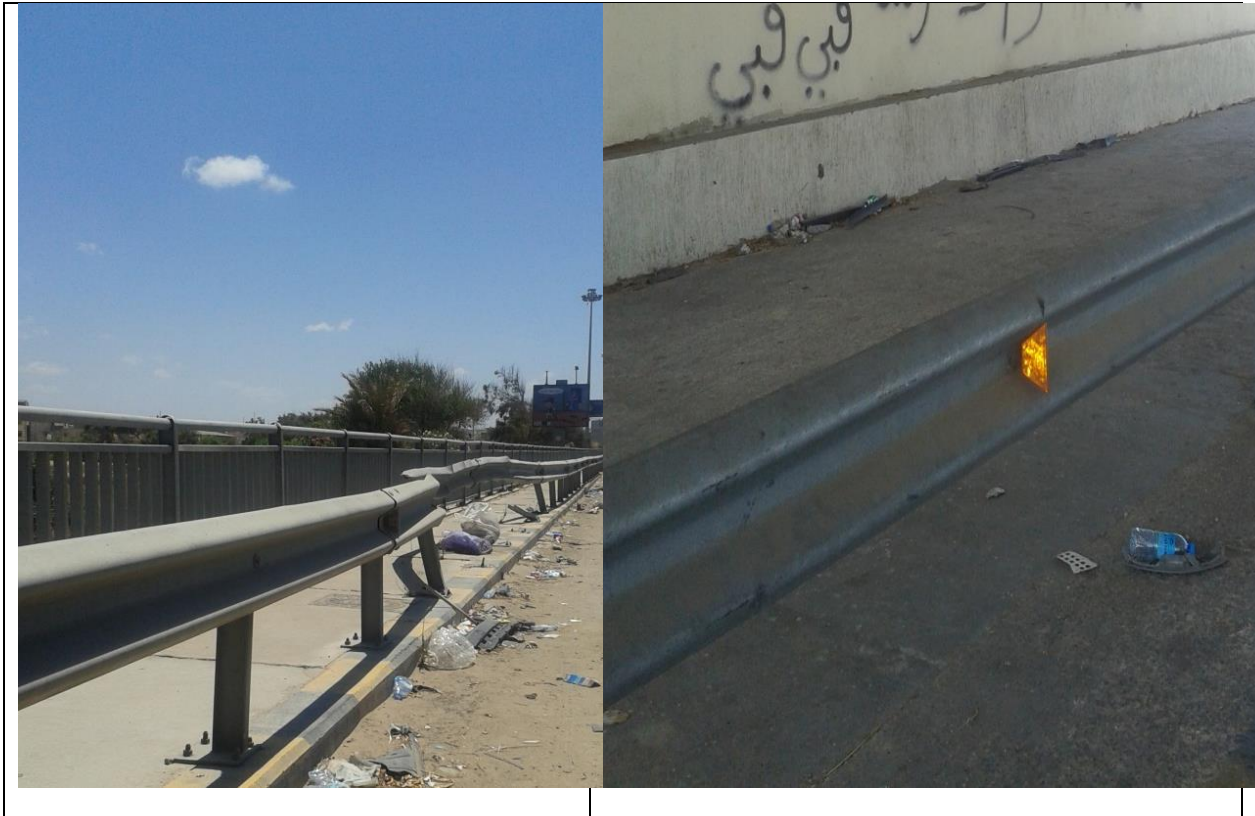
Figure (IX-41): General view of the guardrail on the bridge with damage

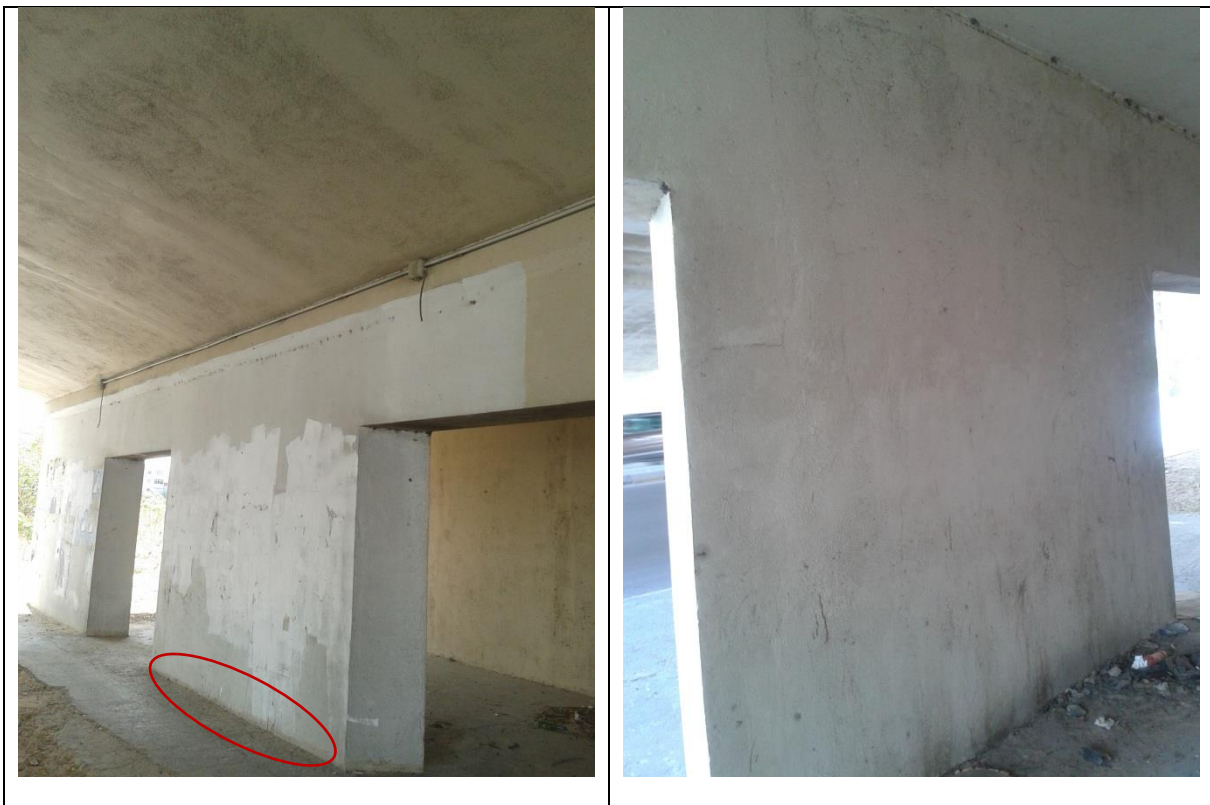
Figure (IX-51) View of supporting wall with ceiling, peeling off protective painting

Figure (IX-52) View of supporting wall, net like cracks

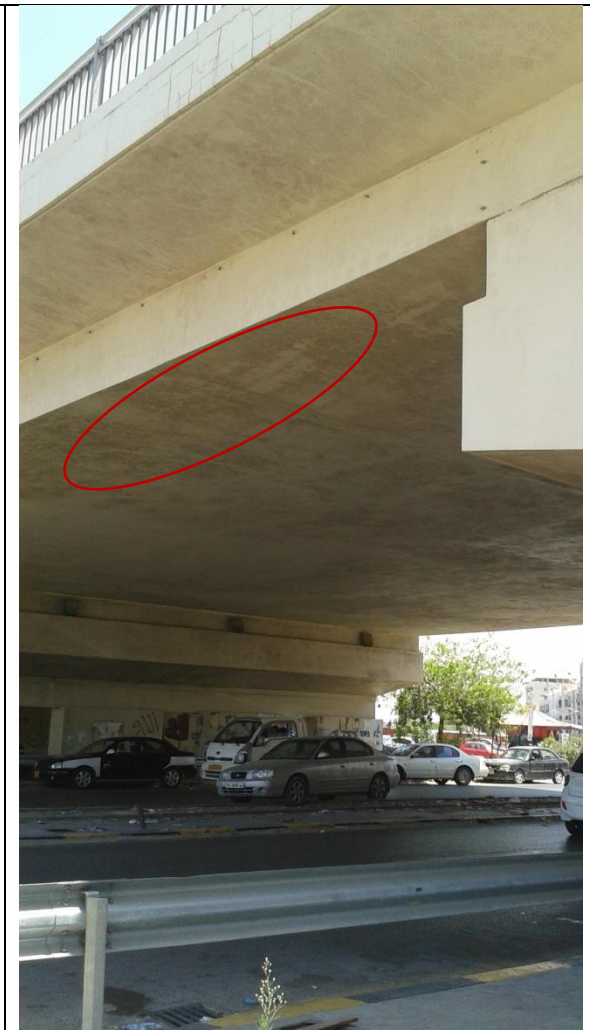
Figure (IX-70) View of deck slab, down side of cantilever slab with support walls, net like crack

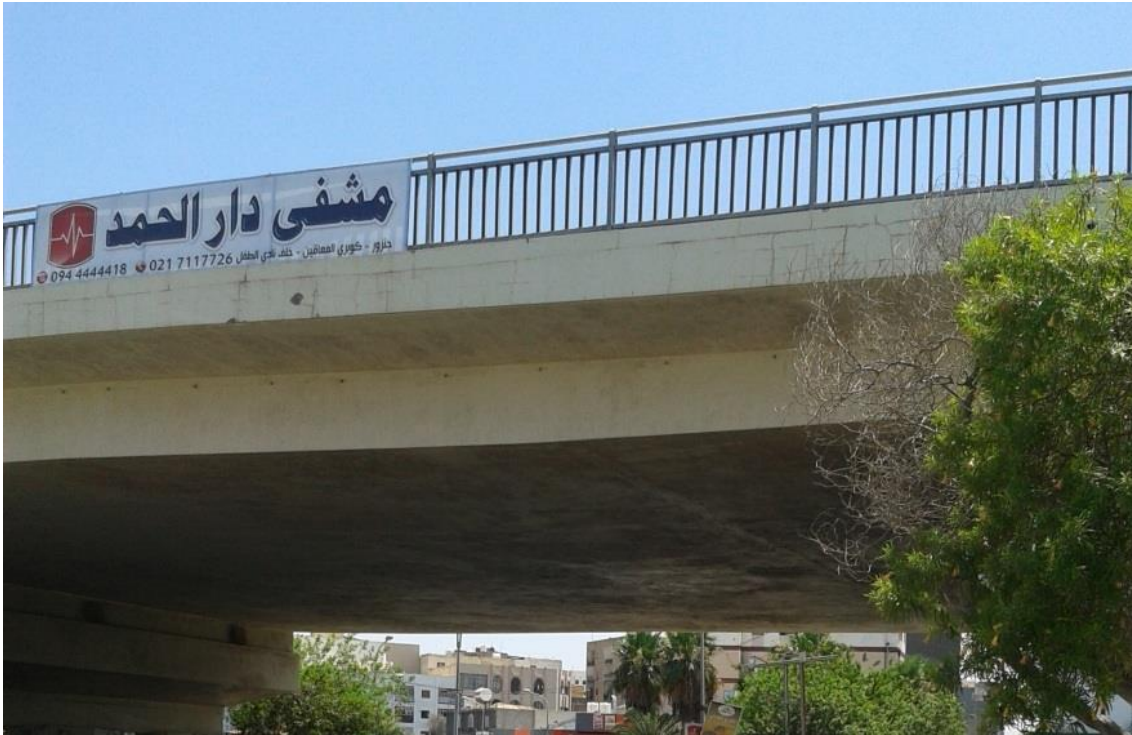
Figure (IX-71) View of cantilever slab, vertical and horizontal cracks

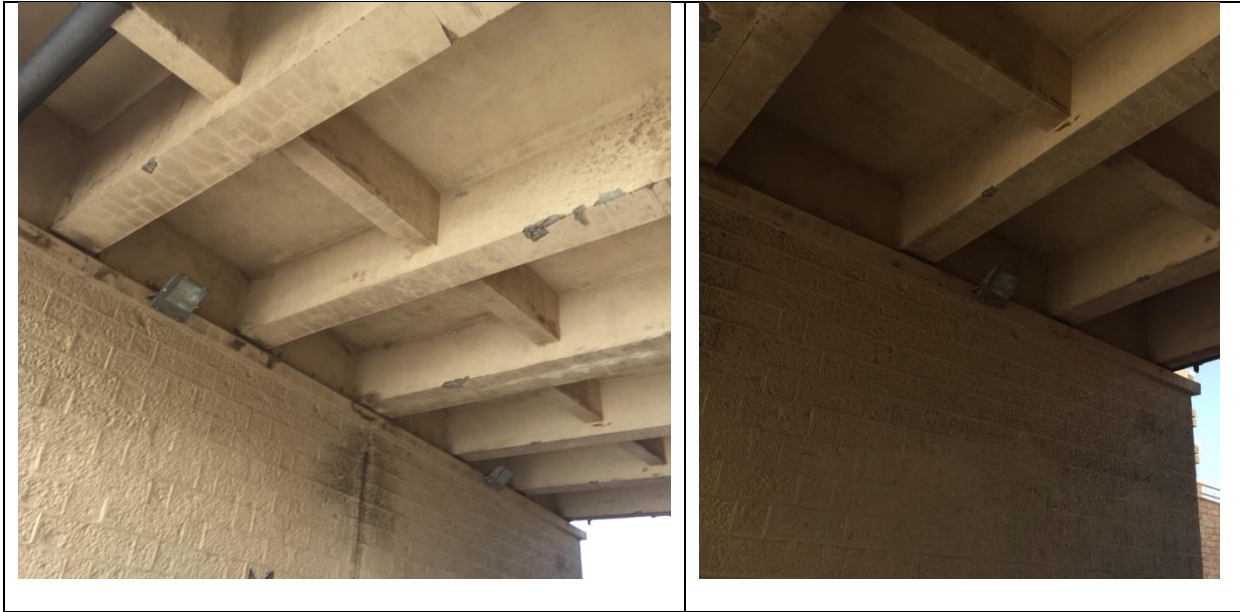
Figure (IX-94) Longitudinal and transversal supporting beams, net like cracks, corner spalling off, traces of dust
