**COMPARATIVE ANALYSIS OF DURABILITY AND
RANKING OF CONCRETE BRIDGES IN HOT
CLIMATES**

DOCTORAL THESIS

Novi Sad, 2022.

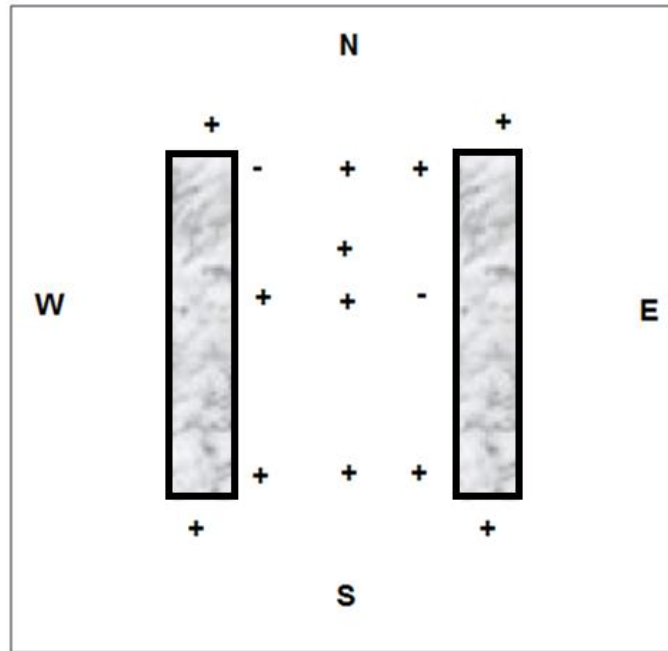
Figure VI-22. Carbonation test results for exterior walls and ceiling

Reference 1	Carbonization 2		Rebar Depth 3	Depth of carbonization 4	In Rebar plan 5	Element 6
	Yes	No	mm	mm		
05.01	X		20	20	Y	Lateral south wall
05.02	X		-	20	-	Abutment south side
05.03	X		20	20	Y	Exterior wall south side
05.04	X		20	20	Y	Exterior wall south side
05.05	X		-	30	-	Exterior wall in the middle
05.06		x	20	0	N	Exterior wall in the middle
05.07	X		-	20	-	Exterior wall north side
05.08		x	20	0	-	Exterior wall north side
05.09	X		20	40	Y	Lateral north wall
05.10		x	20	0	-	Exterior wall north side
05.11		x	40	0	-	In the slab
05.12		x	-	0	-	In the slab
05.13		x	-	0	-	In the slab
05.14	X		40	50	Y	Ceiling- south
05.15	X		60	60	Y	Ceiling- center
05.16	X		70	60	N	Ceiling- center
05.17	X		10	30	Y	Ceiling- center
05.18	X		60	50	N	Ceiling- north

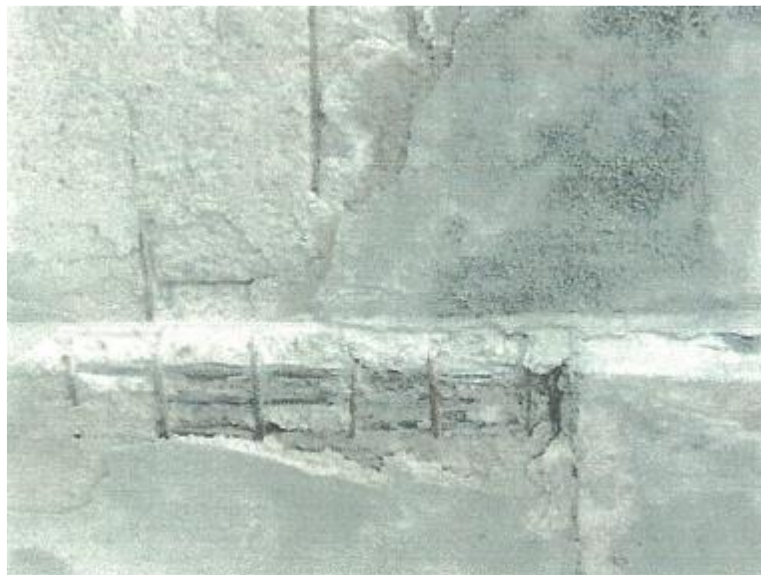
Figure VI-23. Exposed reinforced bars in lateral beam of arch slab, and in cantilever slab.
Corrosion of bars, falling down of cover and plaster layer

The most damaged elements are cantilever slabs with edge beams. The characteristic damage is falling down of concrete cover and ordinary plaster layer (Fig. VI-23, VI-26). Some reinforced bars were bared and affected by surface corrosion. The edges of slabs are rough and stain of water- and water-soluble salts can be seen.

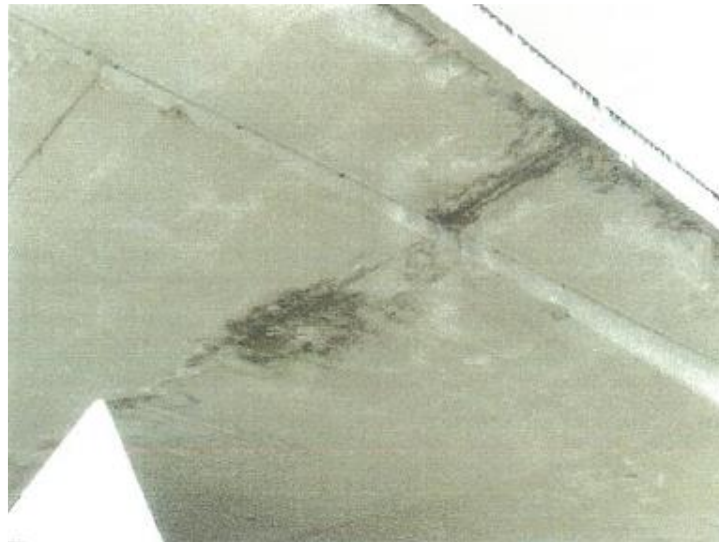
Figure VI-24. Leakage of water through cantilever slab and through joint between arch slab and simple supported beam slab, damaged edge of cantilever slab (edge beam)

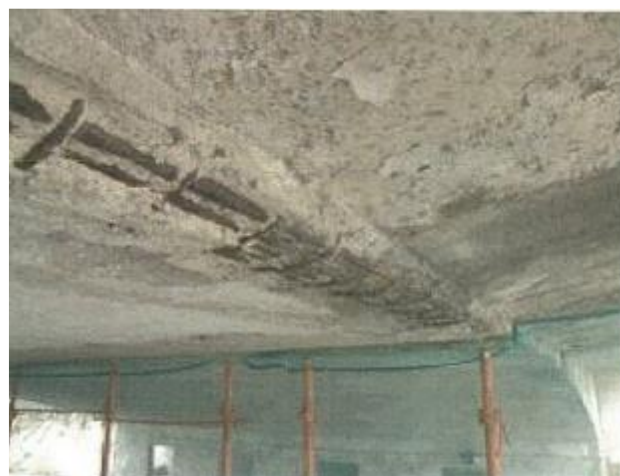
Figure VI-26. Exposed reinforced in beam slab next to the cantilever, corrosion of bars, falling down of cover and plaster coating

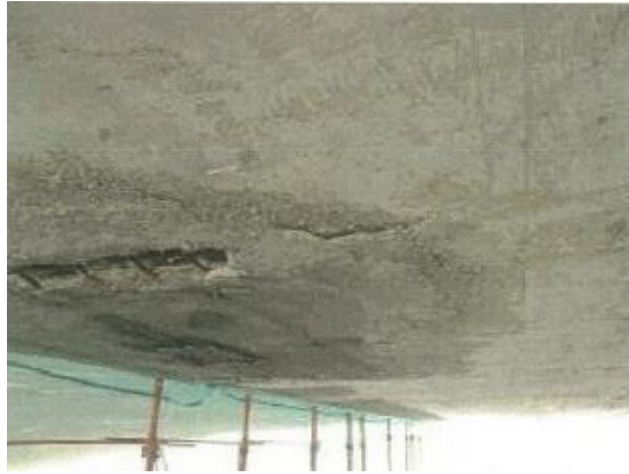
Figure VI-27. Deck ceiling slab: corrosion of rebars, delamination and falling down of deck ceiling cover, wet stains

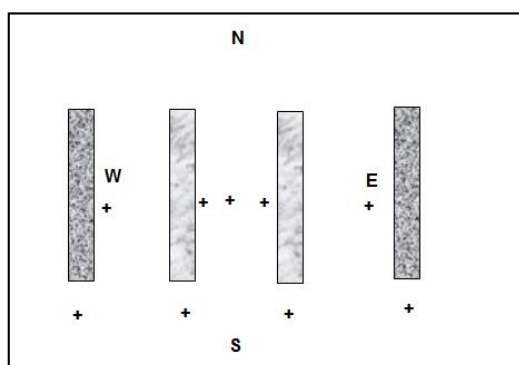
Figure VI-50. Carbonation test results for interior walls and ceiling

The main cause of damage appearance is carbonation. Almost all inspected elements had the problem with carbonation especially ceiling. In some cases, the front of carbonation even passed behind the bars.

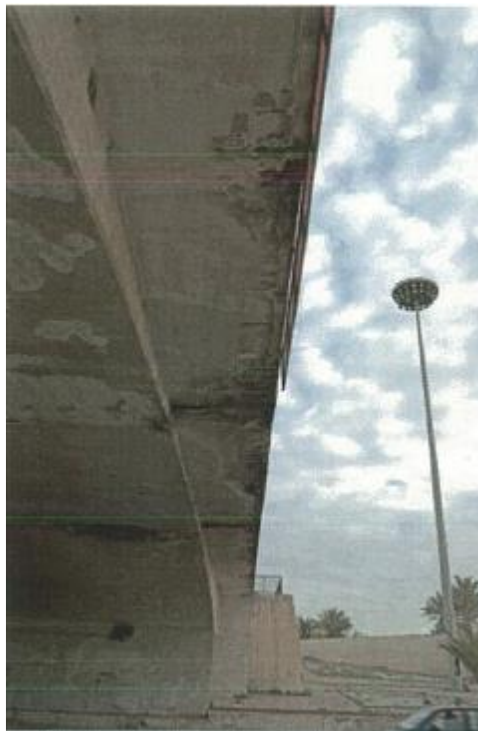
Figure VI-52. Cantilever slab and part of the ceiling deck; falling off painting and plaster layer, white and dark stains along the edge of slab, damage of concrete due to corrosion of reinforced bars

The most damaged elements are cantilever slabs with edge beams. The characteristic damage is falling down of concrete cover and ordinary plaster layer (Fig. VI-52, VI-54). Some reinforced bars were bared and affected by surface corrosion. The edges of slabs are rough and stain of water- and water-soluble salts can be seen.

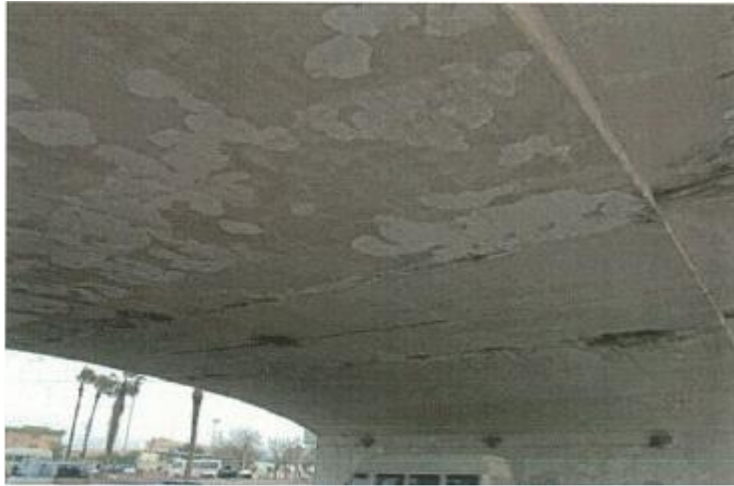
Figure VI-53. Deck ceiling, falling off painting and plaster layer, damage of concrete due to corrosion of reinforced bars

The next most damage element is deck ceiling slab. The most damaged parts of slab are lateral beams and center of simple beam slab (Fig. VI-53, VI-55). The characteristic damage on both places is reinforced corrosion. Due to the expansion of corroded bars, the concrete cover is cracked and fallen off. Apart from the center of ceiling slab, described damage has been noticed at several locations on the down side of ceiling slab (Fig. VI-53).

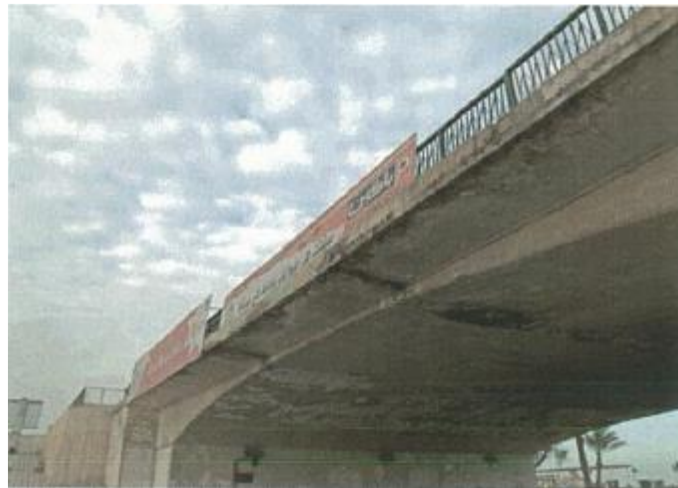
Figure VI-54. Cantilever slab and deck ceiling slab; the largest damage in the centre of these elements

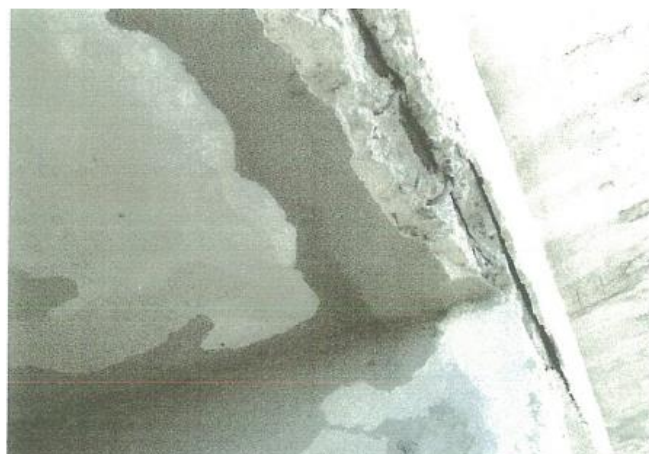
Figure VI-55. Detail of ceiling slab: falling off painting and plaster layer due to bad adhesion and concrete cover caused by corrosion of bars

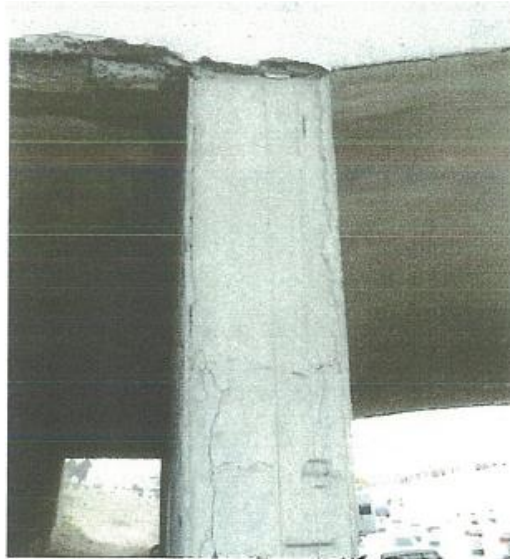
Figure VI-56. Interior wall; longitudinal cracks near edges due to corrosion of reinforced bars

Exterior walls have been damaged due to reinforced corrosion. Characteristic damage is vertical cracks, along bars near the edges of wall (Fig. VI-56).

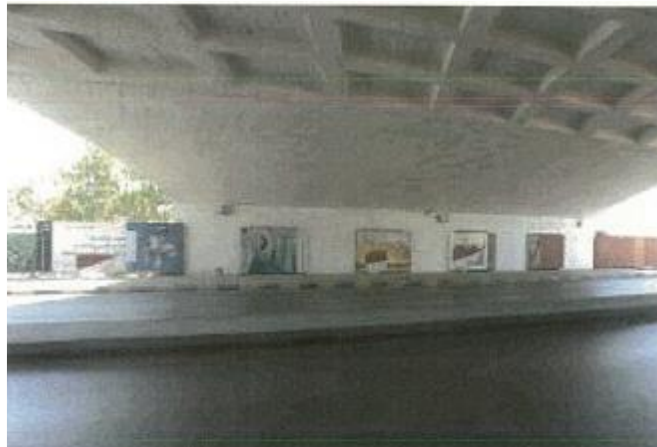
Figure VI-79. Desk ceiling, pilling off painting cover

The characteristic damage of ceiling is falling down of thin concrete cover and pilling off painting cover (Fig. VI-79). Some reinforced bars were borne and affected by surface corrosion. The edges of slabs are rough and stain of water- and water-soluble salts can be seen.

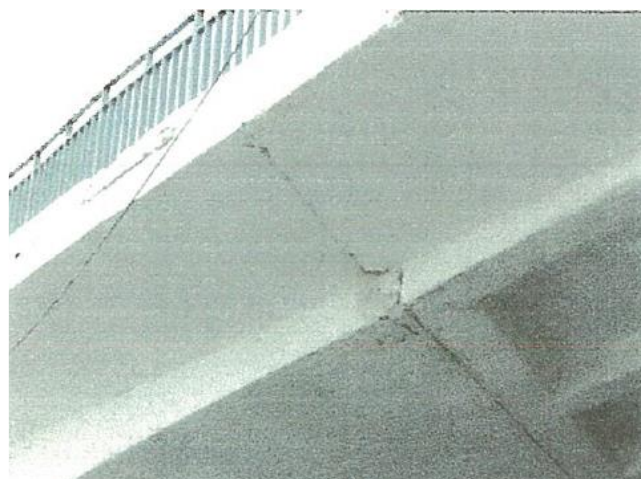
Figure VI-80. Desk ceiling, damaged joint between simple beam slab and arch slab, local corrosion of bars

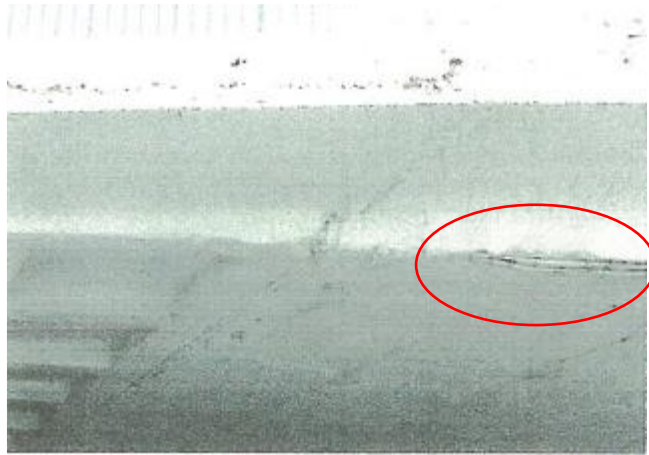
Figure VI-81. Bared and deformed reinforced bars

The most damage element is lateral beam. This beam was hit by truck. (Fig .VI-81 and IV-82). Because of very strong impact, down longitudinal bars were deformed and twisted and lost adhesion with concrete, several stirrups were broken and thin concrete cover was cracked and fallen down.

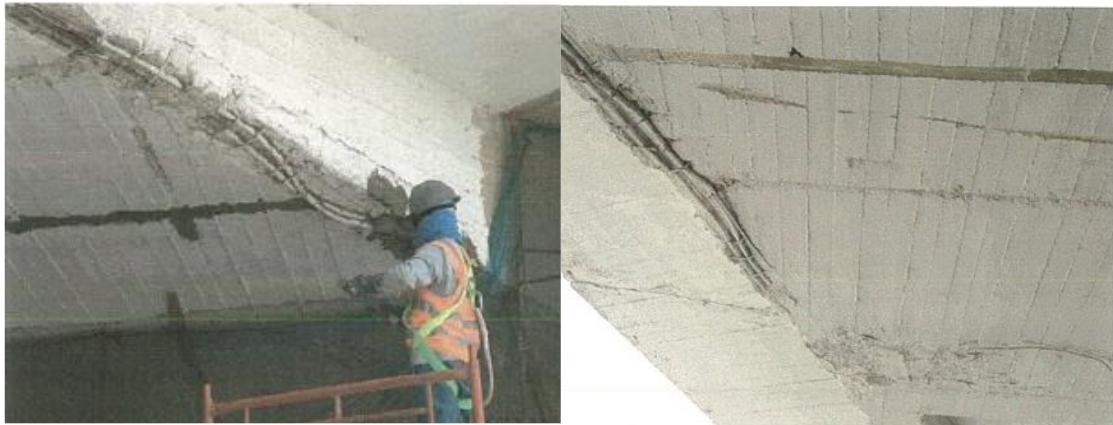
Figure VI-82. Bared, deformed and twisted reinforced bars in ceiling beam

The most damage element is south lateral beam. This beam was hit by truck. Longitudinal bars were deformed and twisted and lost adhesion with concrete, several stirrups were broken and thin concrete cover was cracked and fallen down.

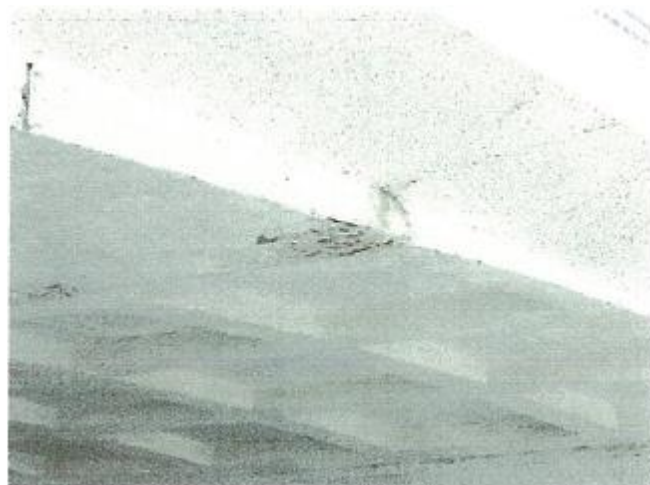
Figure VI-83 Ceiling, Local honeycomb, visible corroded bars

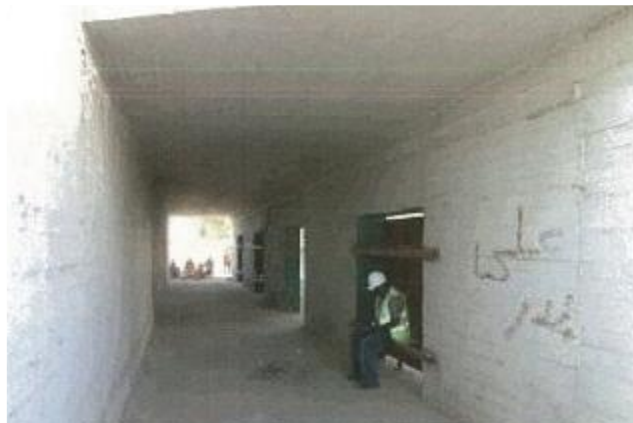
Figure VI-85. Tunnel between the interior wall and exterior wall, uneven concrete surface

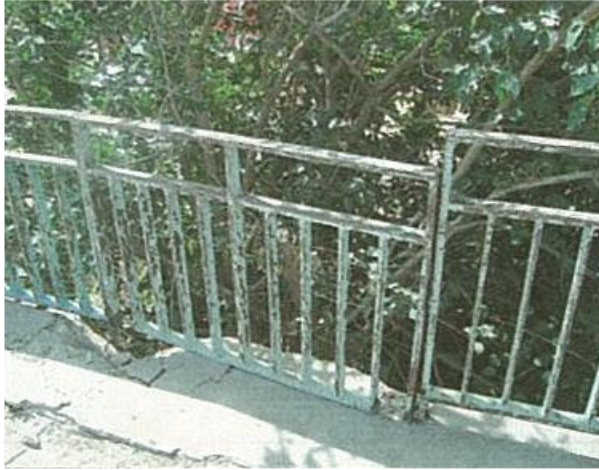
Figure VI-86. Damaged and corroded old fence and damaged part of side walk

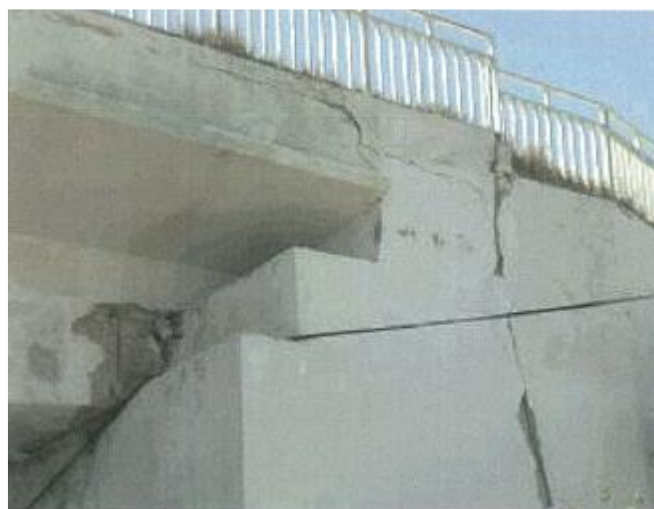
Figure VI-105. Damaged plaster and concrete next to the interior wall

After visual inspection of visible parts of elements of this bridge it was concluded that no serious damages were seen. Most noticed damages had local appearances (spalling of plaster (Fig. VI-105, VI-106, VI-108 and VI-109), surface spalling of concrete (Fig. VI-105), corrosion of rebars (Fig. VI-109) except of traces of leakage water on lateral beam and cantilever slab. They were visible on almost whole lateral surfaces of these elements (Fig. VI-107 and VI-109). The most damaged elements are cantilever slabs with edge beams. The characteristic damage is falling down of ordinary plaster layer (Fig. VI-106). The edges of slabs are rough and stain of water- and water-soluble salts can be seen.

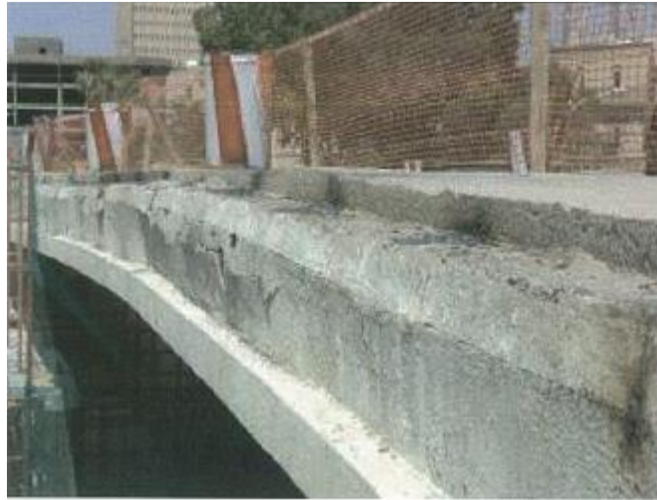
Figure VI-106. View of damaged cantilever from top the bridge

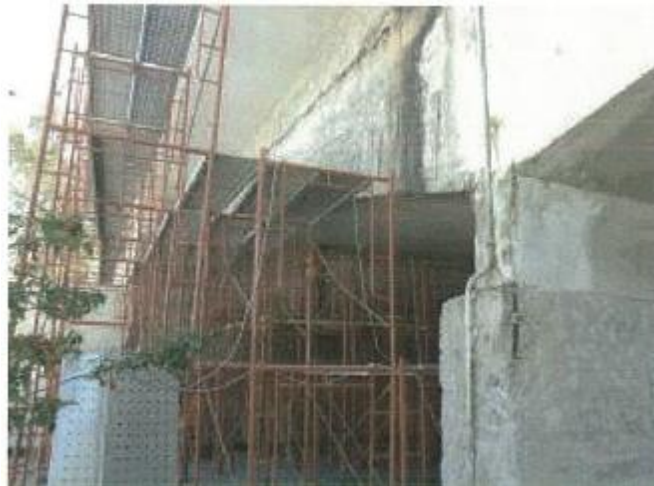
Figure VI-107. Dark traces of leakage water on lateral beam

The next most damage elements are lateral beams. These beams had problem with leakage of water through horizontal cold joints (Fig. VI-107 and VI-109). Described leakage of water caused local surface corrosion of reinforced bars and also local spalling of plaster layer.

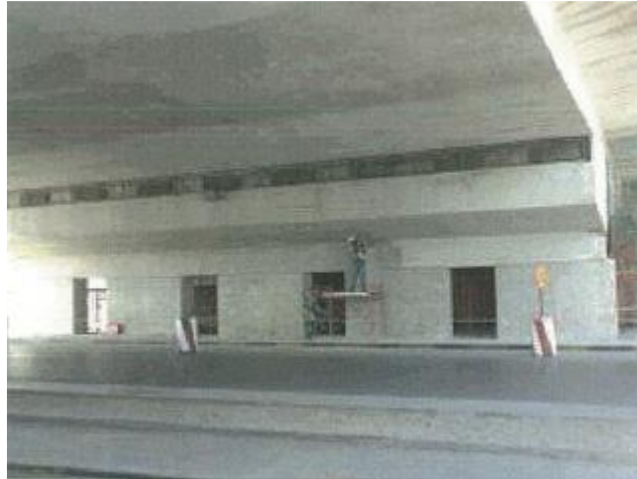
Figure VI-108. View of deck ceiling and exterior wall

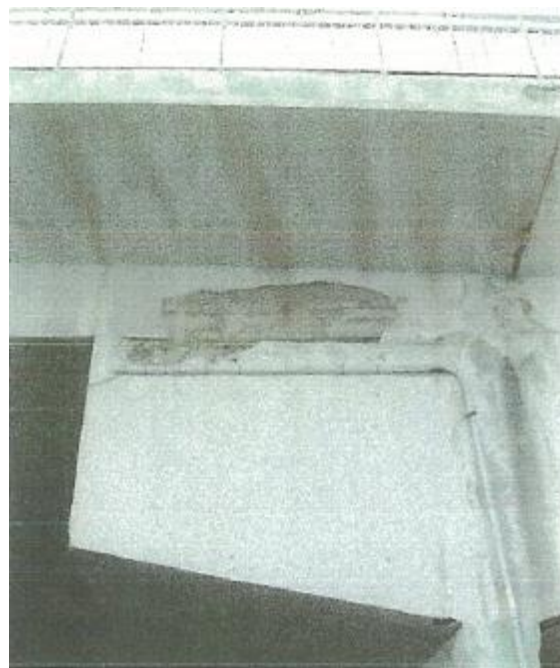
Figure VI-109. Spalling of plaster on deep supporting element

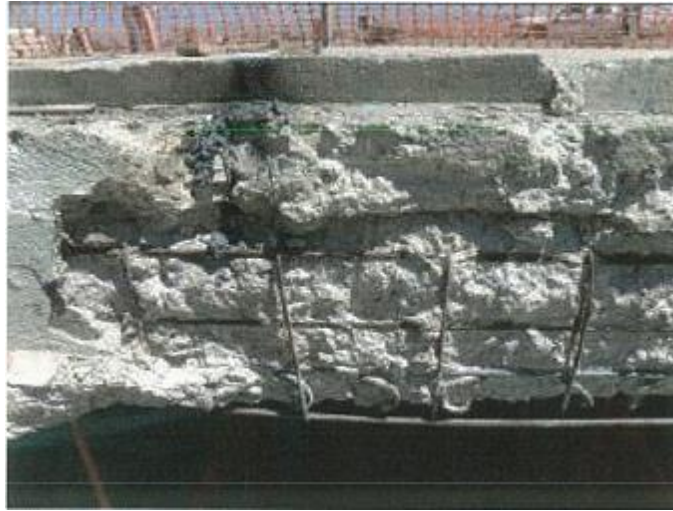
During removal of old plaster layer and carbonated concrete cover it was noticed, that concrete had very bad adhesion with rebars (VI-110), so they decided to remove all

“weak” concrete. They also discovered the almost all RC elements had a small concrete cover.

Figure VI-111. Bad adhesion between reinforced bars and concrete (cantilever slab)

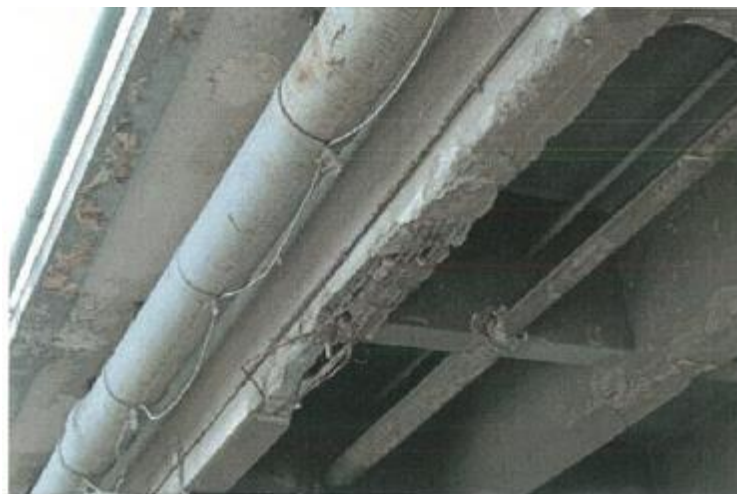
Figure VI-129. Damaged external longitudinal beam: bared, deformed and twisted rebars, crashed and cracked concrete reinforced in beam: spalling of mortar from cantilever slab

The most damaged elements are longitudinal slab beams. The characteristic damages are crashed concrete and deformed, twisted and even broken reinforced rebars (Fig.VI-129, VI-130). Some reinforced bars were bared and then affected by surface corrosion.

The main cause of described damages was hitting by truck. External longitudinal beams of both slab decks are significantly damaged because they were hit by truck several times.

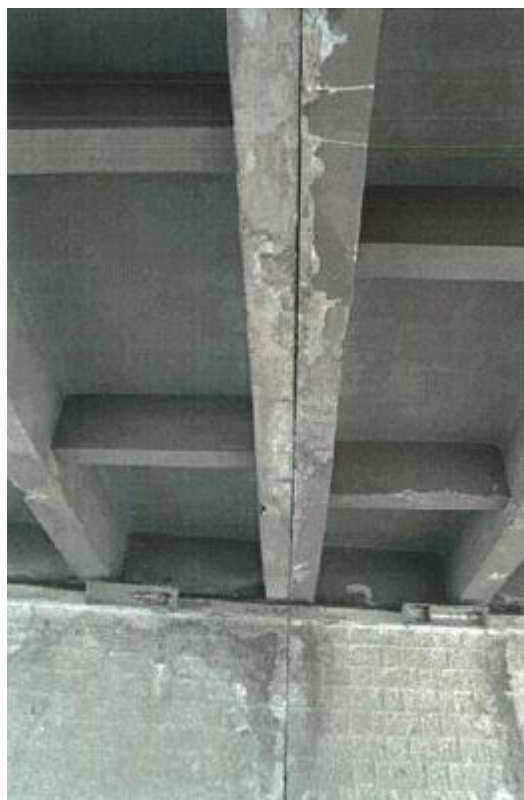
Figure VI-130. Joint between two deck slabs: water leakage, spalling of mortar layer, white and dark stains

Traces of water leakage and of overflow water could be seen in gap between deck slabs and on down surfaces of cantilever slabs.

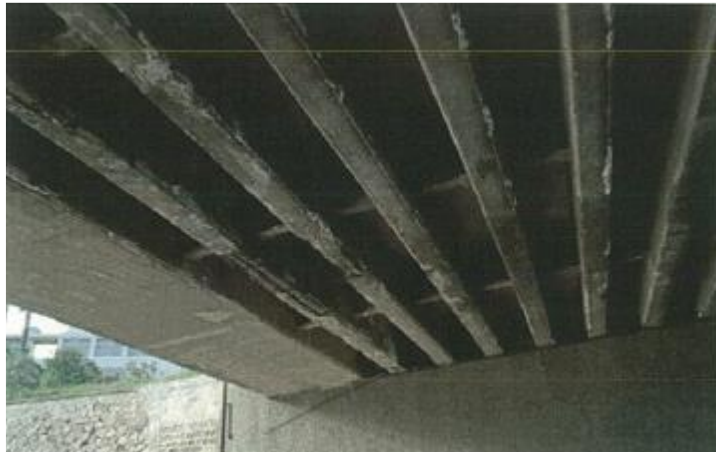
Figure VI-145. Damaged main beams: dark and white steins, reinforcement corrosion, spalling of concrete cover

The most damaged elements are main-longitudinal beams and cantilever slabs. The characteristic damage is reinforcement corrosion and, as result of that, falling down of concrete cover (Fig. VI-146, Vi-148). Some reinforced bars were bared and affected by surface corrosion. The edges of slabs and beams are rough and stain of water- and water-soluble salts can be seen. Due to the corrosion expansion of bars some parts of concrete cover on down side of cantilever slabs have been delaminated and falling to the road (Fig. VI-146).

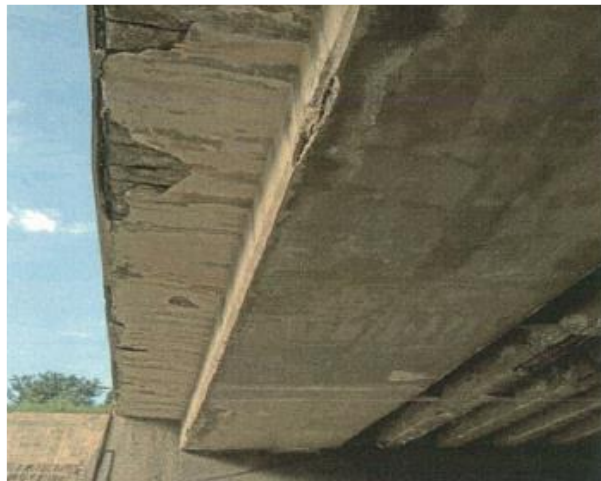
Figure VI-146. Cantilever slabs with damaged concrete (south side): delamination of concrete due to corrosion of rebars and running down of water

The next cause of damage appearance is inadequate drainage of water from the deck. This problem caused leakage of water over the edge of cantilever slabs. Consequently, the corrosion of reinforced bars in deck ceiling and cantilever slabs were caused.

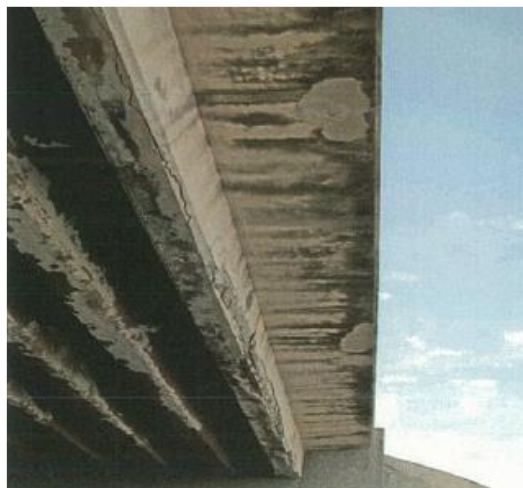
Figure VI-147. View of cantilever slab and main beams (north side): Longitudinal crack along the corner rebar, dark and white steins on beams and cantilever slab

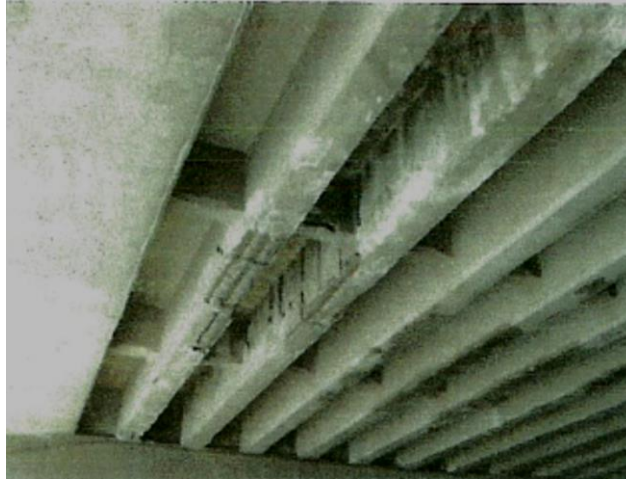
FigureVI-148. Exposed reinforced bars in slabs beams

The main cause of damage appearance is insufficient concrete cover. Measured value of concrete cover in elements of superstructure (ceiling beams and slabs) is only 5mm.

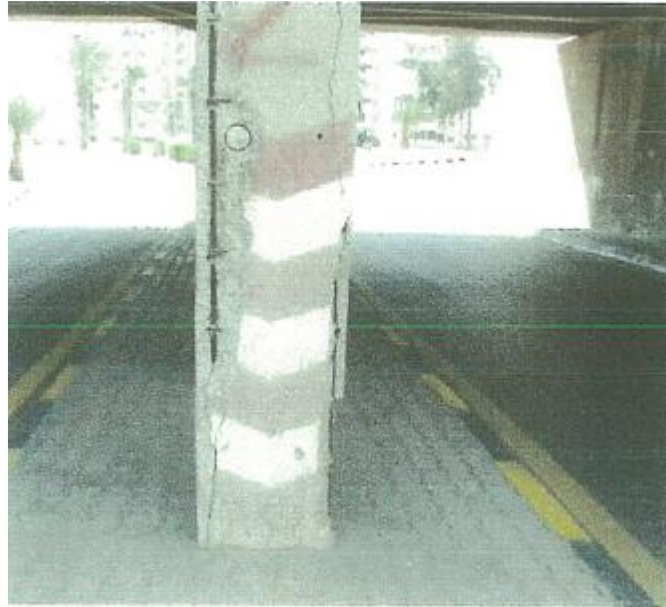
Figure VI-161. Damaged column: Exposed reinforcement bars, corrosion of rebar, cracking of concrete along the edge rebar, spalling off corner concrete

The most damaged elements are supporting columns and abutments. The characteristic damage is deep delamination and falling down of concrete cover (Fig. VI-159 – VI-162) and corrosion of rebars. The delamination and spalling off of cover affected a large area of columns, especially in corners, and a large area of abutments, also. Exposed reinforcing bars lost adhesion with concrete core (other part of concrete). The existing reinforcing bars in abutments are located very deep, almost in the middle of cross section and do not have any role in caring and transfer of load.

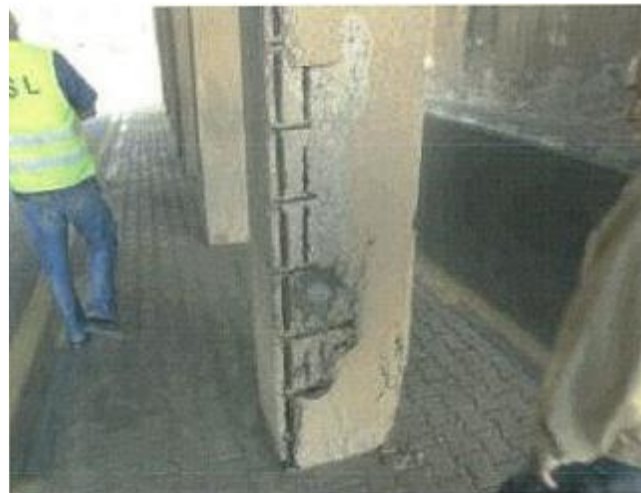
Figure VI-162. Damaged column: A large delamination and spalling off of cover, Exposed corroded reinforcing bars

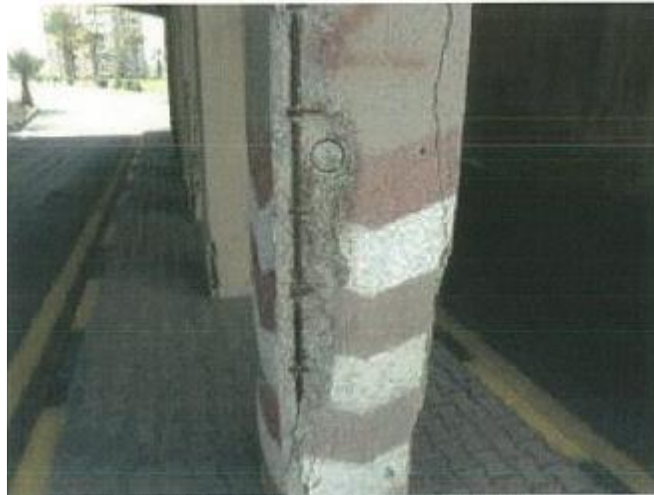
Figure Vi-163. Cracking of cover in support column, spalling off corner concrete

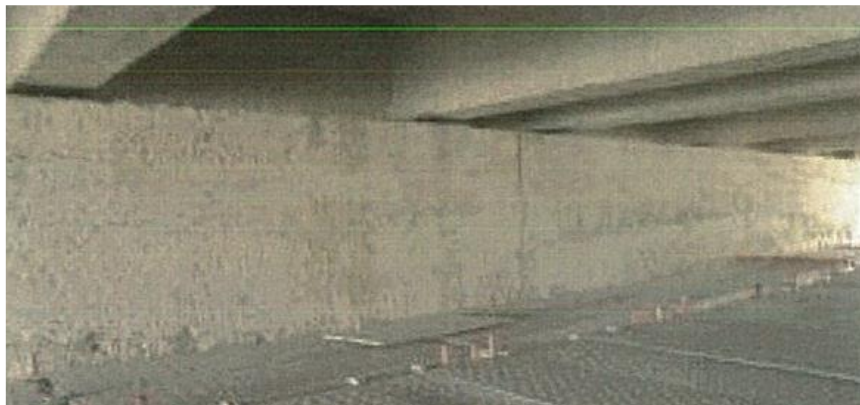
Figure Vi-164. Damaged upper part of abutment: deep spalling off of cover

The most damage elements are supporting columns and abutments. The main cause of damages is corrosion of reinforcing bars. The delamination and spalling off of cover affected a large area of columns, especially in corners, and a large area of abutments, also. Exposed reinforcing bars lost adhesion with concrete core. During visual inspection an inadequate arrangement of stirrups has been noticed in columns and the inadequate arrangement of horizontal and vertical rebars has been spotted in abutments. The distance between stirrups and reinforcing bars is too large. Other concrete elements also have damages caused by corrosion of still, but the degree of registered damages is lower than those in columns and abutments.

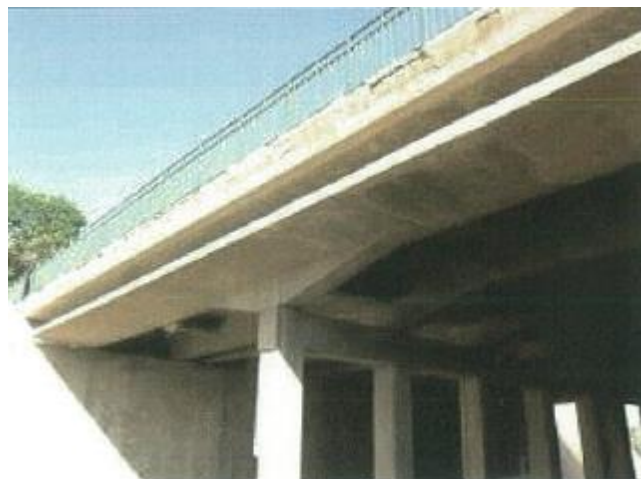
Figure Vi-165. Beam for fence with damaged concrete

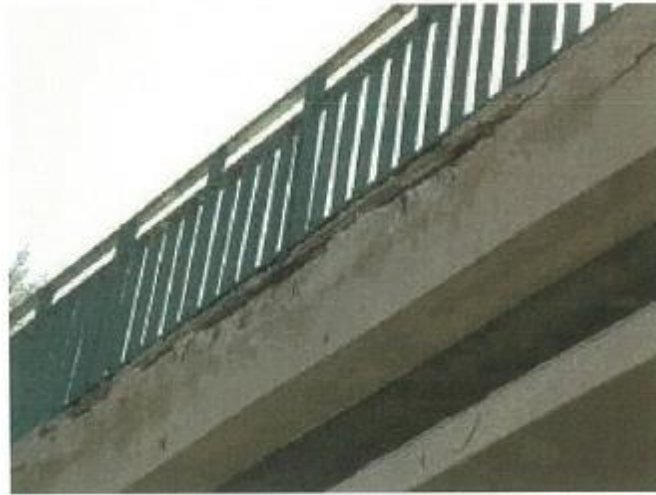
Figure VI-166. Beam for fence: Corrosion of reinforcing bars, insufficient depth of cover, cracking and falling off of concrete cover, water stains due to overflow of water over the edge of the beam

The next most damage element is beam for fence in the bridge deck. These elements have damages in the form of surface corrosion of rebars followed by cracking and falling off of cover (Fig. VI-161 and VI-168). The edges of beams are rough and stain of water- and water-soluble salts can be seen (Fig. VI-166). The main cause of described damage appearance is insufficient concrete cover and overflow of water over the edge of those beams.

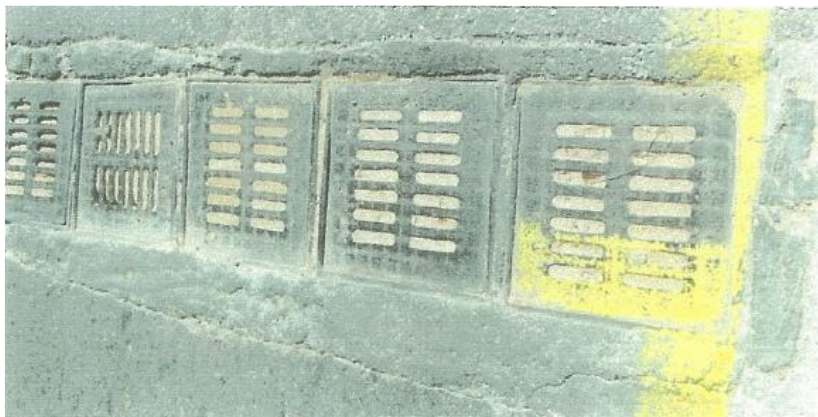
The drainage system of traffic lanes below the bridge is completely blocked with sand Fig VI-167. Because of that, storm water is collected below the bridge and formed accumulation of water up to 1,5m high. Those accumulations need long period of time for drying. The wetting and drying cycles during service life of bridge lead to heavy corrosion of the reinforcement in columns and abutments.

Figure VI-167. Blockage sewerage with sand

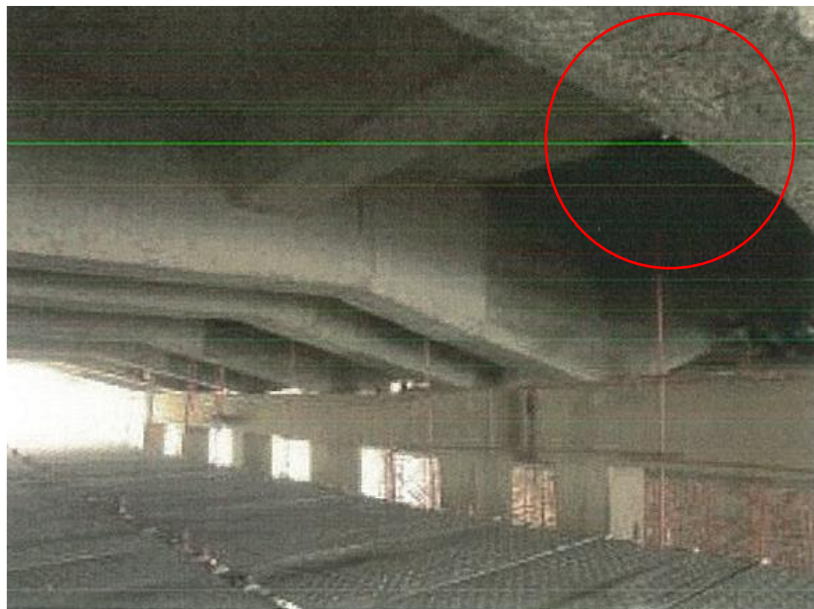
Other concrete structural elements (transversal beam, deck ceiling beams with top slab) are also damaged due to corrosion of reinforced bars in the form of cracking and spalling of concrete cover, but described damages aren't deep and catch only concrete cover. The main cause of described damage appearance is insufficient concrete cover and leakage of water over through expansions and cold joints. The concrete cover is thin and, in some cases, doesn't exist. Characteristic view of down surface of damaged deck ceiling beams is illustrated in Fig. VI-168.

Figure VI-168. Damaged deck ceiling beams, exposed rebar, thin cover, spalling off of cover

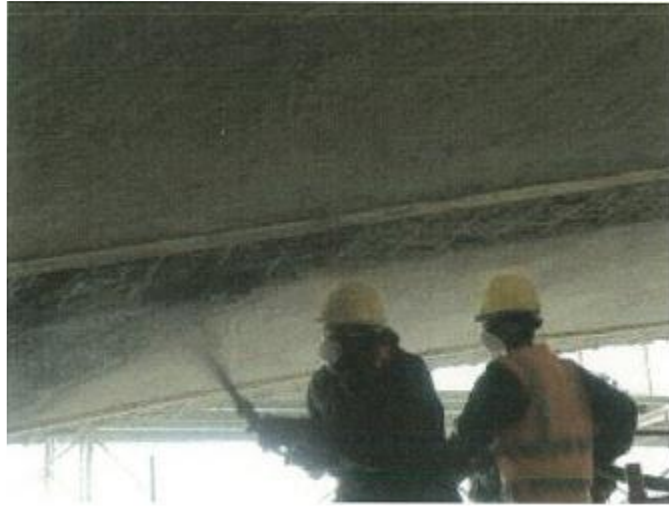
Figure (VIII-15) cementitious base special mortar on deck ceiling beams

For concrete restoration and for compensation of missing concrete cover the spatial type of repair mortar on cement base is chosen. Selected repair mortar should has next properties: strength class $\geq 45\text{MPa}$, low shrinkage, good adhesion $\geq 2\text{MPa}$, lower modulus of elasticity ($\geq 20\text{GPa}$) and good carbonation resistance.

For applying repair mortar, the method of spraying of repair mortar is suggested. This method has been selected as large surfaces have to be restored. Hence the new mortar cover sometimes overpasses 70mm it strongly recommended to apply mortar in min 2 layers to avoid drop of the fresh mortar, especially from ceiling.

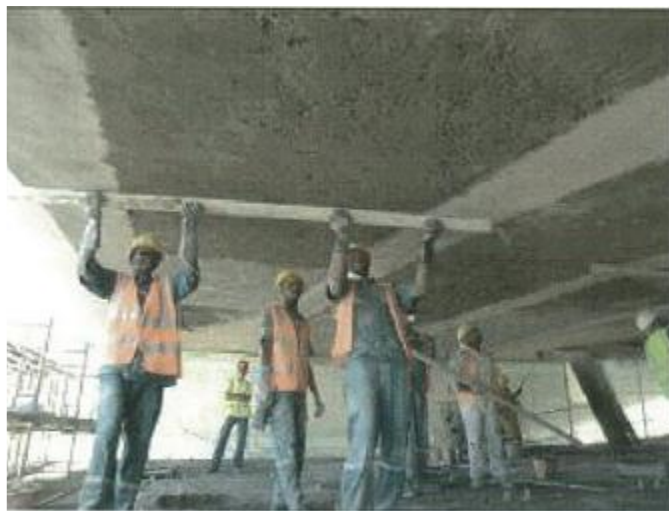
Figure (VIII-16) Deck ceiling slab with special mortar

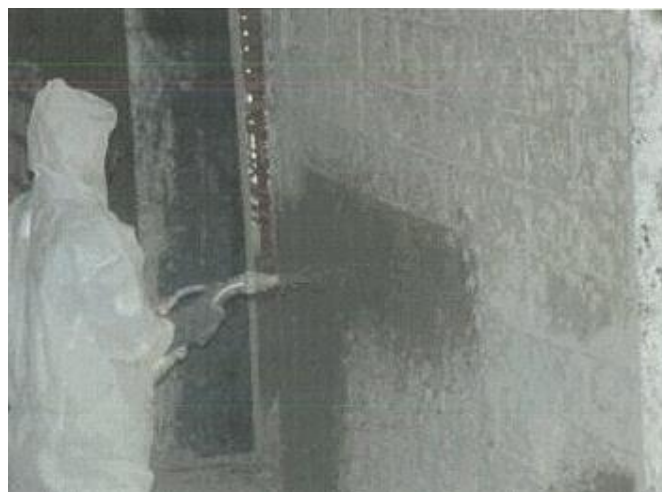
Figure (VIII-17) cementitious base special mortar on exterior walls

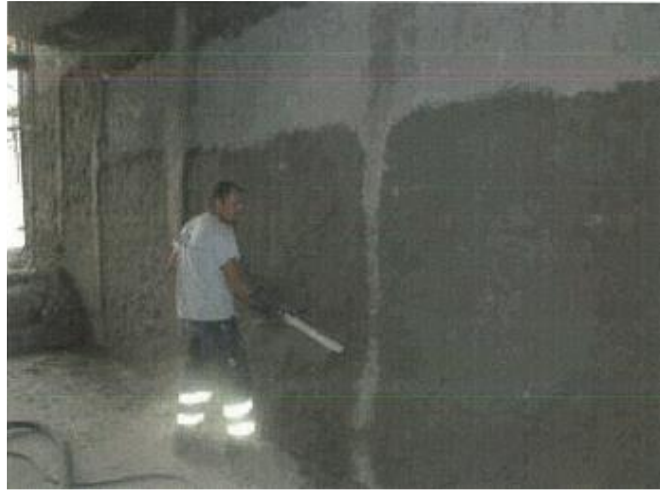
Figure (VIII-18) Levelling on the interior walls

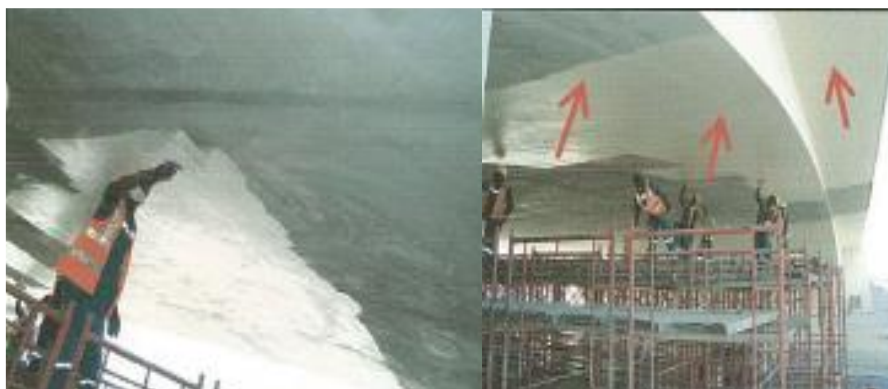
Figure (VIII-19) Application of protecting coating on ceiling by roller

For prolong the durability of repaired bridge it is advised to protect surface of concrete/repair mortar by applying surface coating. This coating will make continuous protective layer against carbonation and capillary water absorption. The acrylate resin base material is chosen for this purpose. Selected coating should has following properties: permeability to CO_2 ($S_d > 50\text{m}$), permeability to water vapor Class II, capillary water absorption ($w < 0,1 \text{ kg/m}^2 \text{ h}^{0,5}$), adhesion by pull-off test ($\geq 1,5 \text{ MPa}$). Selected protecting coating should be applied after finishing curing of concrete/repair mortar. For applying coating, the roller or brush can be used.

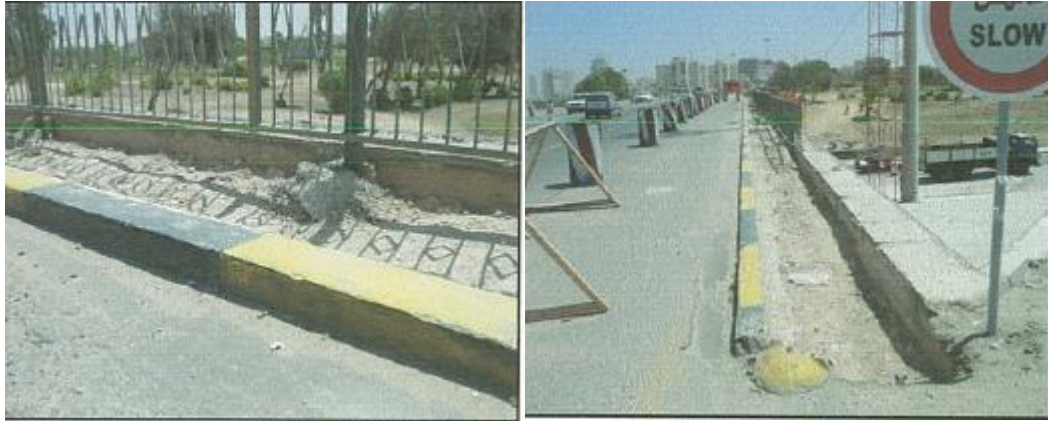
Figure (VIII-21) Removing of old sidewalks on bridge and between them

During the repair of these bridges, it was decided to remove all sidewalks and part of curbstone and old concrete under the fences over the bridges Souk Athulatha1 and 2 and between these bridges (Fig VIII-21). After repairing the edge beams and other structural elements of bridge and preparing sub base between the bridges, it has been planned to cast new sidewalks and curbstone (FigVIII-22, VIII-23).

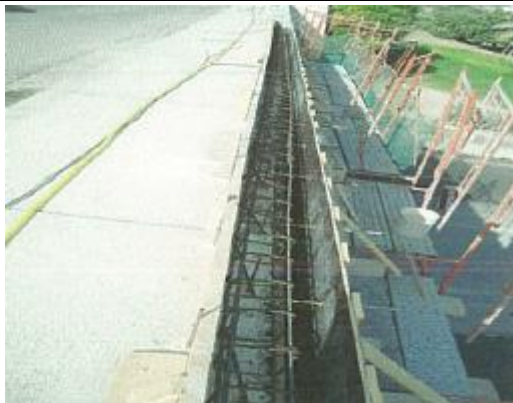
Figure (VIII-28) Reinforcement for new beam

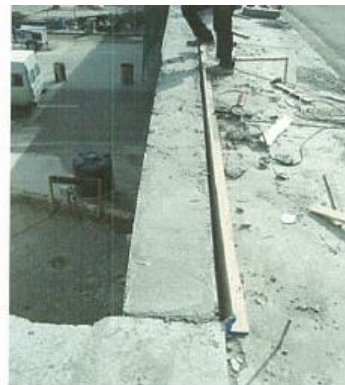
Figure (VIII-29) Casted edge beam

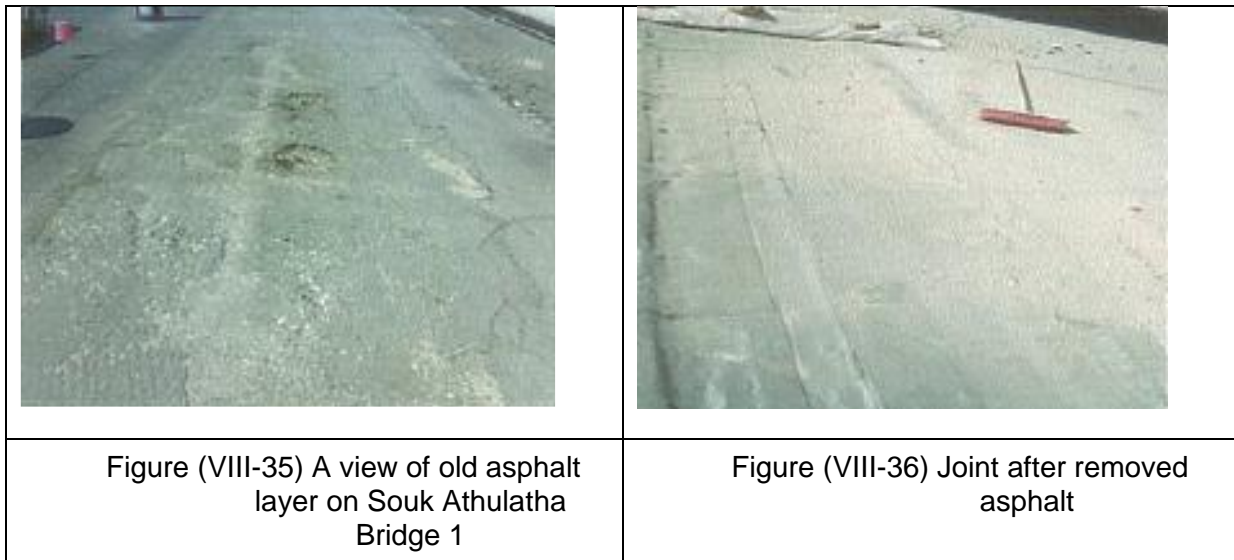
Figure (VIII-35) A view of old asphalt layer on Souk Athulatha Bridge 1

Figure (VIII-36) Joint after removed asphalt

- Removing the surface layer over the bridge ($t=4\text{cm}$) using milling machine.
- Opening the cracks
- Cleaning cracks and whole surfaces
- Injecting of all cracks in binder course
- Laying of new wearing layer

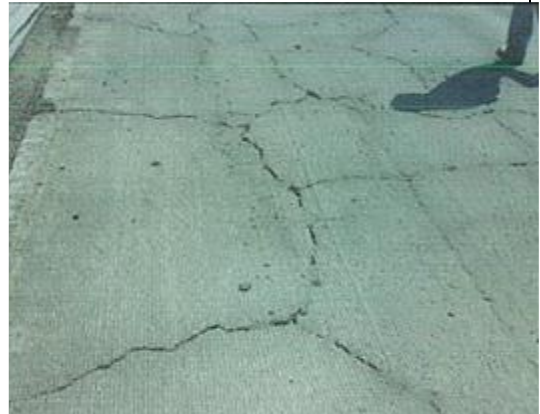
Since a lot of cracks have been noticed in down layer, it was decided to fulfill them by injection. Before injection, the cracks have to be opened and cleaned. All these operations are shown in fig (VIII-37-VIII-38).

Figure (VIII-38) Cracks in down layer, after cleaning

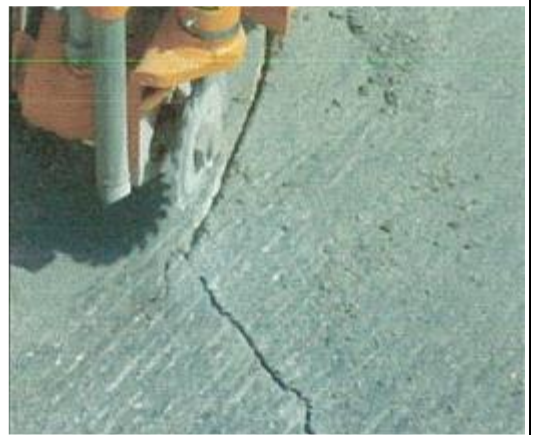
Figure (VIII-40) Opening the crack by special machine

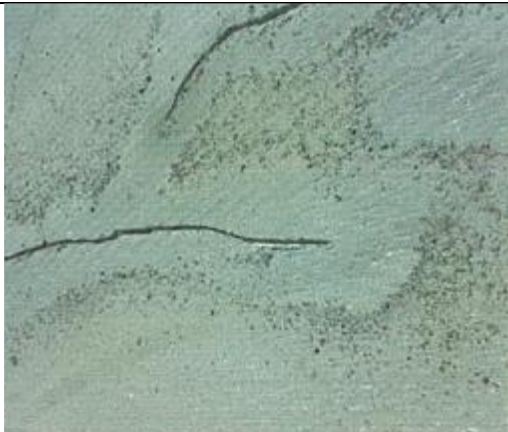
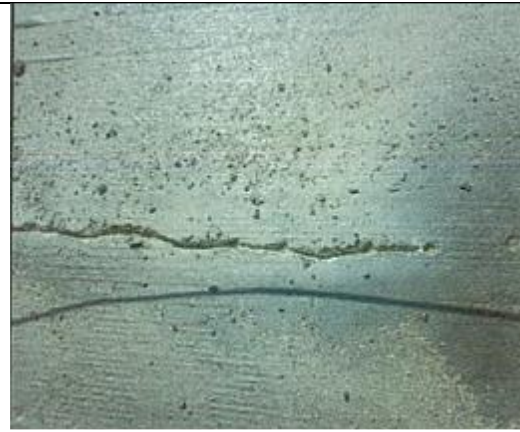
Figure (VIII-41) The view of cracks after use machine

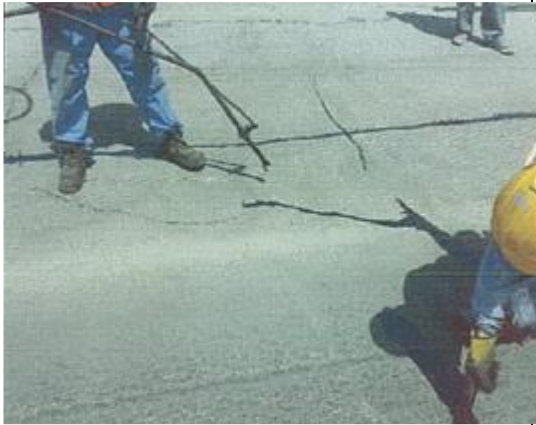
Figure (VIII-42) Injection of cracks by machine

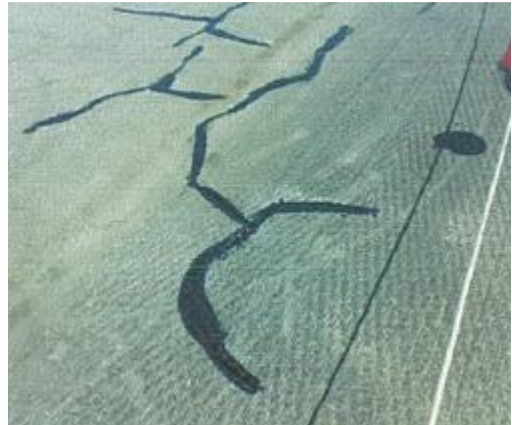
Figure (VIII-43) View of cracks after injection

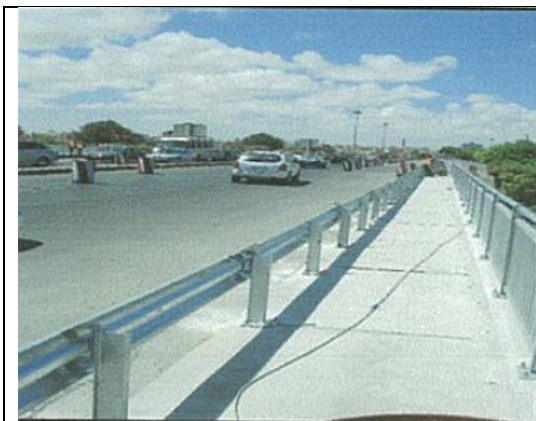
Figure (VIII-55) Fence and guardrail after installation

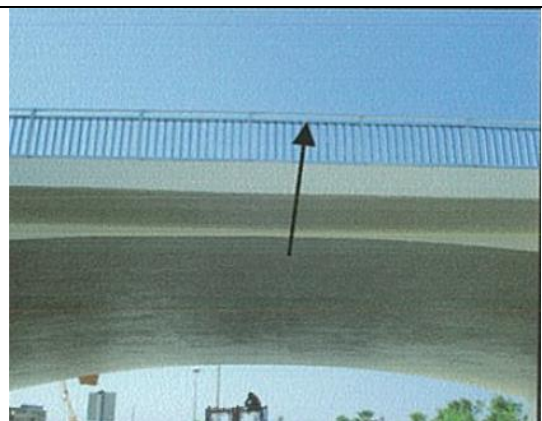
Figure (VIII-56) Fence on bridge after fixing

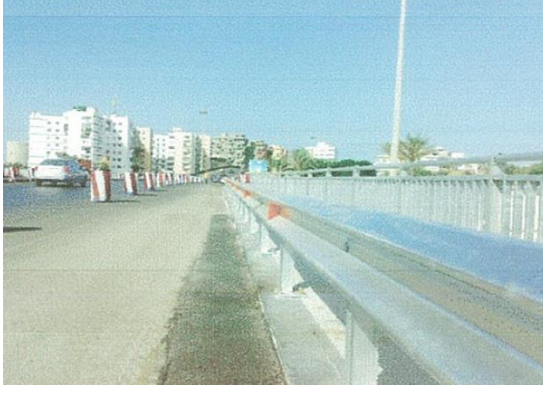
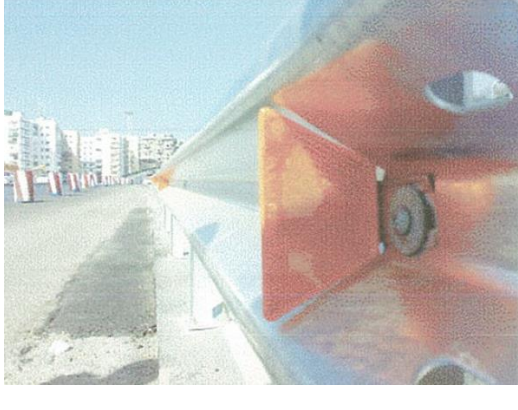
<p>Figure (VIII-57) Reflective sign in guardrail</p>	<p>Figure (VIII-58) Reflective sign in guardrail, detail</p>
