**COMPARATIVE ANALYSIS OF DURABILITY AND
RANKING OF CONCRETE BRIDGES IN HOT
CLIMATES**

DOCTORAL THESIS

Novi Sad, 2022.

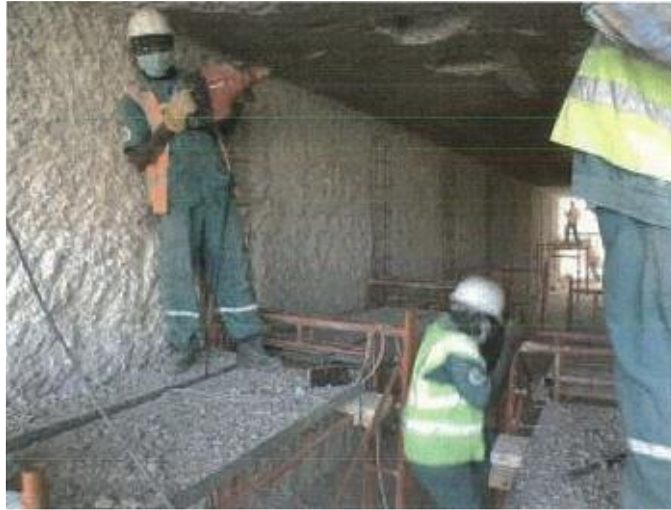
Figure (VIII-60) Damaged concrete removal from tunnel ceiling

- Complete removal and execution of new RC edge beams,
- Complete concrete cover removal,
- Complete rebar treatment (even including rebar replacement)
- Rebar protection
- Bonding slurry application
- Execution of new concrete cover with minimum depth of 20mm.
- Corrosion inhibition impregnation of all bridge exposed surfaces.
- Surface protection with coating of all repaired concrete elements.

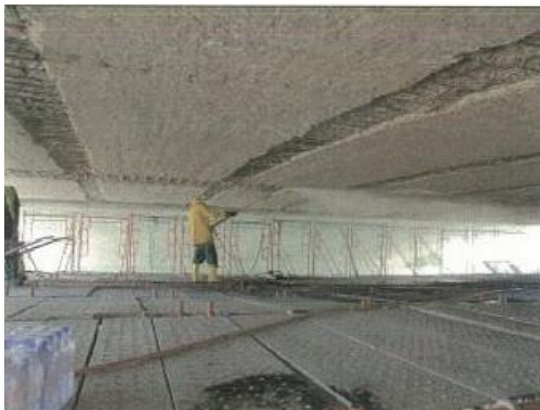
Figure (VIII-61) Rebars cleaning with water-sand blasting in deck ceiling slab

Fig (VIII-61, VIII-62) show the operation of cleaning bars with mixed water-sand blasting method.

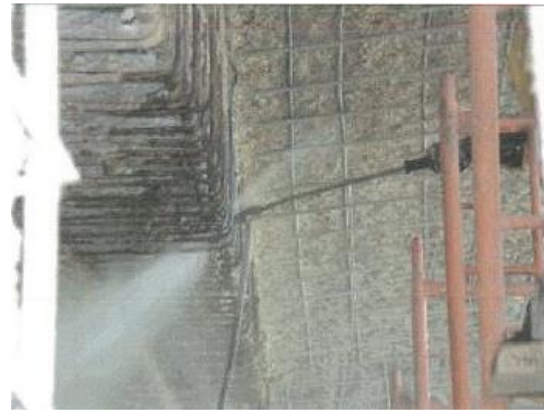
Figure (VIII-62) Rebars cleaning with water-sand blasting on lateral beam

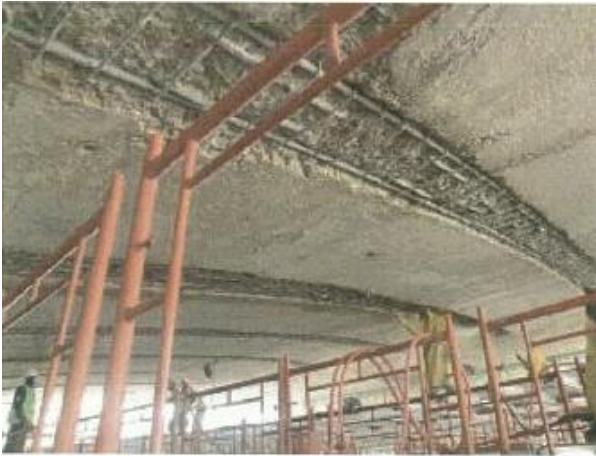
Figure (VIII-63) Covering the rebars on ceiling beams with cementitious base protection

Photos (VIII-63, VIII-64) illustrate the process of treatment rebar with cementitious base protection material and view of protected rebar.

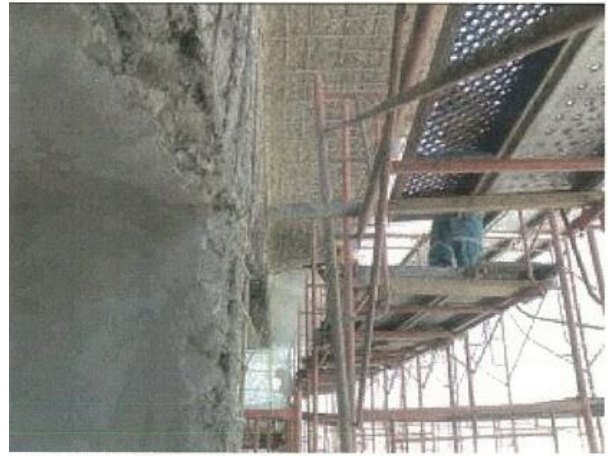
Figure (VIII-64) Rebars protective coating on cantilever

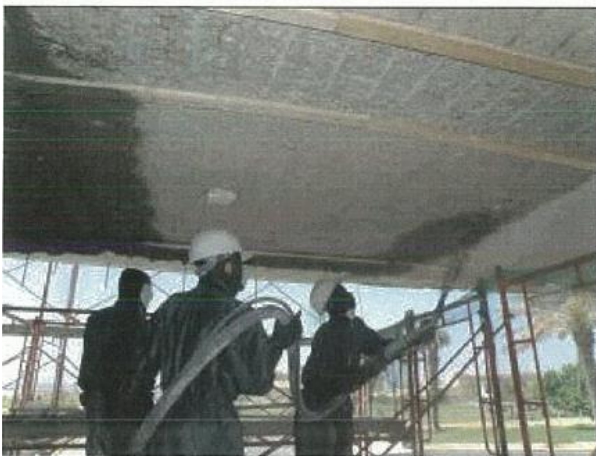
Figure (VIII-65) Cementitious base special mortar on deck ceiling beams

Photos (VIII-65 – VIII-66) illustrate procedures of applying and finishing of new mortar layer on ceiling and on walls.

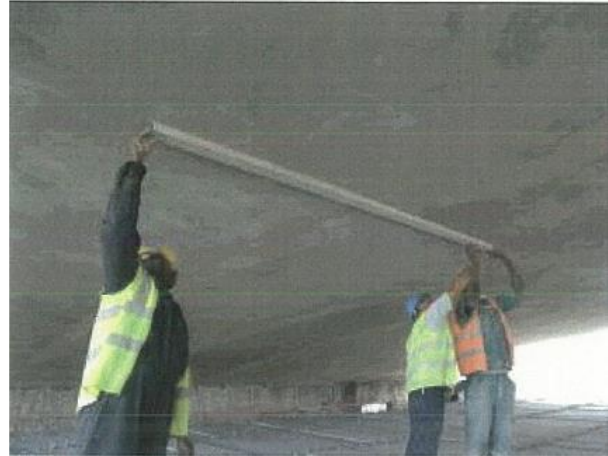
Figure (VIII-66) Deck ceiling slab with special mortar

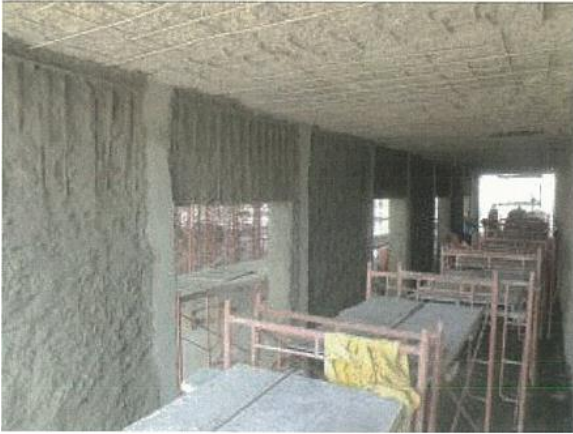
Figure (VIII-67) Cementitious base special mortar on exterior walls

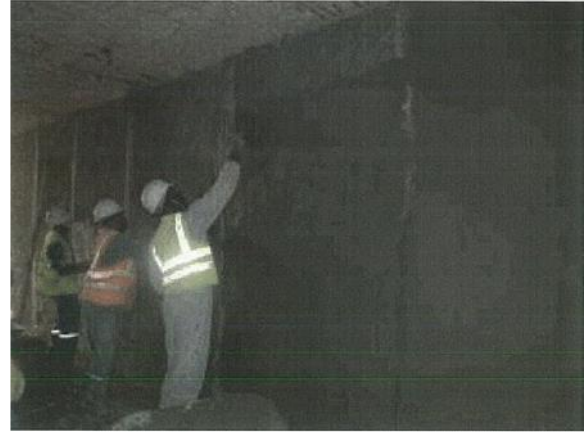
Figure (VIII-68) Levelling on the interior walls

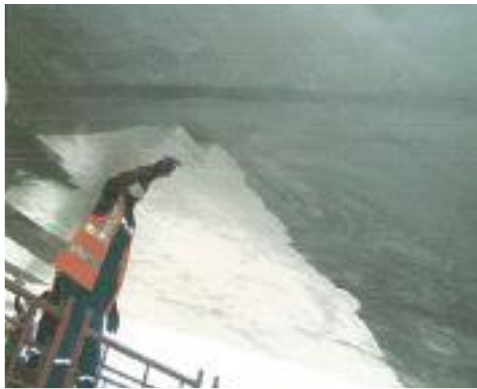
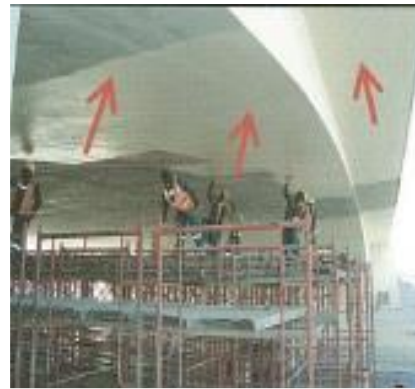
Figure (VIII-69) Application of protecting coating on ceiling by roller

Application of protecting coating is shown in fig (VIII-69).

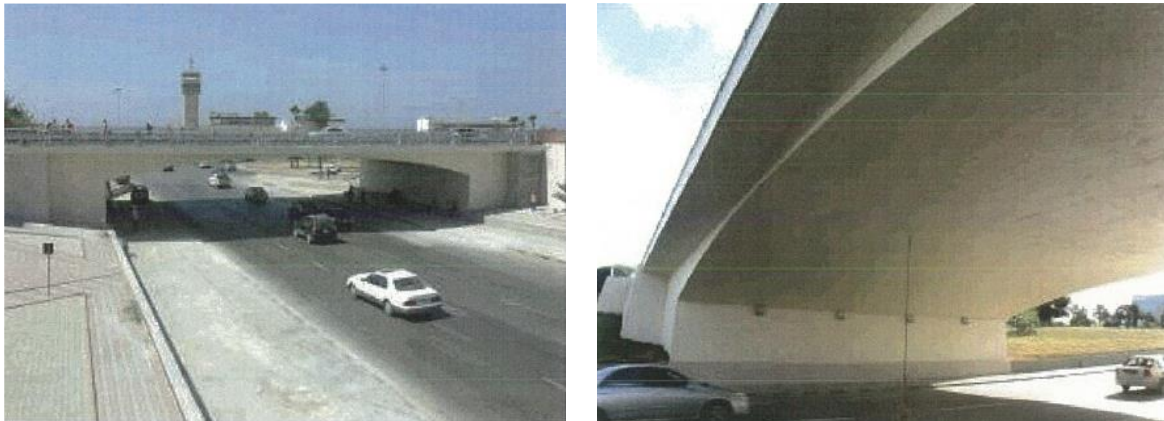
Figure (VIII-71) Final bridge

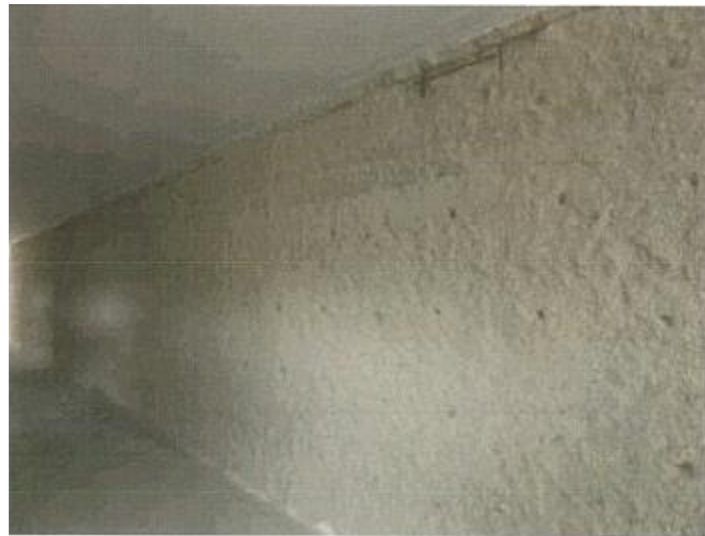
Main causes of described damage are carbonization of concrete (up to 70mm in ceiling and up to 90mm in abutment), insufficient concrete cover depth and porous concrete.

Figure (VIII-72) Damaged concrete cover removal from interior walls

After finishing concrete removal all surfaces must be clean with water jet with pressure of 200bar. The application of water jet has to be with angle of 45° and with 5 cm distance.

The removal of old porous and carbonated concrete cover from abutment wall and ceiling beam is shown in figures Fig (VIII-72- VIII-75).

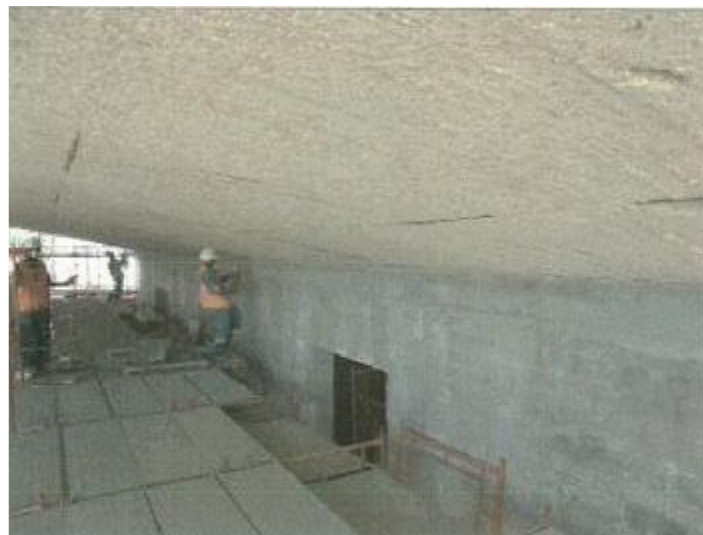
Figure (VIII-73) Damaged concrete cover removal from ceiling beams

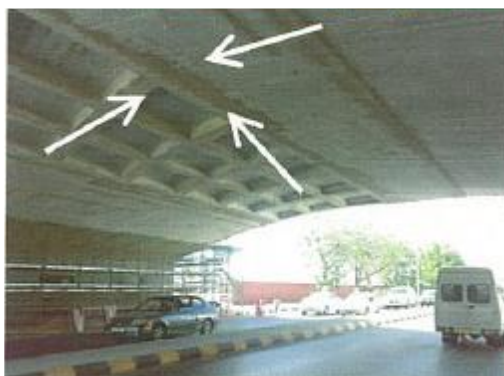
Figure (VIII-74) Local removal work on ceiling

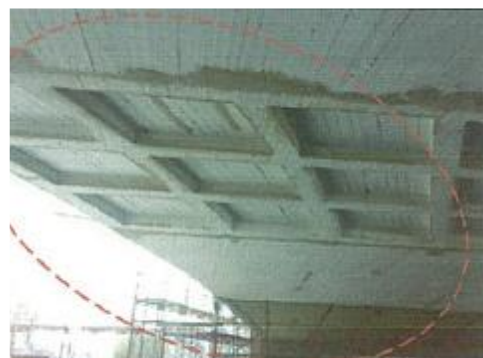
Figure (VIII-75) Local removal work on ceiling of simple beam

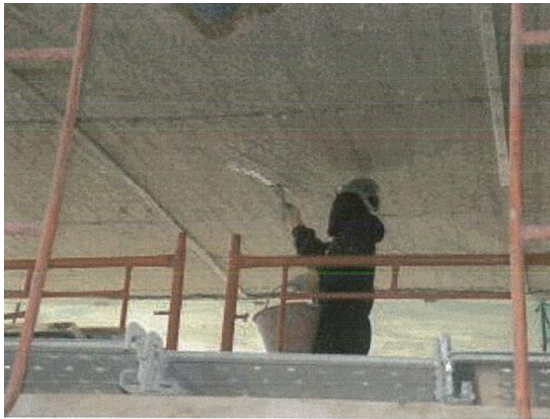
Figure (VIII-76) Rebars protection with cementitious base material

All recommended measures for repairing damaged concrete elements were: rebar protection, reinforcement rebar replacement (deformed and broken ones), bonding agent application, concrete restoration and execution of new cover, corrosion inhibition protection and surface protection.

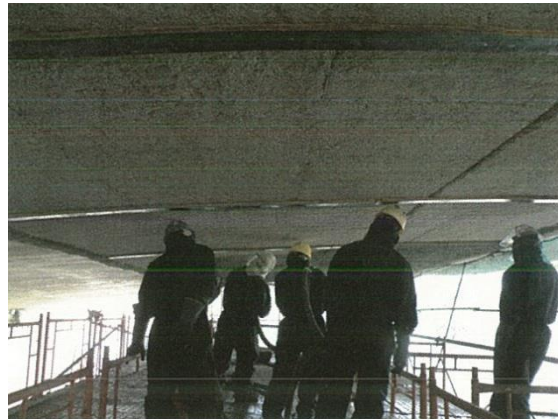
Figure (VIII-77) Preparing for plastering ceiling

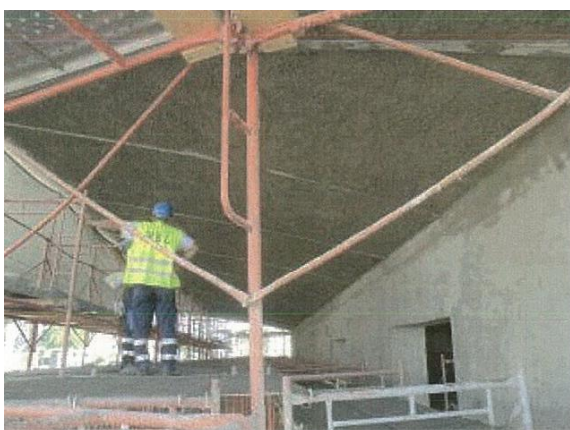
Figure (VIII-78) Execution of new protecting mortar cover on ceiling

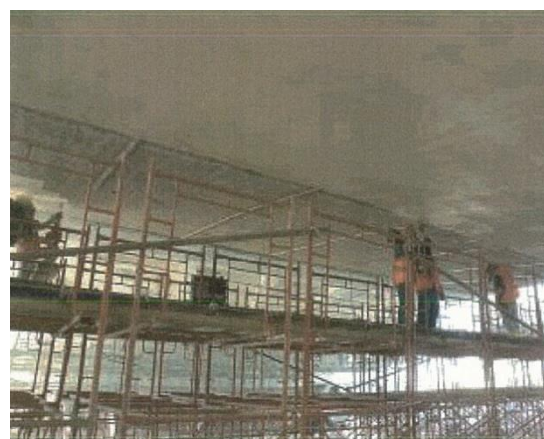
Figure (VIII-79) Finalizing of protecting mortar cover on ceiling

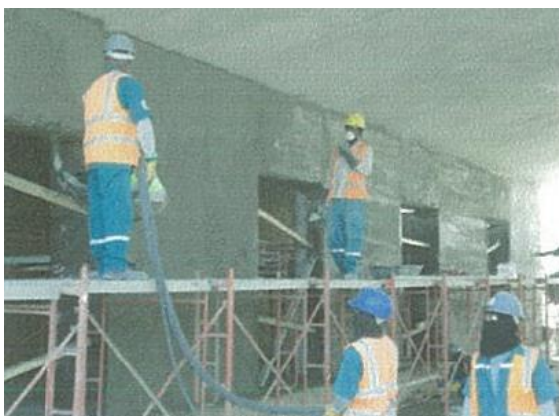
Figure (VIII-80) Plastering of exterior wall

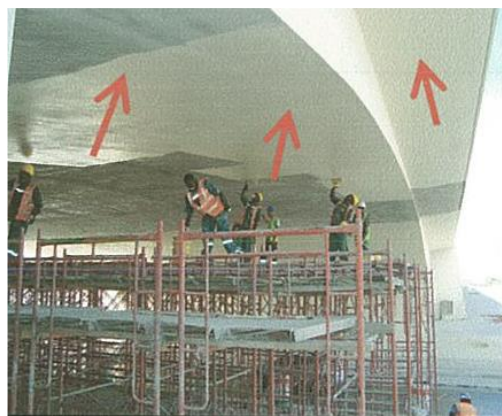
Figure (VIII-81) Painting of repaired surfaces of bridge elements

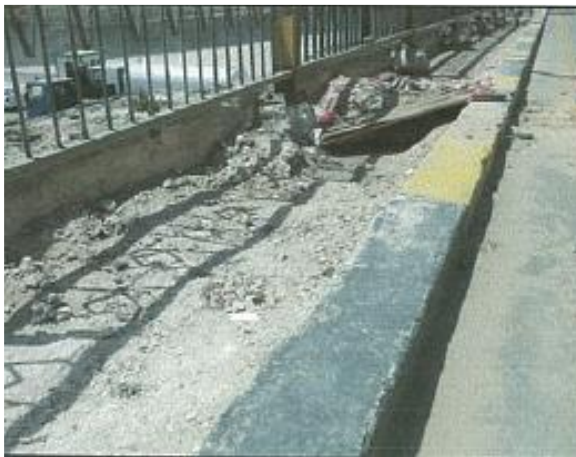
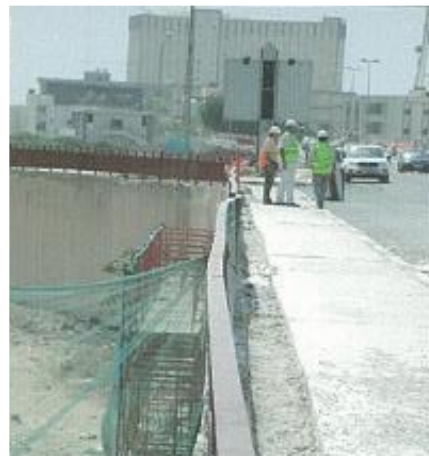
Figure (VIII-83). Removing of old sidewalks on bridge and between them

During the repair of these bridges, it was decided to remove all old sidewalks on Center Island over bridges (AL Sseka and Bab Bin Gheshir road) and part of curbstone and old concrete under the fences over the bridges and between these

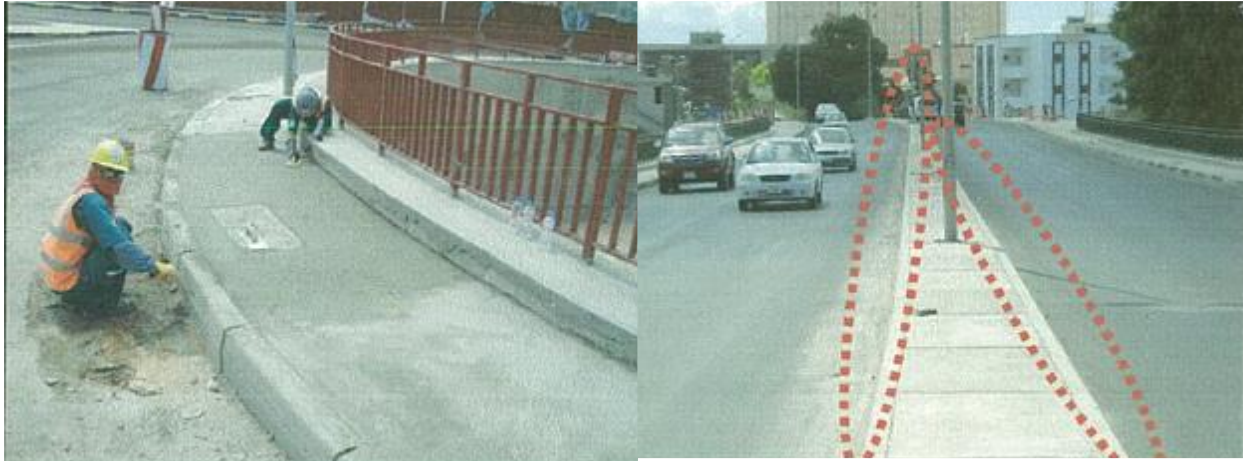
Figure (VIII-88) New side walk with new curbstone and casting of new catch pit

- Concreting of beam under side walk and lining of sub base layer,
- Concreting of the sidewalk slabs with dimensions $1.20\text{m} \times 2.50\text{m} \times 0.1\text{m}$ on top of concrete beam, with 2cm expansion joint filled with elastic material.
- Concreting of the layer under the fences with the height 10cm above the sidewalk level.
- Casting the new lean concrete under the new curbstone with a 30cm width.
- Concreting of new curbstone with expansion joint every 12m.
- Concreting and installing of the new catch pit.

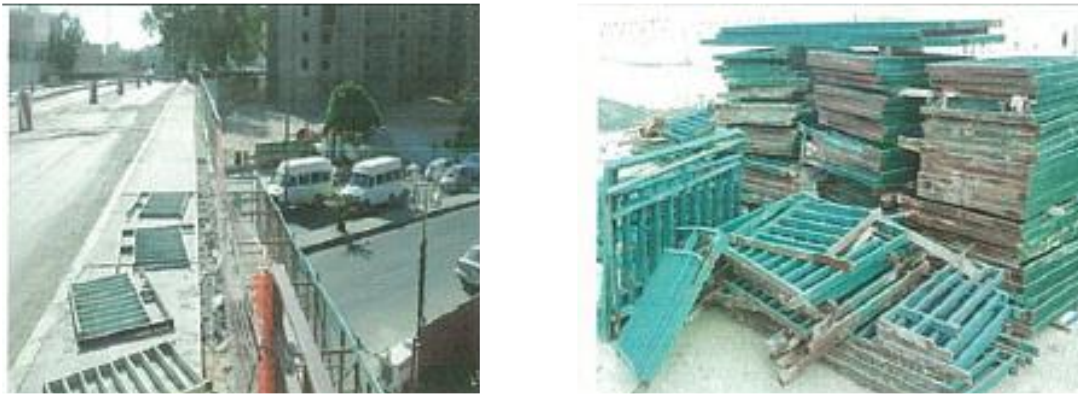
Figure (VIII-89). Removal of old fence

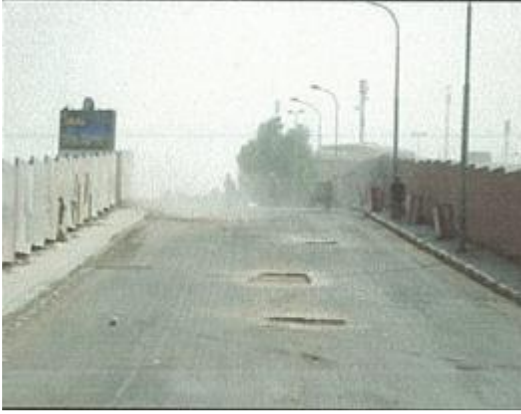
In fig (VIII-90 and VIII-91) the condition of upper layer of asphalt before removing of surface layer and the view after its removal are shown.

Figure (VIII-90). A view of old asphalt layer on the bridge before removing of surface layer

- Removing the surface layer over the bridge ($t=4\text{cm}$) using milling machine.
- Opening the cracks
- Cleaning cracks and whole surfaces
- Injecting of all cracks in binder course
- Laying of new wearing layer

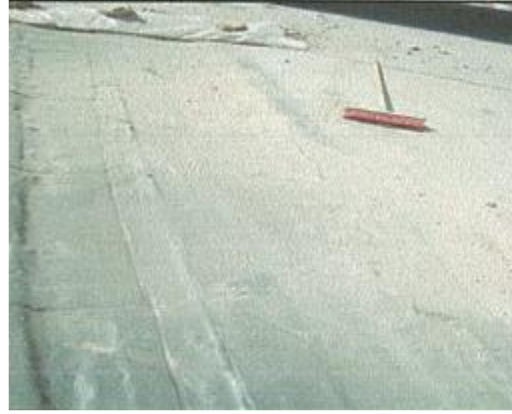
Figure (VIII-91). The view of surface after asphalt was removed

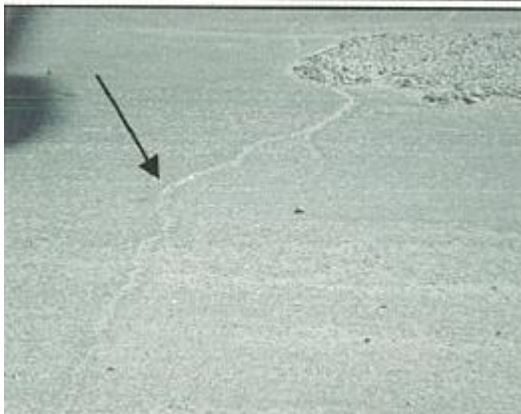
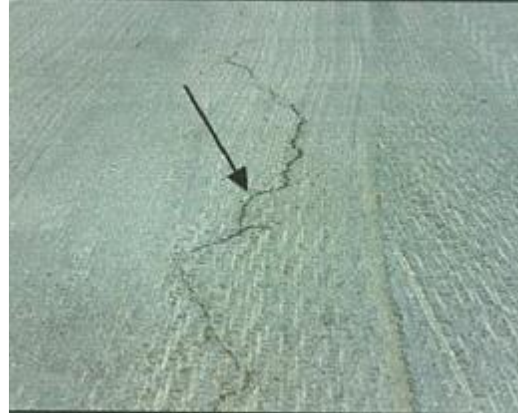
Since a lot of cracks have been noticed in down layer, it was decided to fulfill them by injection. Before injection, the cracks have to be opened and cleaned. All these operations are shown in fig (VIII-92 and VIII-93).

Figure (VIII-92). cracks before injection

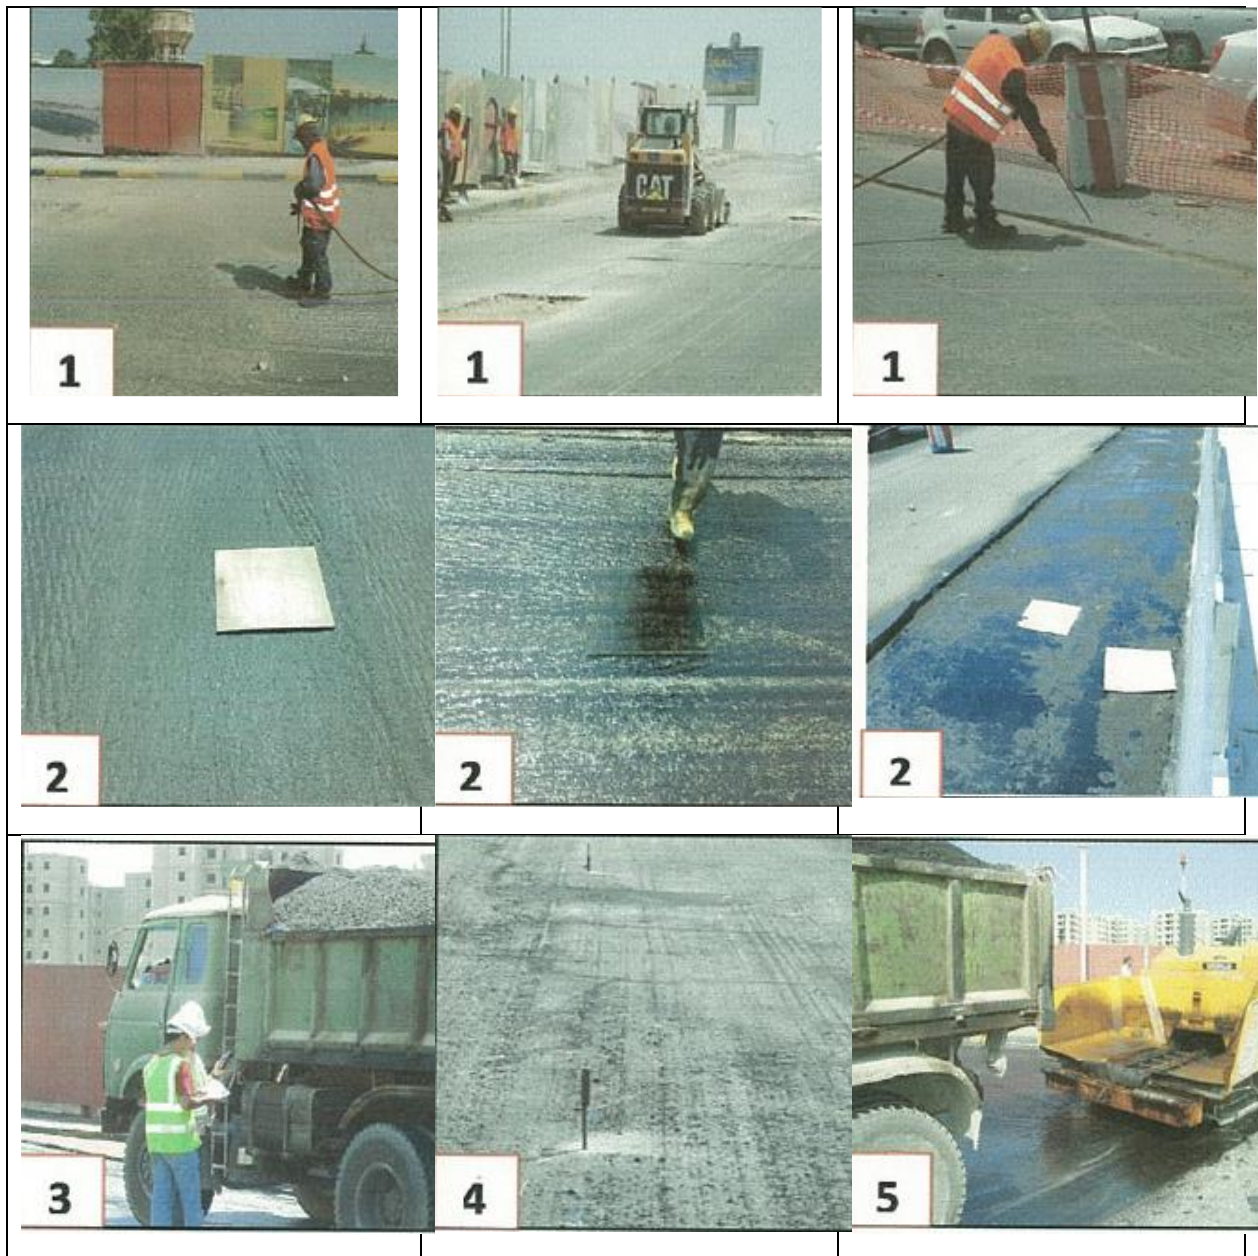
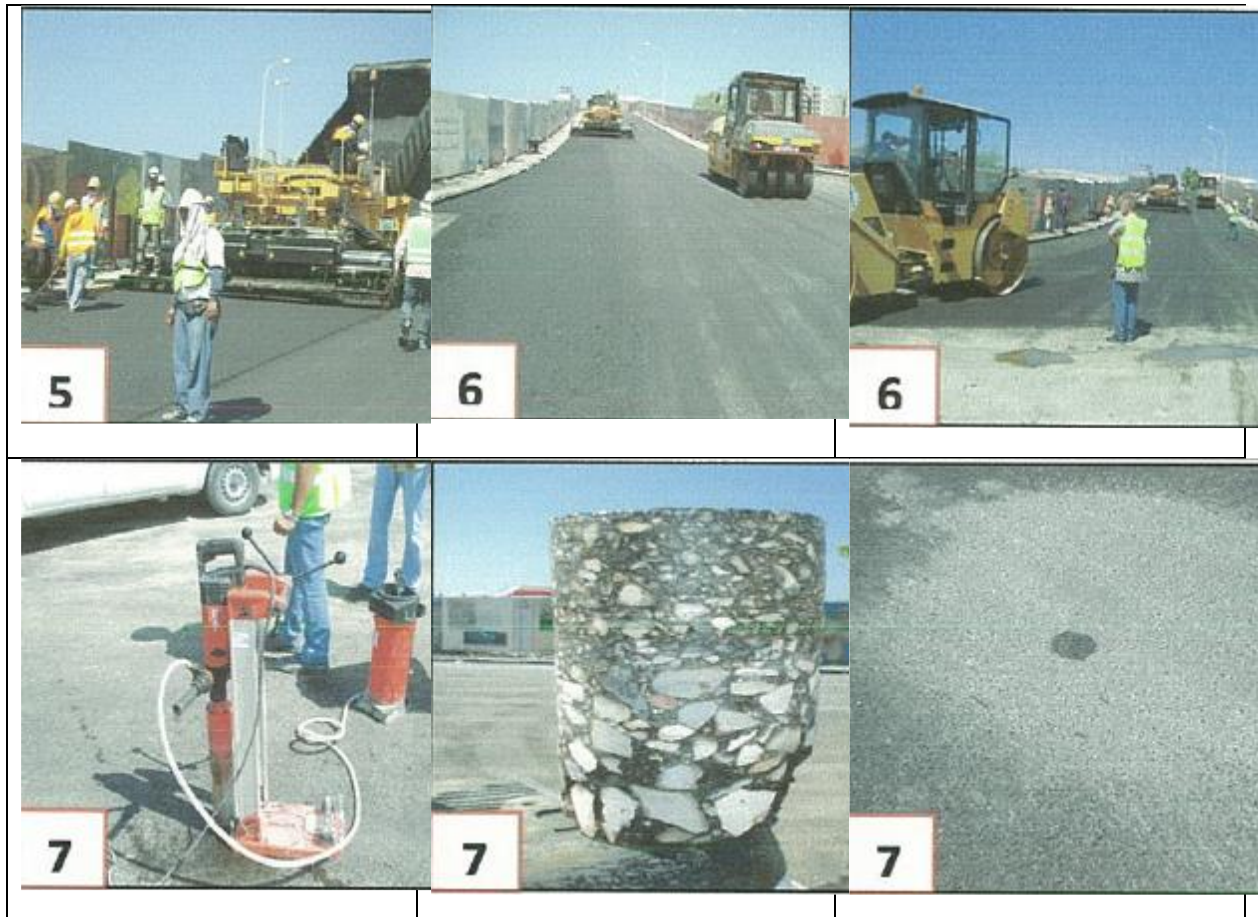
Figure (VIII-94). Phases of placing of bituminous materials

Conti. ... Figure (VIII-94). Phases of placing of bituminous materials

- 1- Cleaning the surface by using air compressor.
- 2- Spraying bitumen MC-250 by using MC tank according to required spray rate.
- 3- Checking of the temperature of asphalt mixture when the trucks arrive.
- 4- Controlling of thickness of asphalt by elevation of the steel wires.
- 5- Spreading wearing course by automatic controlled pavers.
- 6- Compacting asphalt by using steel roller and tire roller.
- 7- Taking asphalt cores for checking the thickness and compaction.

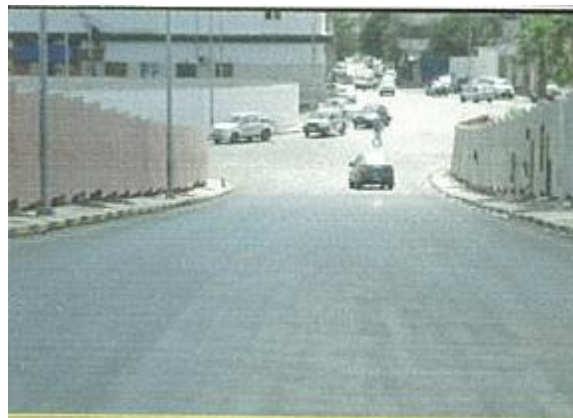
Figure (VIII-95). The road after finish asphaltting

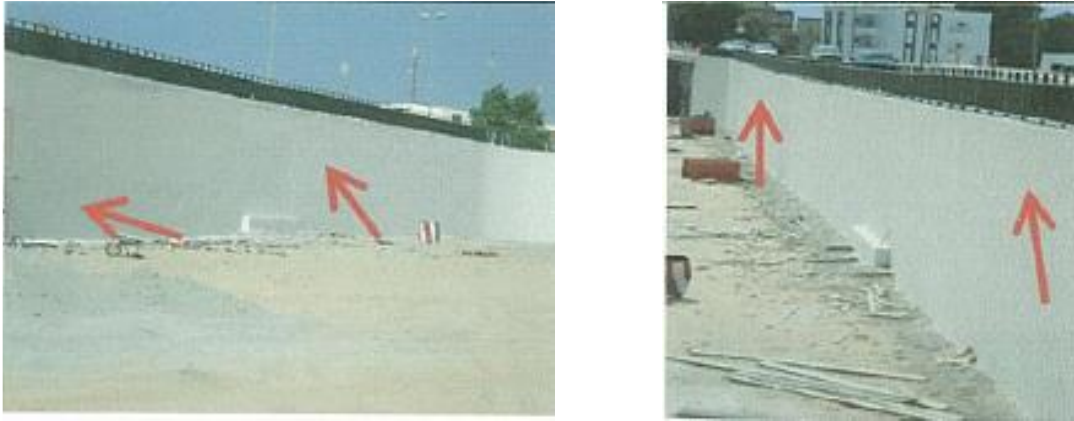
Figure (VIII-96). Painting of protective walls

Other nonstructural repair measure is painting of protective walls and traffic lines (fig VIII-96 and VIII-97).

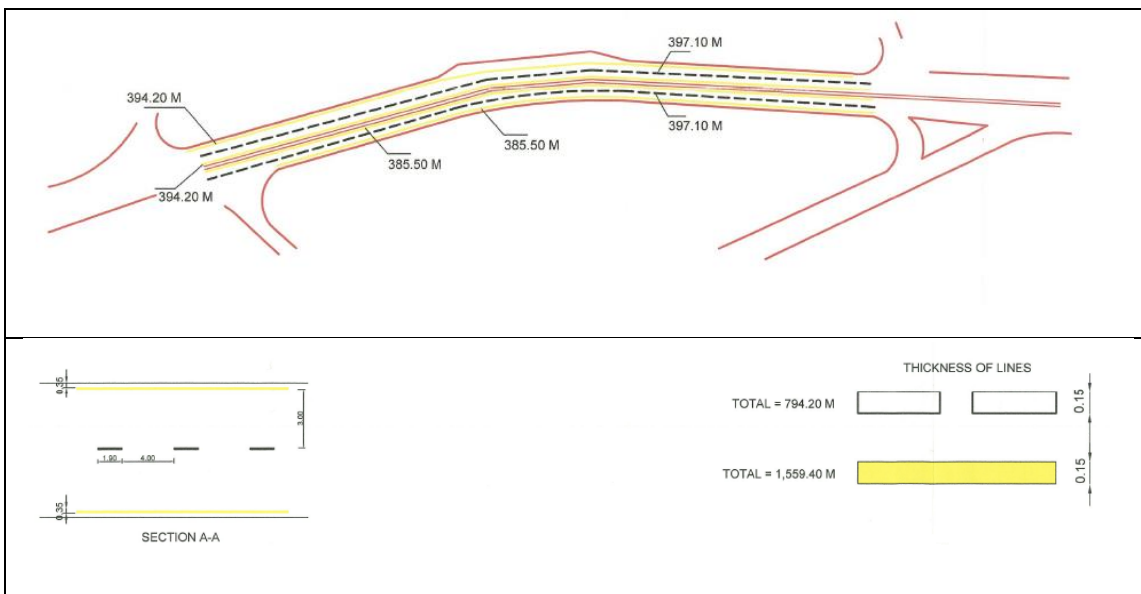
Figure (VIII-97). Plan of traffic lines paintworks

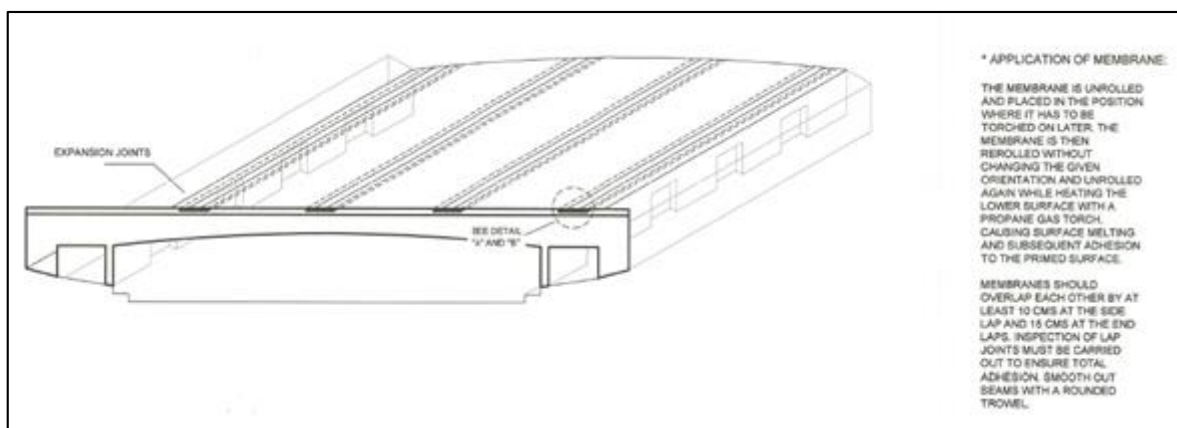
Figure (VIII-98) Plan of expansion joints in bridge structure

In origin design, the expansion joints were planned in four places. The layout of expansion joints is given in Figure (VIII-98). The description of suggested repair measure for them is also given in figure VIII- 26, and specific detail could be seen in Figure (VIII-99).

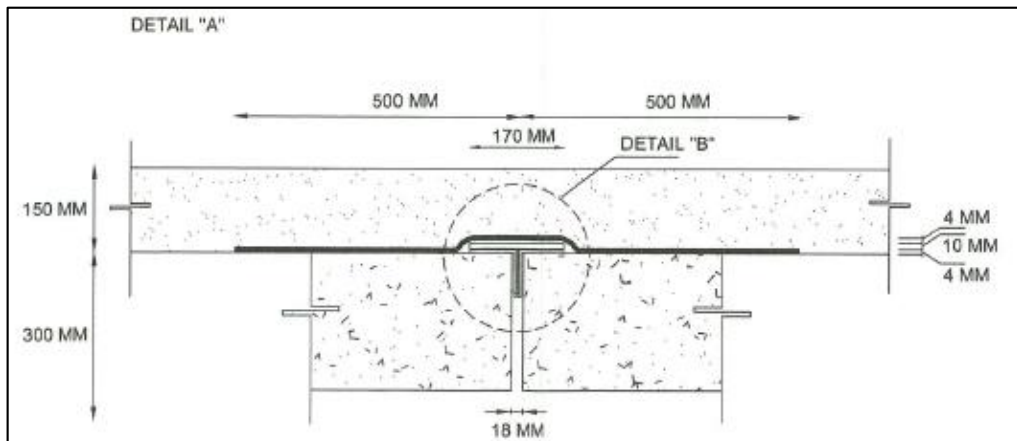
Figure (VIII-99) A detail of setting up of membrane over the expansion joints in bridge structure

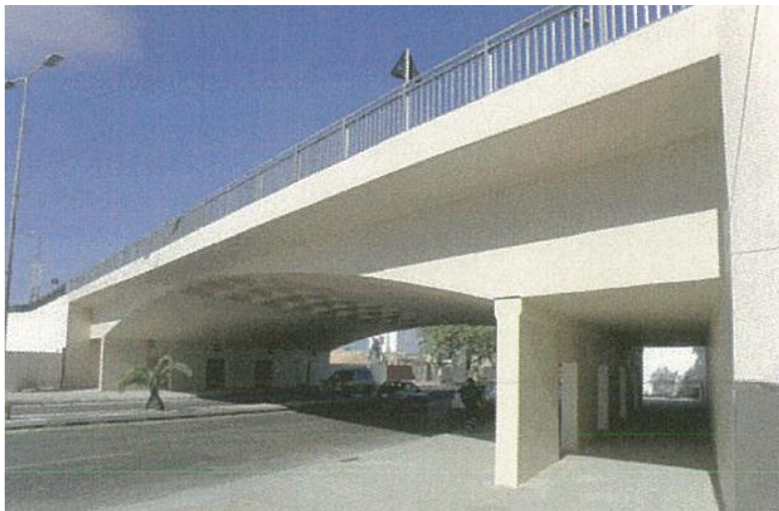
Figure (VIII-100) Al Seeka Bridge after all repair measures.

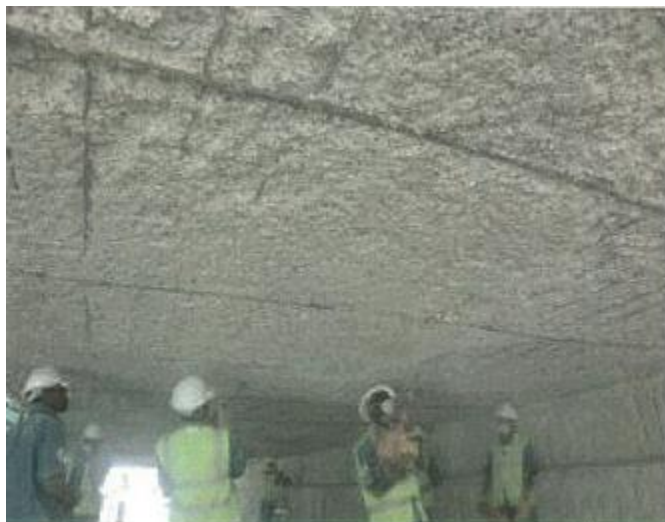
The removal of old carbonated concrete cover by electric hammers from deck ceiling slab is shown in figures (VIII-101- VIII-103). The removal of whole edge beams is shown in figure VIII-104.

Figure (VIII-101) Damaged concrete removal from deck ceiling slab

As it was recommended, all plaster layer and poor quality concrete cover or/and carbonated part of concrete have to be removed. For that operation the electric hammers with max weight of 6kg have been chosen.

In some cases the removal of concrete with 70mm depth has been suggested to be ensure that all damaged concrete is removed and all rebars are treated (10mm existing cover + 10mm stirrups+ 32mm rebars+ 20mm over rebar plan).

After finishing concrete removal all surfaces must be clean with water jet with pressure of 200bar.

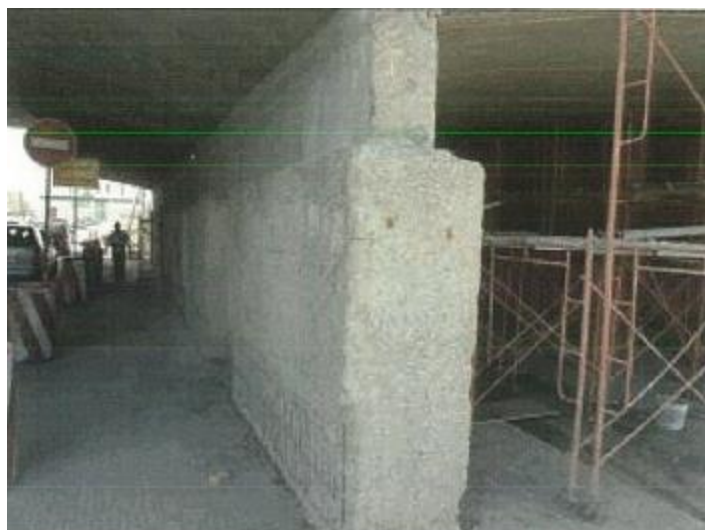
Figure (VIII-102) Supporting wall with damaged concrete removed and exposed reinforcing bars

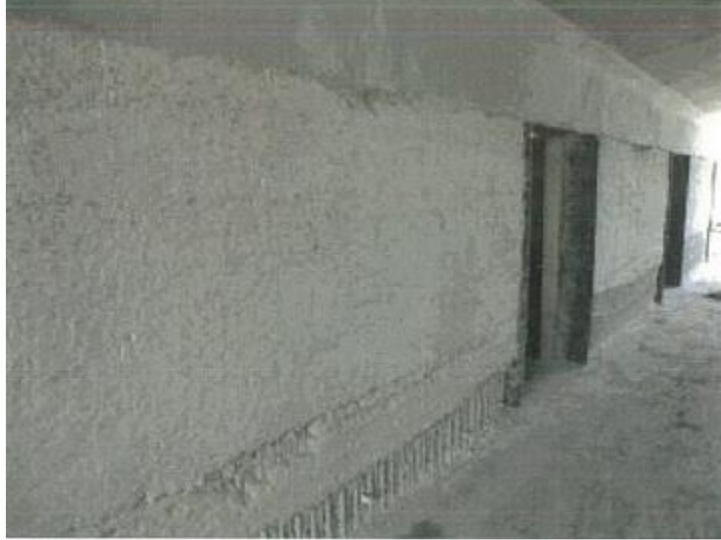
Figure (VIII-103) General view of the supporting wall with damaged concrete removed and exposed rebar

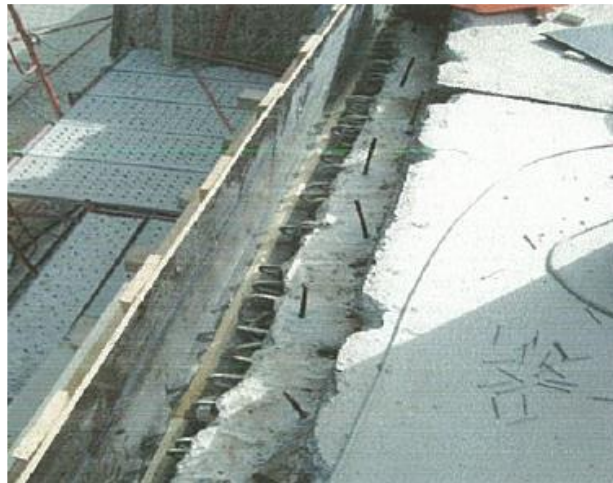
Figure (VIII-104) Removal of old edge beam

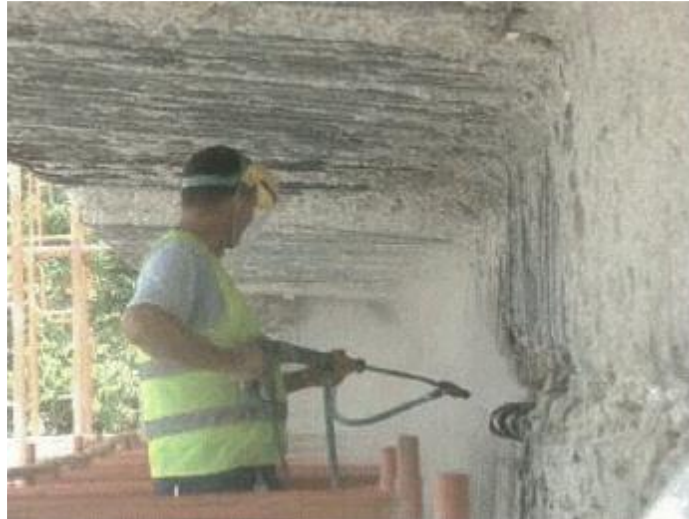
Figure (VIII-105) Rebars cleaning with water-sand blasting

After removing of “old” damaged concrete cover, the next operation has been cleaning of reinforcing bars from remains of hardened cement paste and rust as the products of steel corrosion. For this operation the water sand blasting technic is selected with pressure of 250 bar. The procedure of cleaning reinforcing bars is shown in figure (VIII-105).

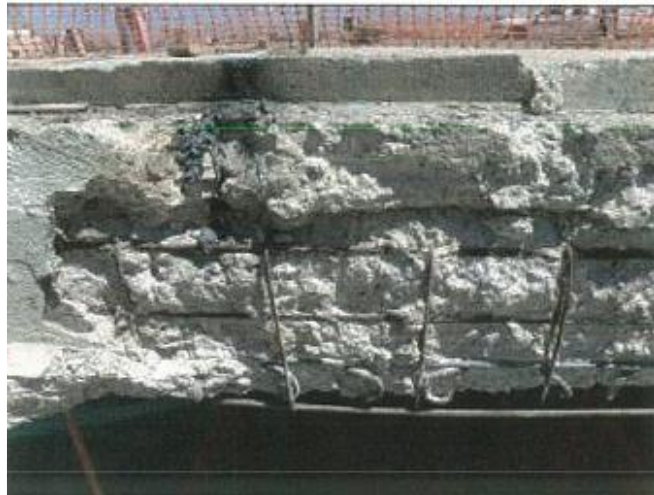
Figure (VIII-106) Corroded steel on the cantilevers

The following recommended measures for repairing damaged concrete elements were: rebar protection, bonding agent application, injection of cracks, concrete restoration and execution of new cover, corrosion inhibition protection and surface protection.

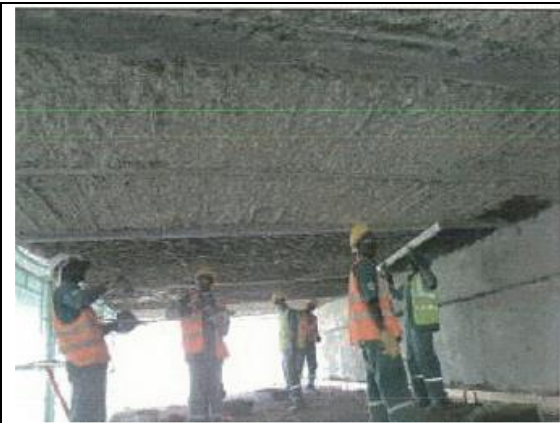
Figure (VIII-107) Finalizing underpass ceiling with cementitious base special mortar

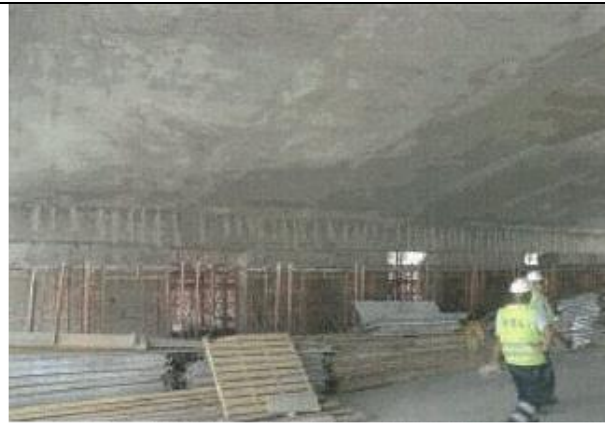
Figure (VIII-108) Finalizing underpass ceiling with special mortar

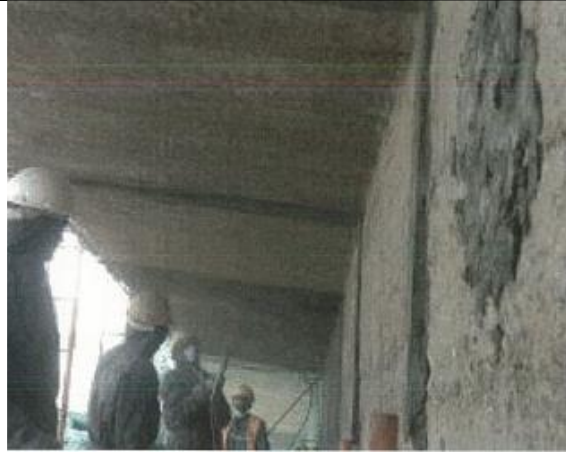
Figure (VIII-109) Finalizing cantilevers and lateral beam with special mortar

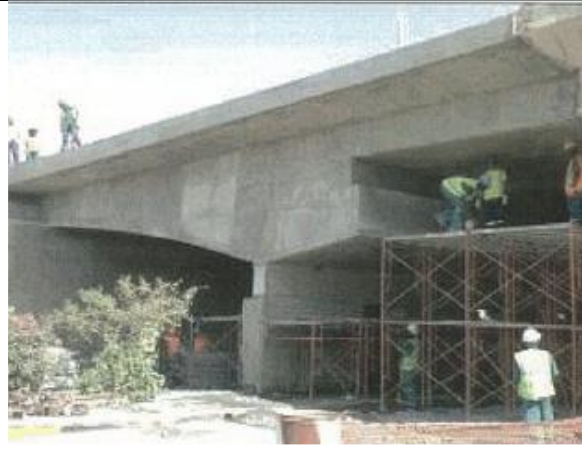
Figure (VIII-110) Finalized lateral beam with special mortar

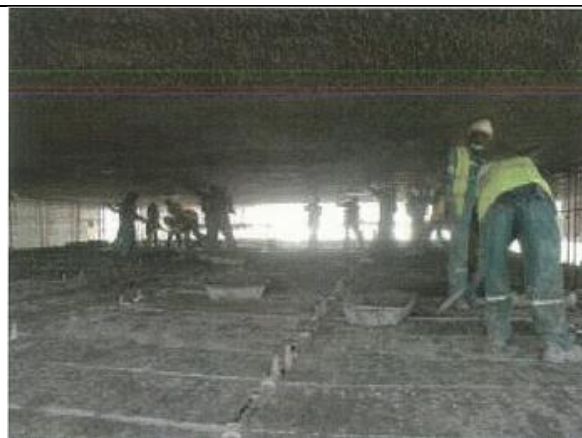
Figure (VIII-111) Finalizing deck ceiling with special mortar

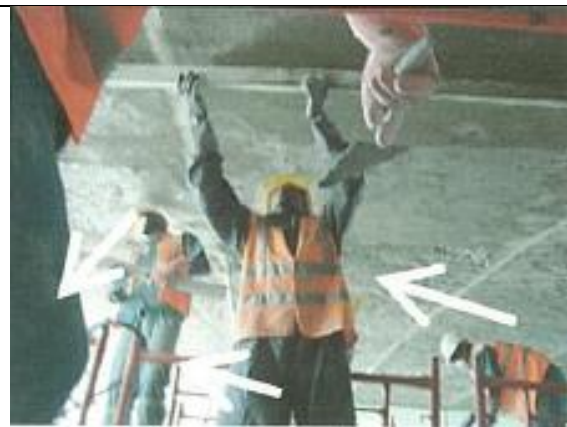
Figure (VIII-112) plastering for ceiling

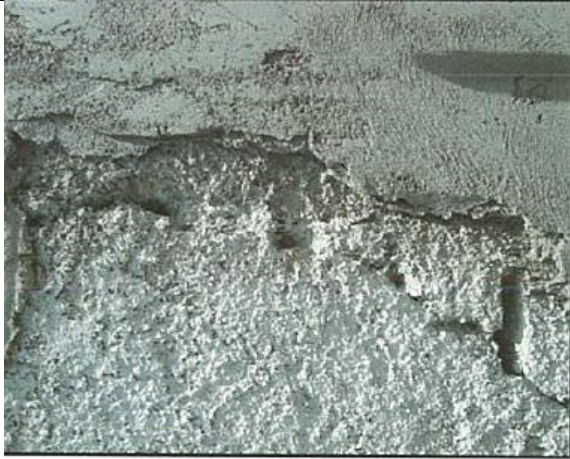
Figure (VIII-113) A very large crack in abutment wall

In this case, the repair works on the damaged abutment walls was included crack injection and/or crack sealing. The cracks with wideness $w \leq 0.2\text{mm}$ should be only sealed, but cracks with wideness $w \geq 0.2\text{mm}$ should be sealed and injected. The crack $w \geq 0.2\text{mm}$ have to be sealed with epoxy mortar prior to injection. Then, drilled packers have to be installed at the distance of 20cm, from each other. The holes for packers have to be cleaned by compressed air to remove dust. Injection of epoxy resin should be done with low pressure pump ($\leq 1\text{bar}$). After 24hours of injection, all surface protection and packers have to be removed. The view of noticed cruck in abutment and its preparation for injection are shown in Figures VIII-113 and VIII-114.

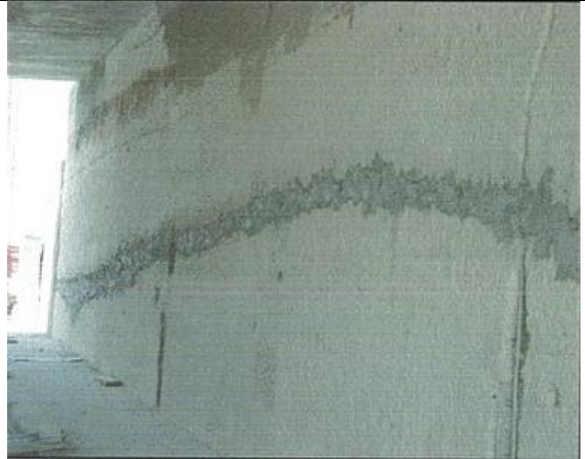
Figure (VIII-114) The crack in abutment prepared for injection

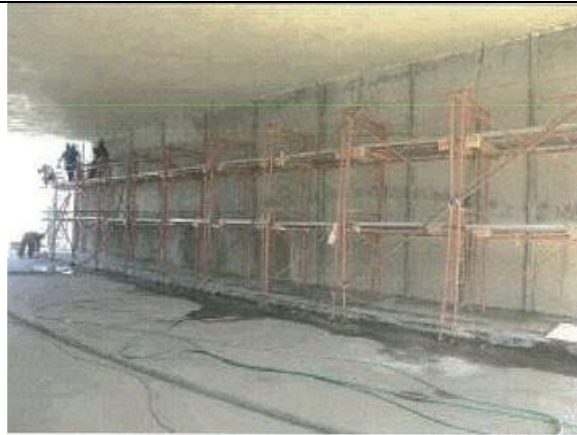
Figure (VIII-115) Abutment wall repair

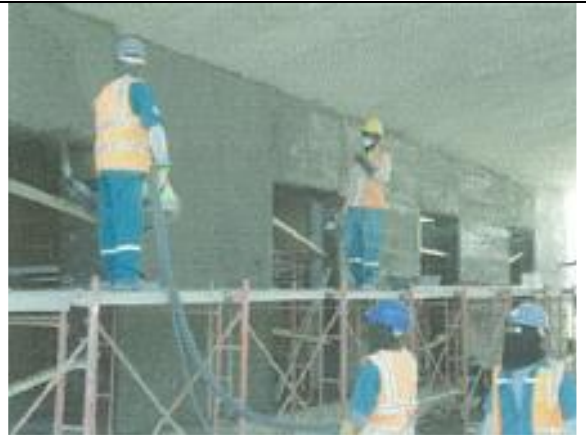
Figure (VIII-116) Plastering of supporting wall

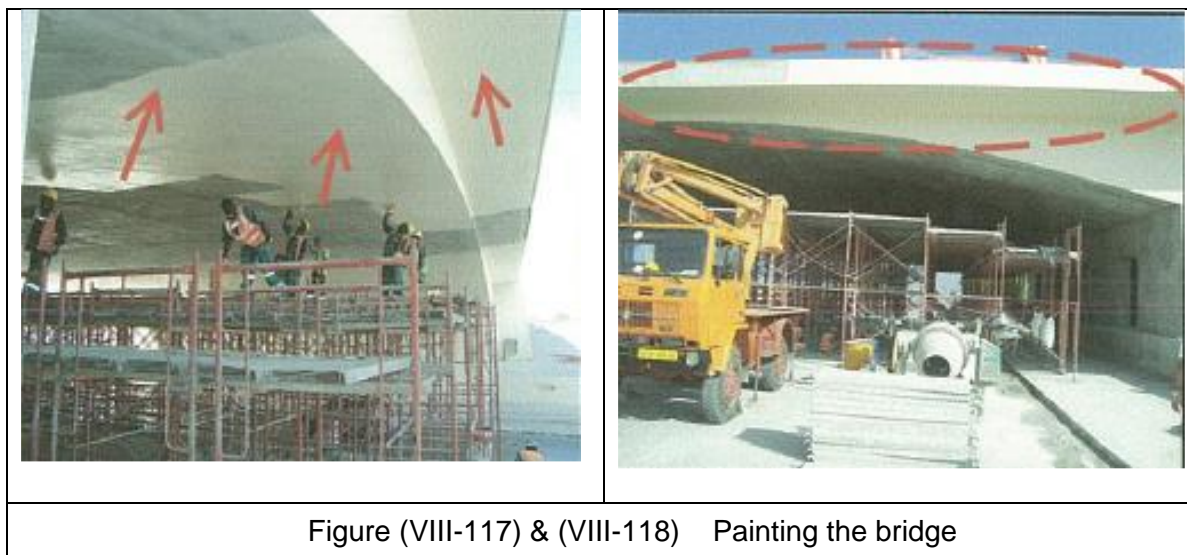
Figure (VIII-117) & (VIII-118) Painting the bridge

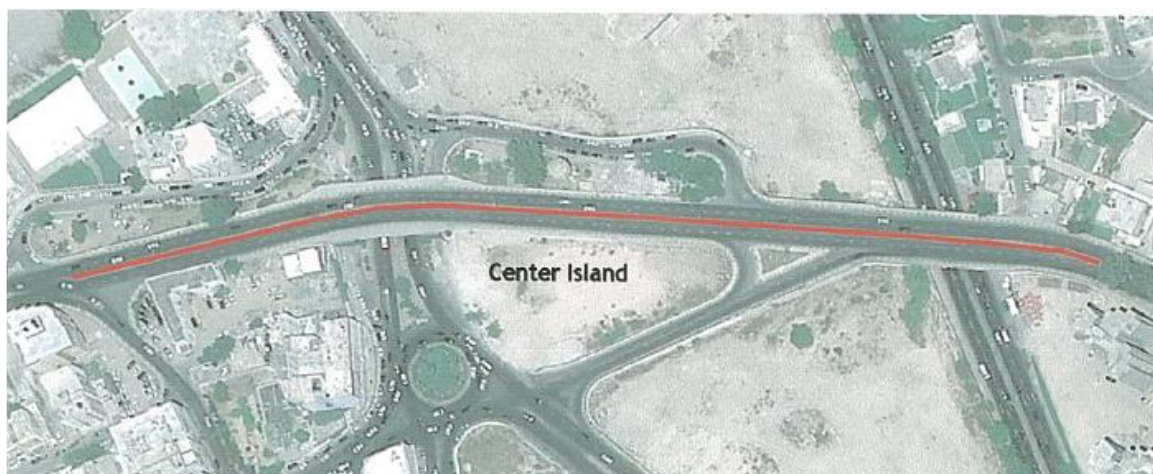
Figure (VIII-119) Site plan of bridges Bab Bin Gheshir road and AL Sseka

During the repair of these bridges, it was decided to remove all old sidewalks on Center Island over bridges (Bab Bin Gheshir road and AL Sseka) and part of curbstone and old concrete under the fences over the bridges and between these bridges (Fig VIII-119). The detail of removal of damaged sidewalk is shown in figure (VIII-120).

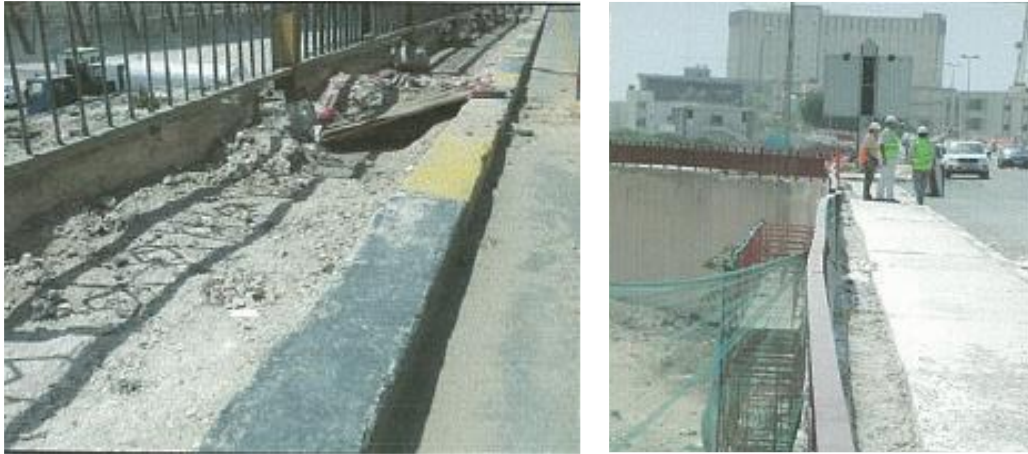
Figure (VIII-120) Removing of old sidewalks on bridge and between them

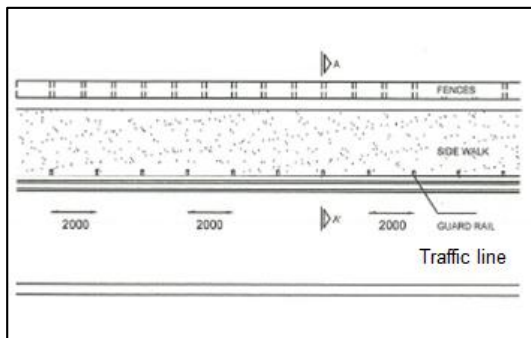
Figure (VIII-121) Sidewalk elements arrangement

After repairing the edge beams and other structural elements of bridge and preparing sub base between the bridges, it has been planned to cast new sidewalks and curbstone (Fig VIII-121 and VIII-122).

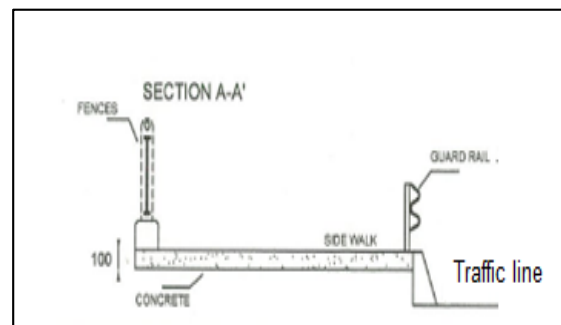
Figure (VIII-122) Cross section of sidewalk elements

- Concreting of beam under side walk and lining of sub base layer,
- Concreting of the sidewalk slabs with dimensions 1.20m×2.50m×0.1m on top of concrete beam, with 2cm expansion joint filled with elastic material.
- Concreting of the layer under the fences with the height 10cm above the sidewalk level.
- Casting the new lean concrete under the new curbstone with a 30cm width.
- Concreting of new curbstone with expansion joint every 12m.
- Concreting and installing of the new catch pit.
