**COMPARATIVE ANALYSIS OF DURABILITY AND
RANKING OF CONCRETE BRIDGES IN HOT
CLIMATES**

DOCTORAL THESIS

Novi Sad, 2022.

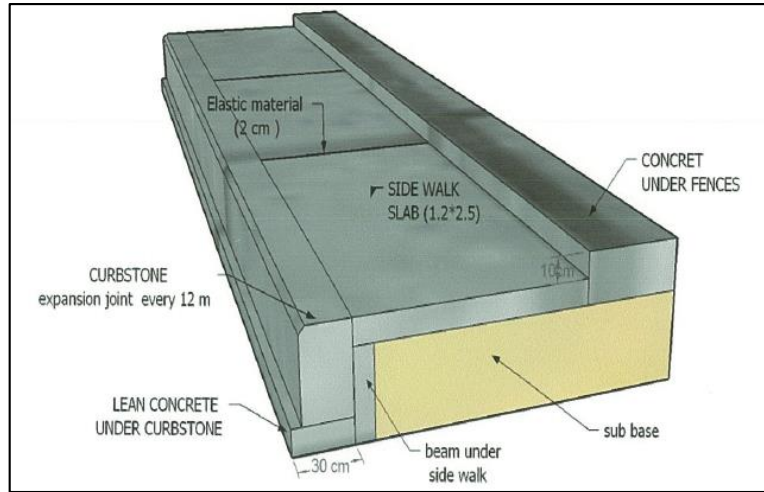
Figure (VIII-123) new sidewalk between the bridges Bab Bin Gheshir road and AL Seeka

The cross section of new sidewalks between the bridges with all necessary elements is shown in Fig VIII-123.

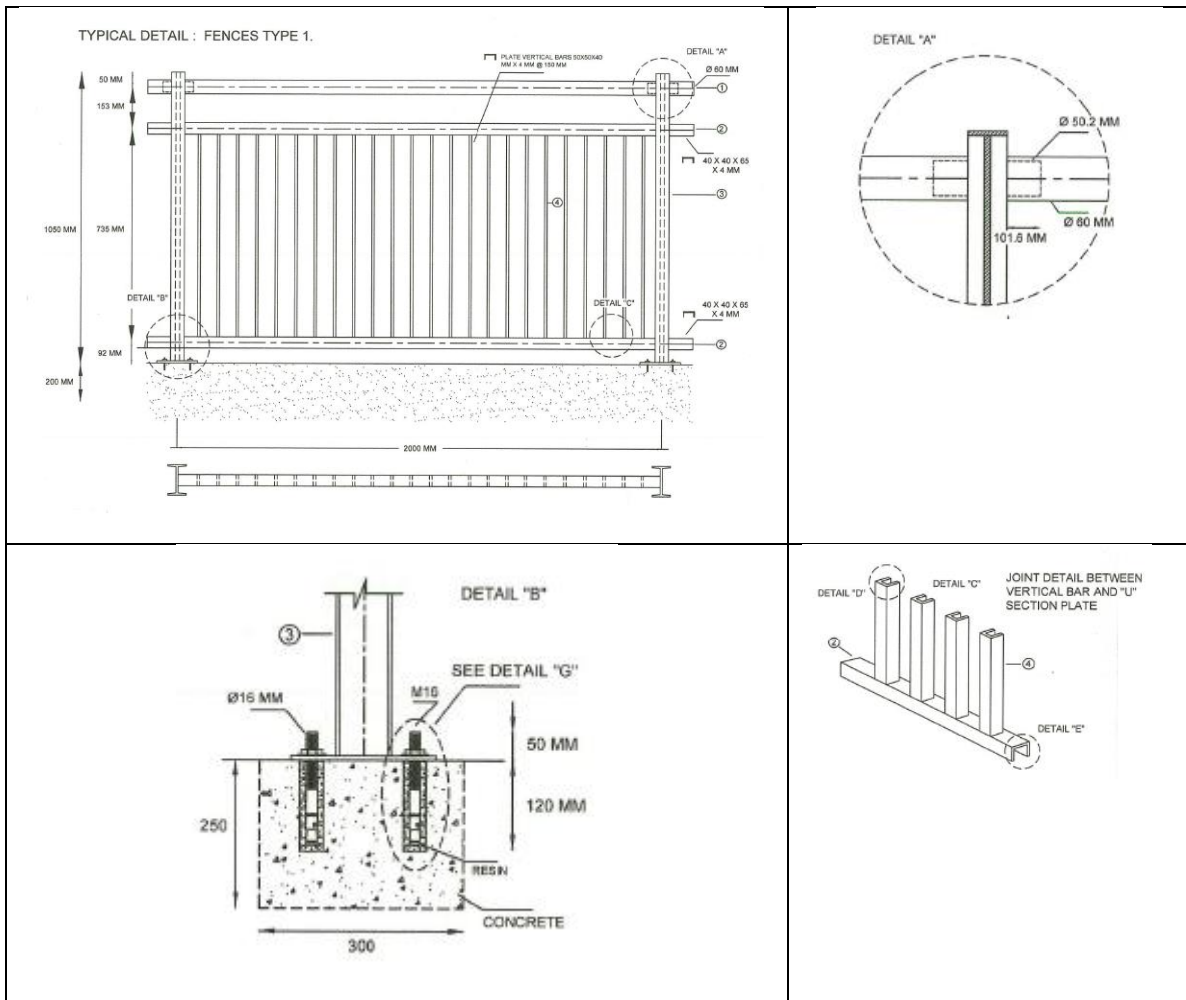
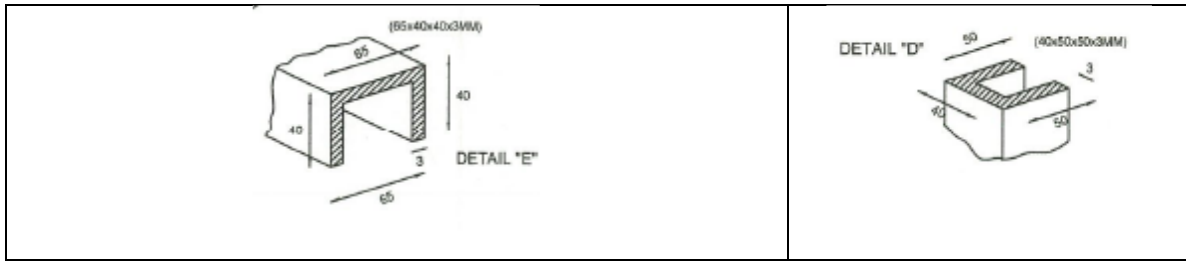
Figure (VIII-124) Fences view and installing plan

Figure (VIII-124) shows the details of new fence and the plan of installing the new fence.

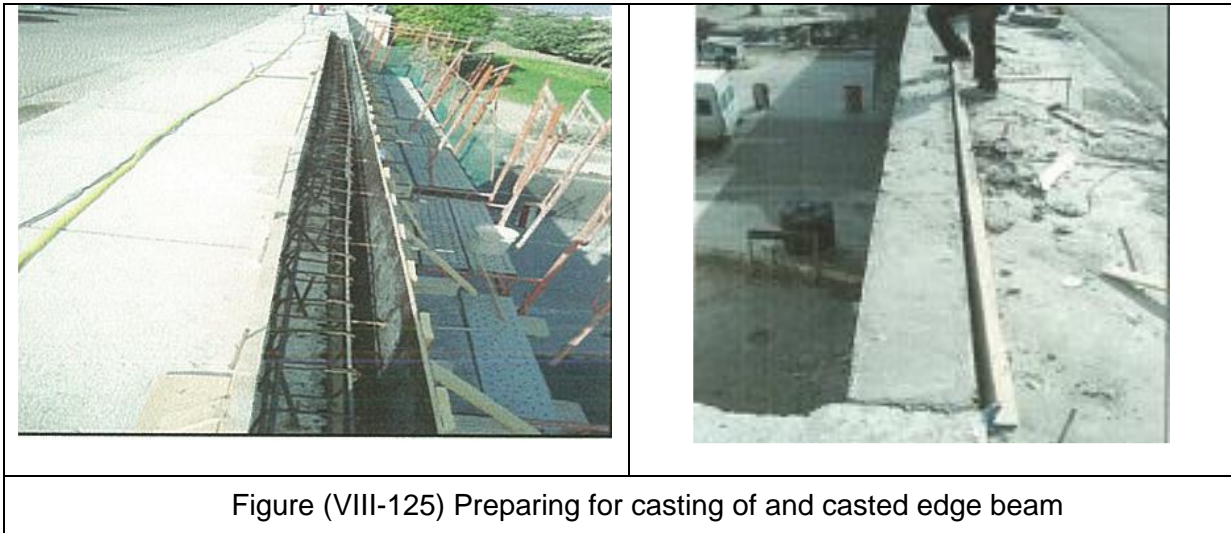
Figure (VIII-125) Preparing for casting of and casted edge beam

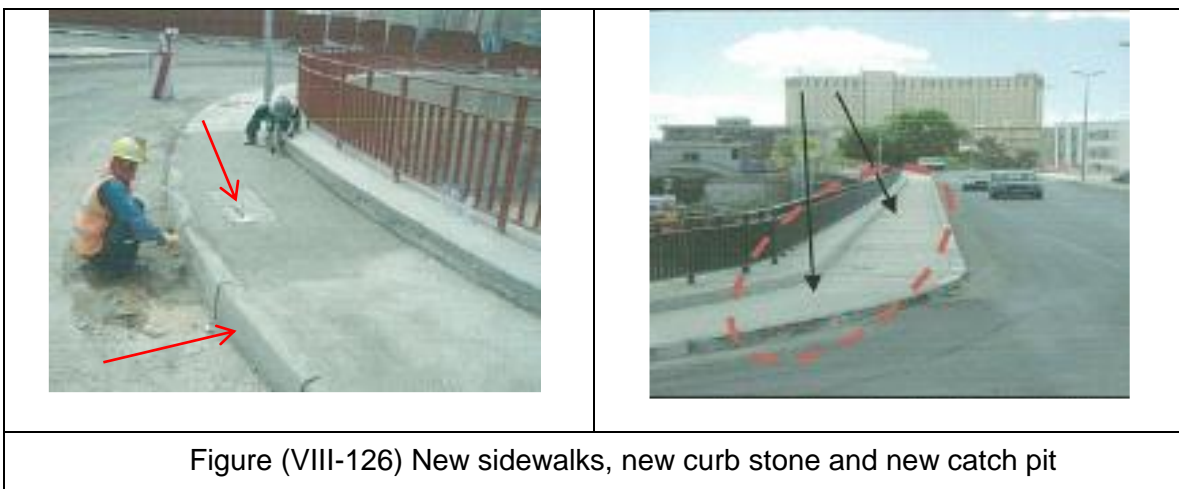
Figure (VIII-126) New sidewalks, new curb stone and new catch pit

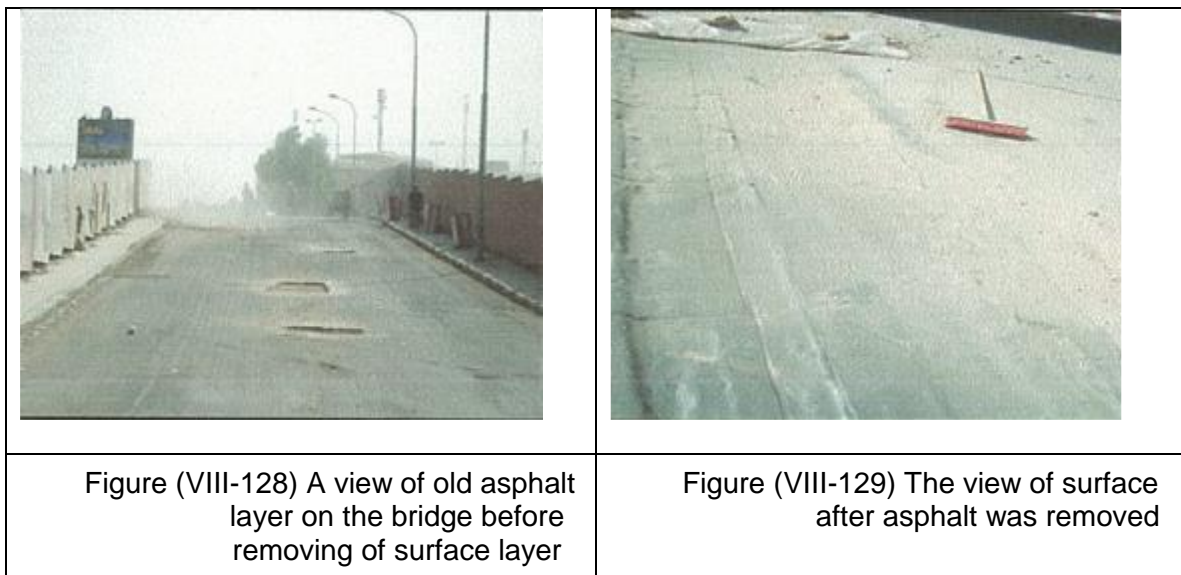
In fig (VIII-128) and (VIII-129) the condition of upper layer of asphalt before removing of surface layer and the view after its removal are shown.

- Removing the surface layer over the bridge ($t=4\text{cm}$) using milling machine.
- Opening the cracks
- Cleaning cracks and whole surfaces
- Injecting of all cracks in binder course
- Laying of new wearing layer

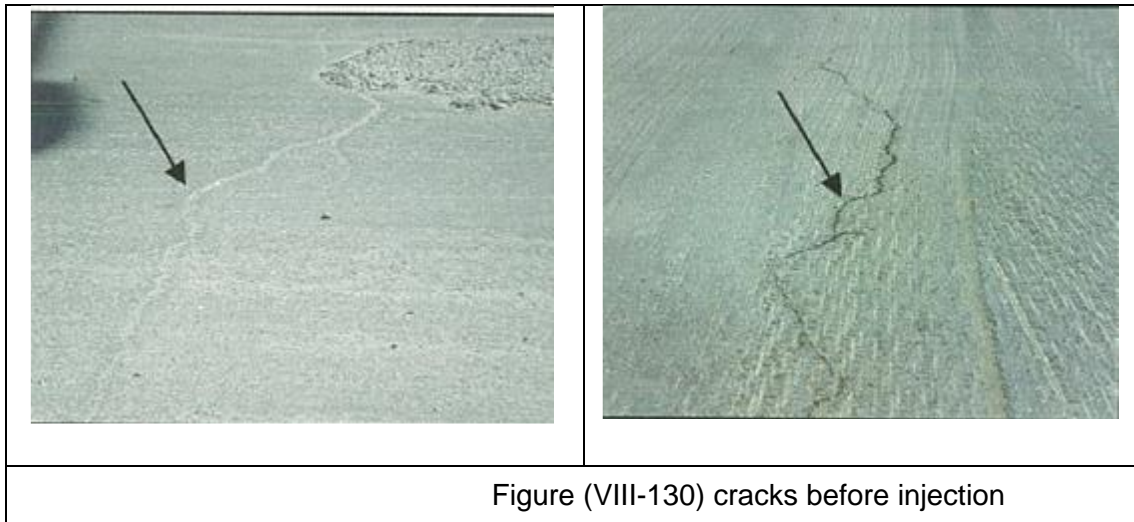
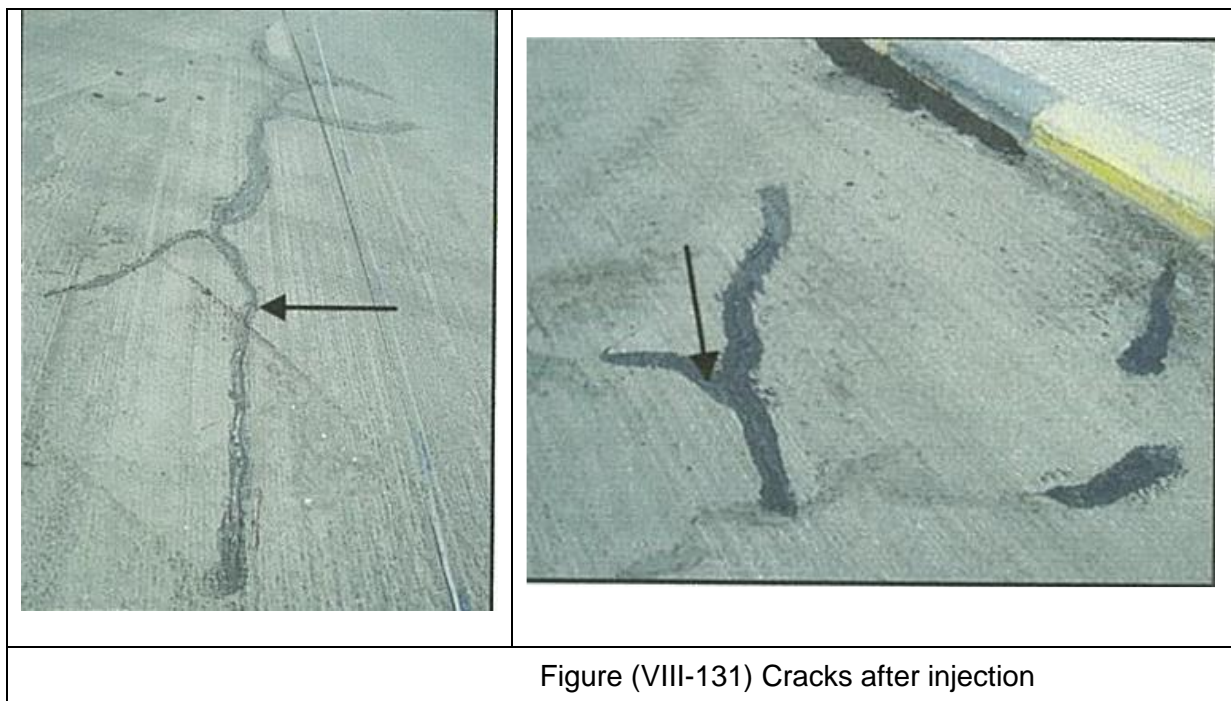
Since a lot of cracks have been noticed in down layer, it was decided to fulfill them by injection. Before injection, the cracks have to be opened and cleaned. All these operations are shown in fig VIII-130 and VIII-131.

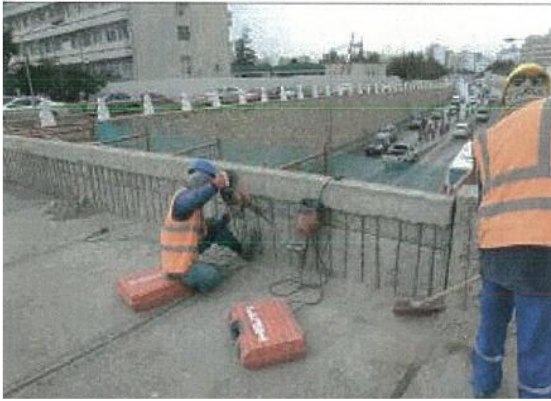
Figure (VIII-139) Damaged cover removal from concrete part of fence, top of the bridge

As it was recommended, all poor-quality concrete cover or/and carbonated part of concrete have to be removed. For that operation the electric hammers with max weight of 6kg have been chosen.

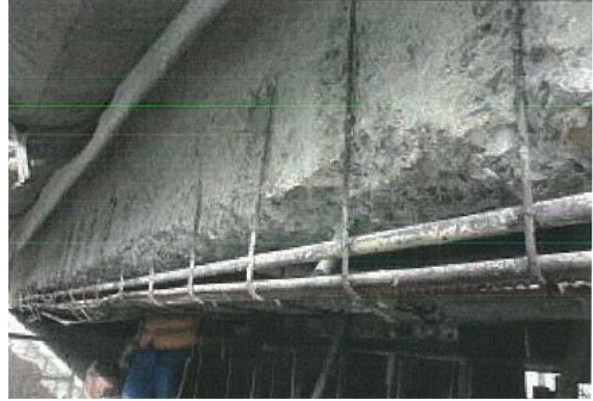
Figure (VIII-140) Damaged concrete cover removal from longitudinal slab beam

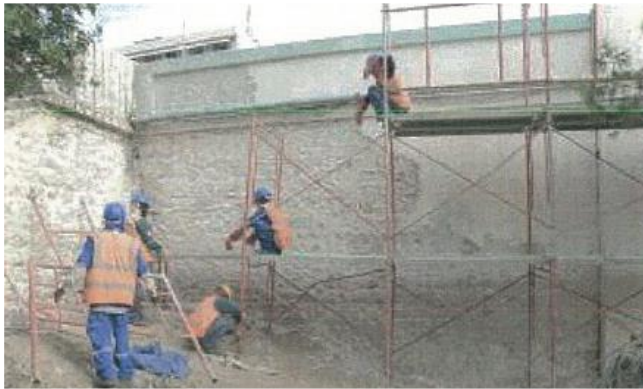
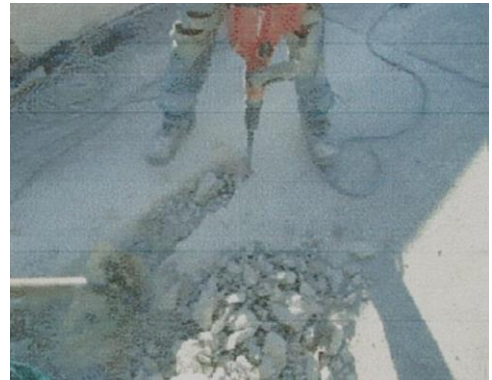
Figure (VIII-141) Damaged plastering and concrete removal from the abutments and sidewalk

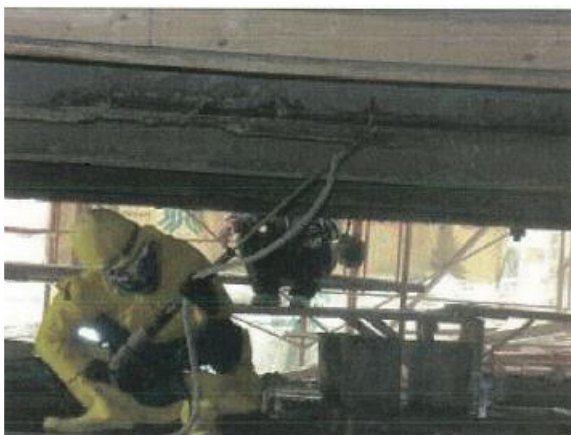
Figure (VIII-142) Cleaning of rebars with water-sand blasting, deck ceiling beams

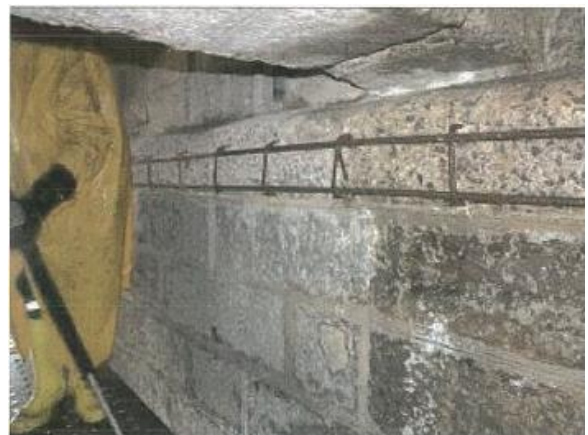
Figure (VIII-143) Cleaning of rebars with water-sand blasting, top beam of the support wall

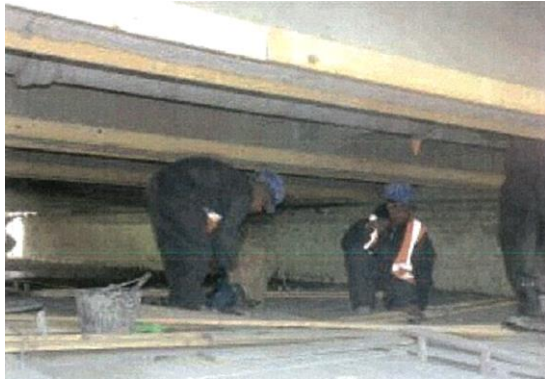
Figure (VIII-146) Reprofiling of lateral slab beams, bottom part

- Grouting/pouring of self-compacting mortar into prepared wooden ply formwork for bottom part of beam (Fig. VIII-146), and
- Plastering with mortar for vertical (side) surfaces.

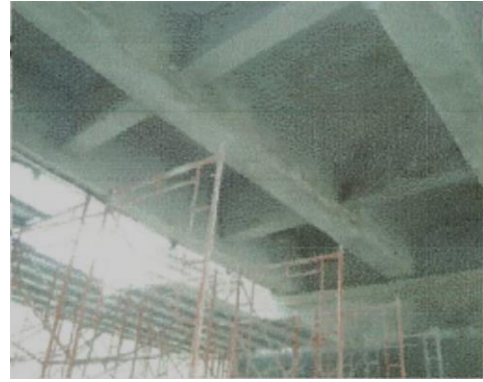
Figure (VIII-147) Execution of new cover on ceiling of bridge superstructure by plastering

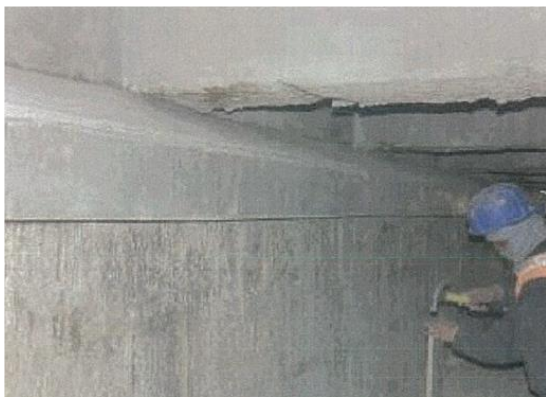
Figure (VIII-148) Repaired top beam of stone supporting wall

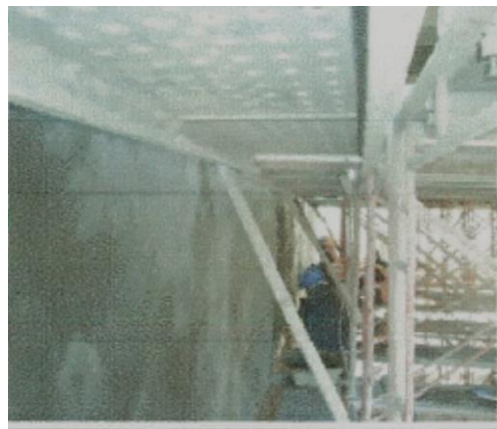
Figure (VIII-149) plastering of abutment wall

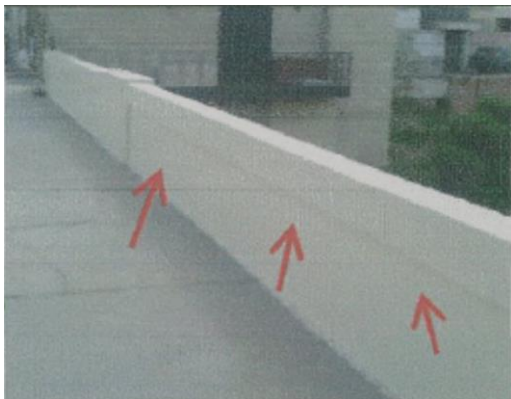
Figure (VIII-150) Repaired and painted concrete part of fence

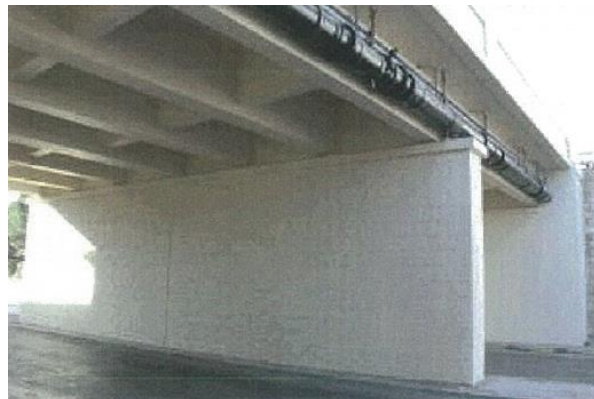
Figure (VIII-151) View of bridge after repairing and painting measures

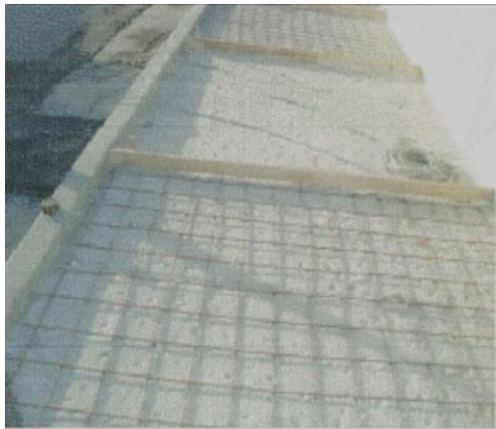
Figure (VIII-152) New wire mesh for new layer of concrete sidewalk

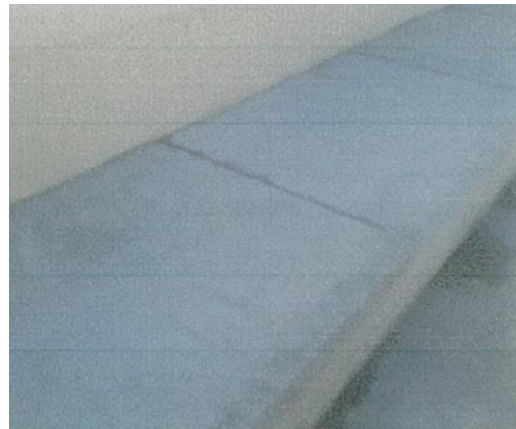
Figure (VIII-153) New sidewalk

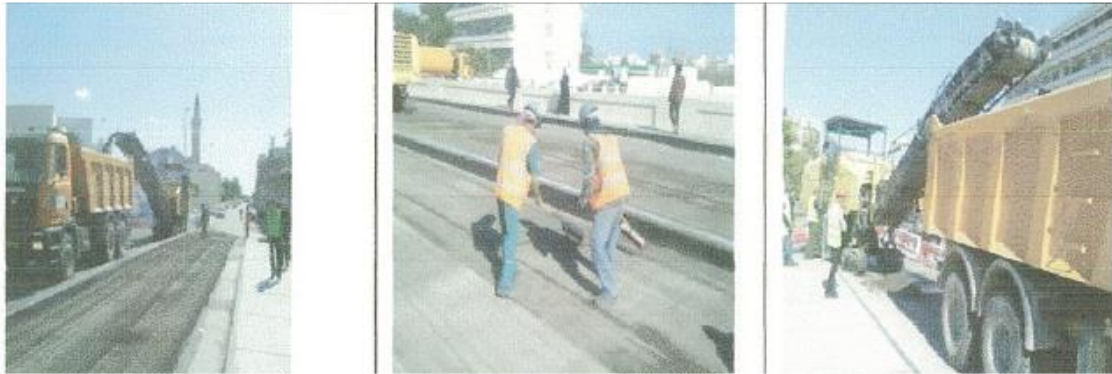
Figure (VIII-154) Removing existing asphalt wearing layer, reclaimed asphalt

- Cleaning was performed by brushes directly after milling & by air compressor prior to spreading tack coat,
- Tack coat was spread within specification limits (0.1-0.6 lt/m²),
- Laboratory team checks the temp. Of asphalt mixture for each asphalt truck to maintain the temp. of asphalt to be more than 135c⁰,
- Asphalt mix sample was taken for performing bitumen extraction marshall stability & sieve analysis tests,
- Wearing course was laid by automatic controlled pavers,
- Compacting was performed by using steel roller and pneumatic tire roller,

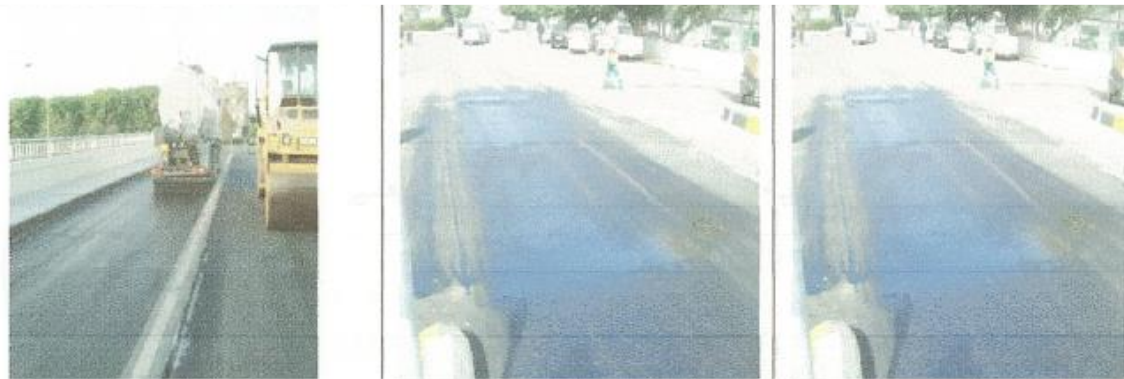
Figure (VIII-155) Spreading tack coat (RC2)

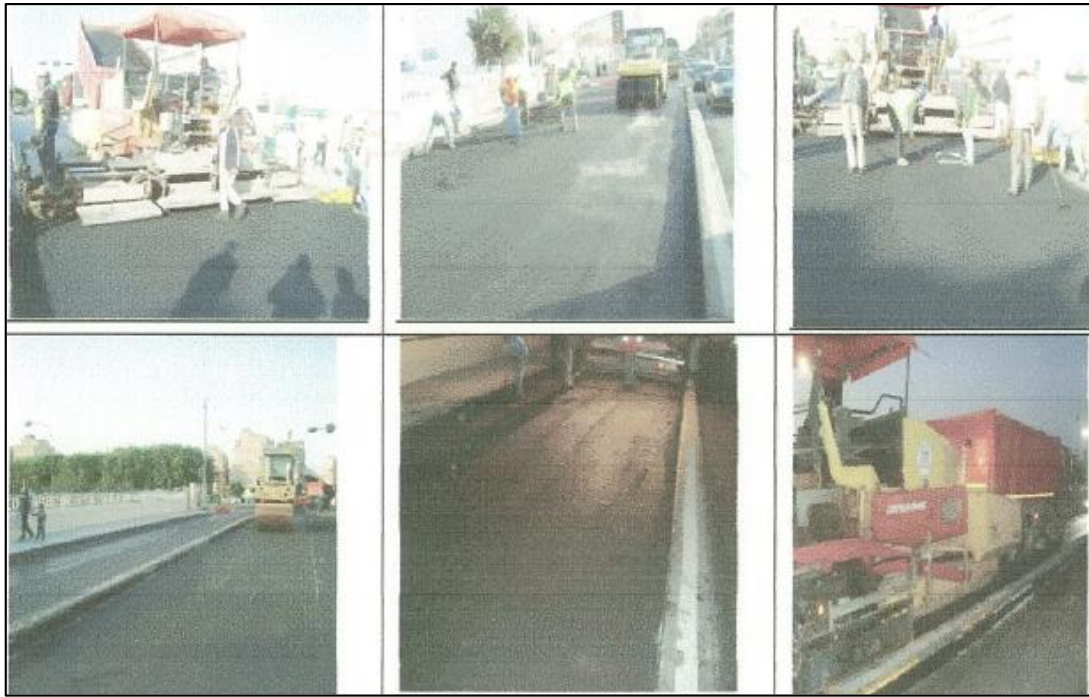
Figure (VIII-156) Placing the new wearing course

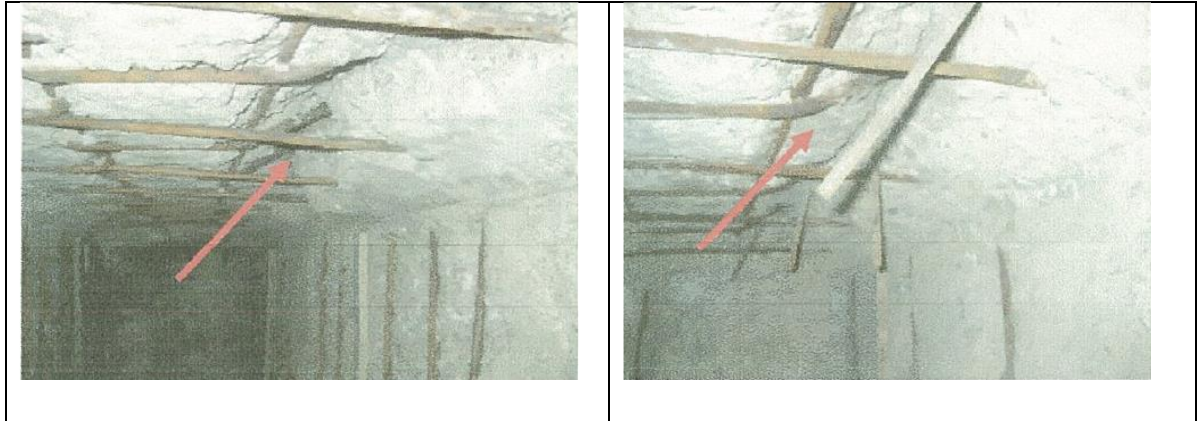
During the removing damaged concrete from ceiling of topping slab, several cracks were spotted. In this case, the repair works on the damaged topping slab was included crack injection. The cracks with wideness $w \geq 0.2\text{mm}$ should be sealed and injected. The crack $w \geq 0.2\text{mm}$ have to be sealed with epoxy mortar prior to injection. Then, drilled packers have to be installed at the distance of 20cm, from each other. The holes for packers have to be cleaned by compressed air to remove dust. Injection of epoxy resin should be done with low pressure pump ($\leq 1\text{bar}$). After 24hours of injection, all surface protection and packers have to be removed. The view of noticed crack in topping slab is shown in Figures VIII-160 and VIII-161.

Figure (VIII-160 & VI-161) Crack in topping slab

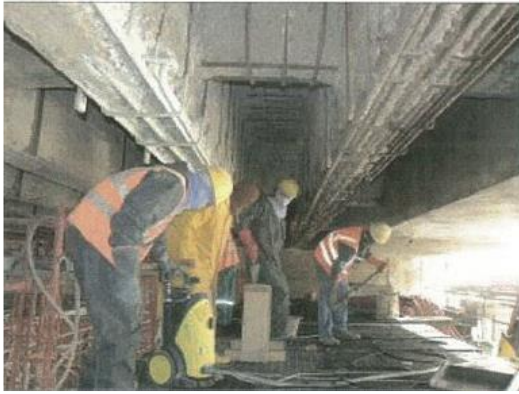
Figure (VIII-162) Removal of damaged concrete and rebars cleaning with water-sand blasting, longitudinal slab beam

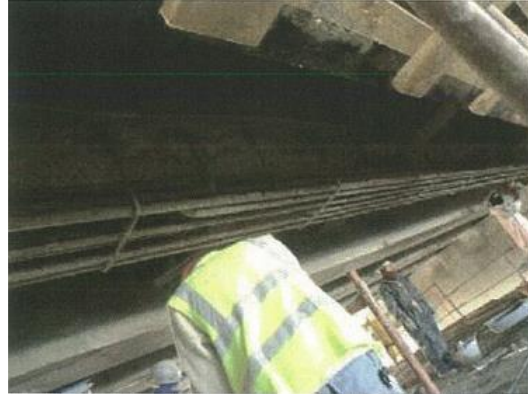
Figure (VIII-163) Reinforcement rods after cleaning, longitudinal slab beam

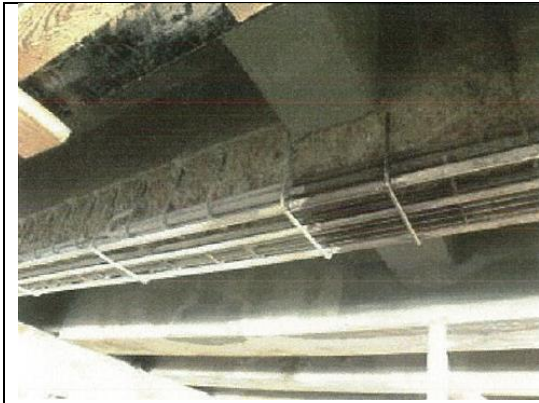
Figure(VIII-164) Rebar protective coating, longitudinal slab beam

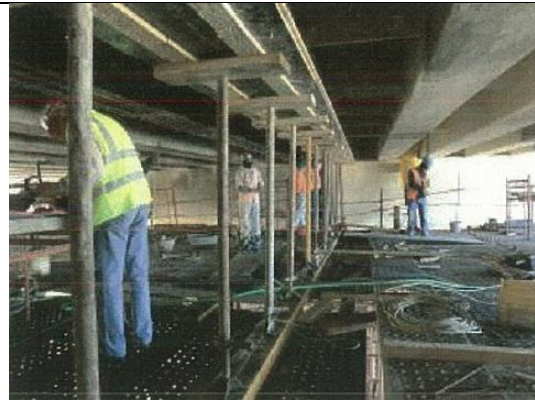
Figure (VIII-165) Longitudinal slab beam bottom grouting

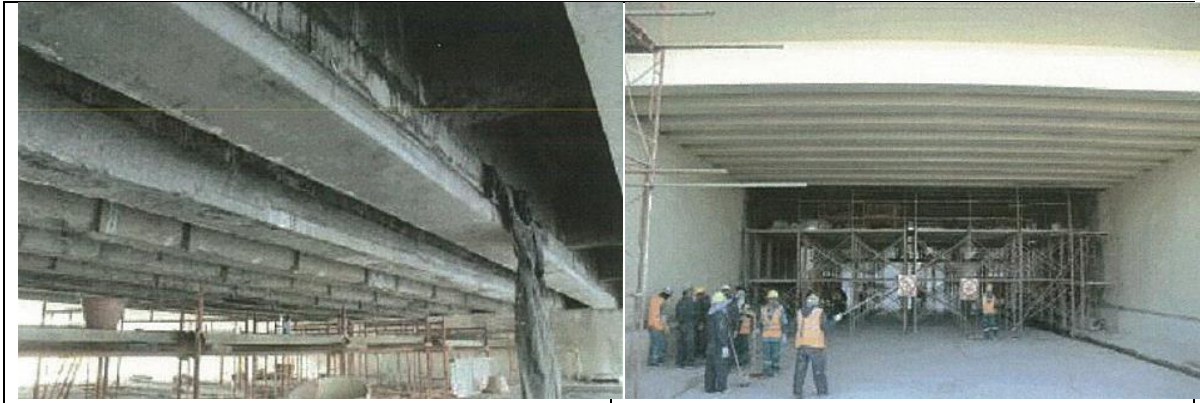
Figure (VIII-166) Longitudinal slab beam bottom repaired

Figure (VIII-167) View of superstructure of the bridge, after painting

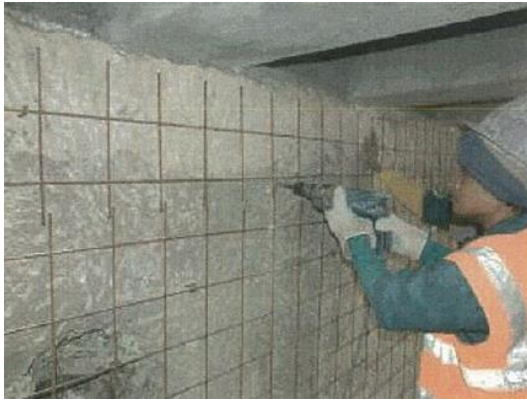
Figure (VIII-168) Abutment wall wire mesh application

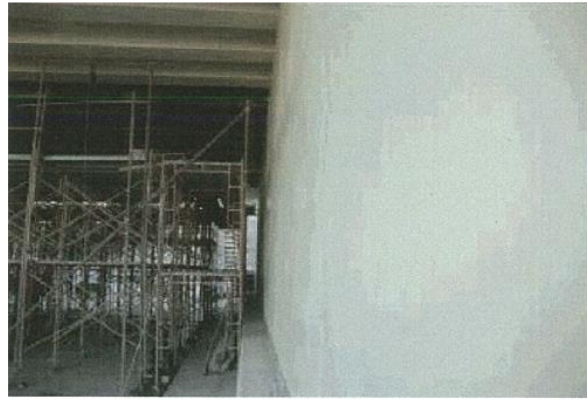
Figure (VIII-169) View of abutment wall after plastering and painting

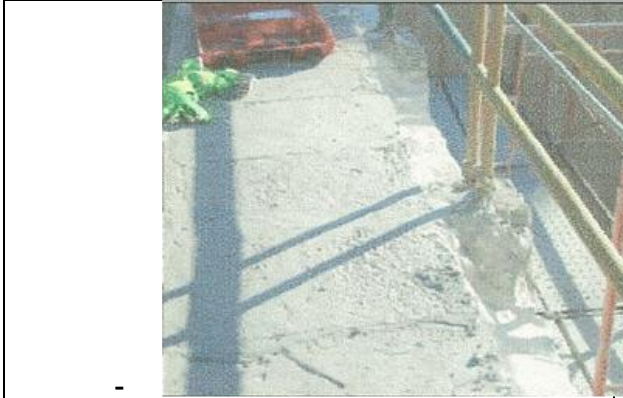
Figure (VIII-170) Removal of "old" beam for fence

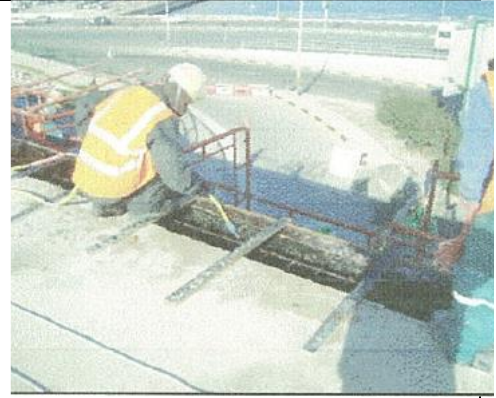
Figure (VIII-171) The new RC beam for fence: casting of concrete in framework

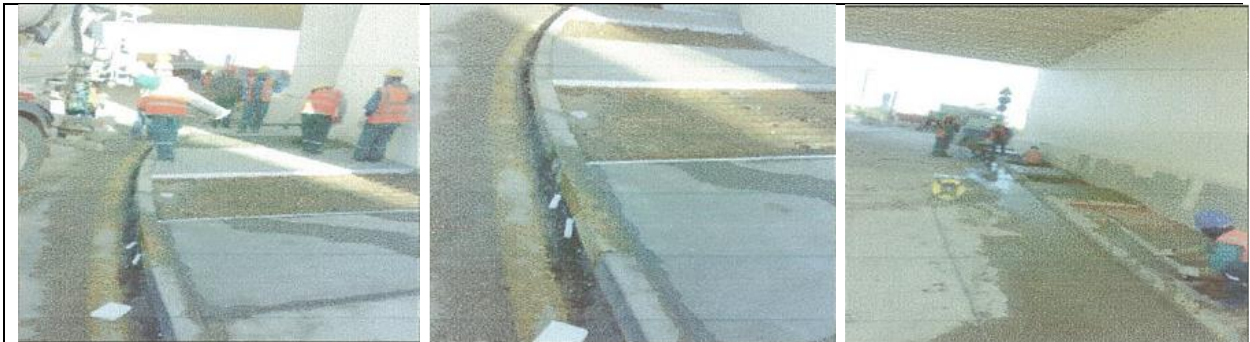
Figure (VIII-172) Execution of a new part of sidewalk under bridge

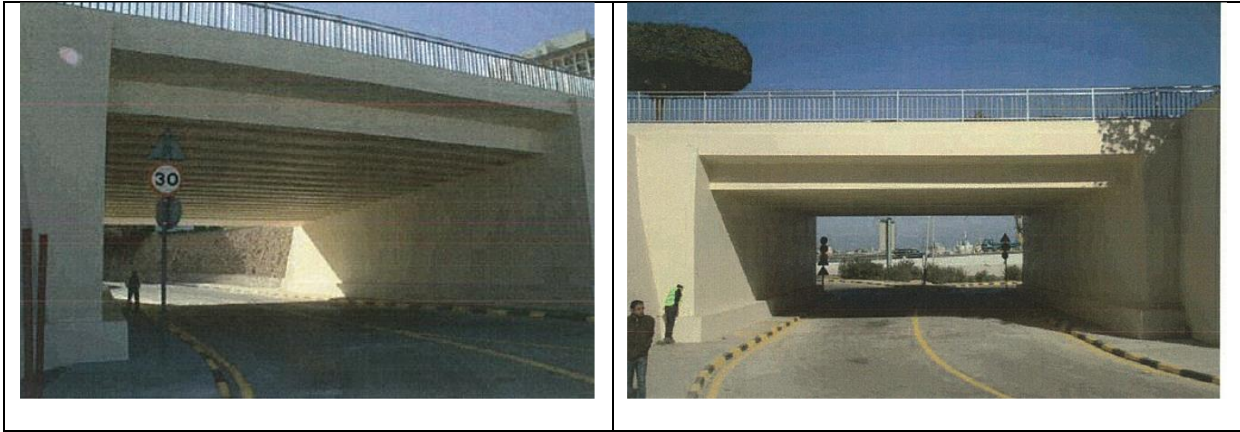
Figure VIII-173 & VI-174. The view of bridge after reconstruction

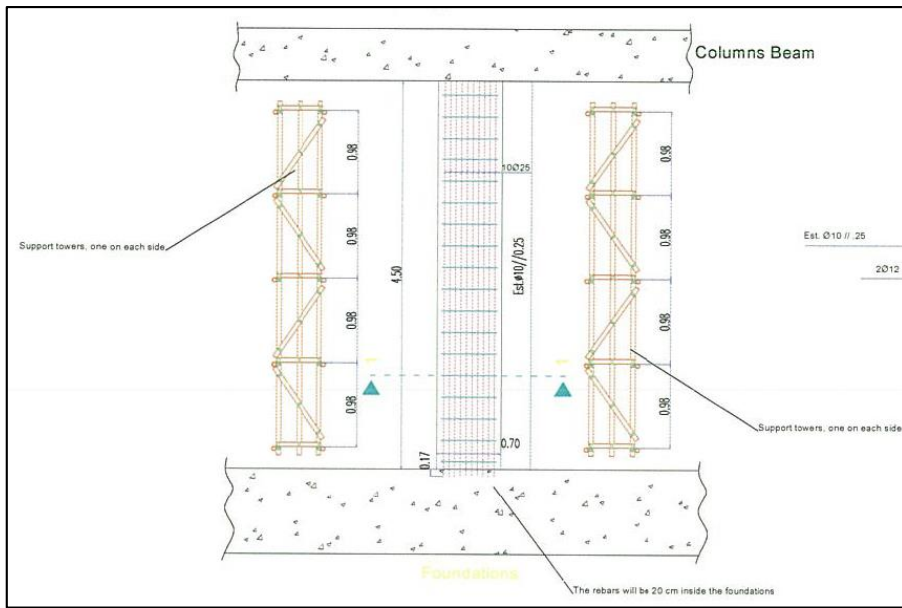
Figure (VIII-175) Support towers for temporary supporting upper part of bridge during column repair

Before executing of strengthening repair of columns the additional temporary supports have to be use. The view and location of support towers is given in Fig (VIII-175)

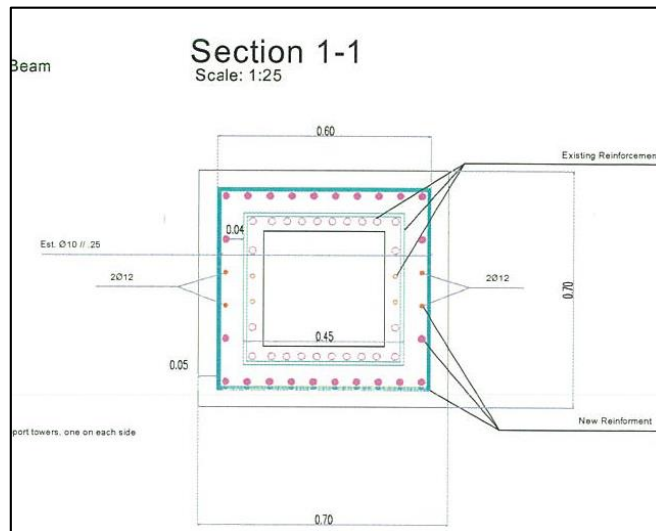
Figure (VIII-176) Cross section of strengthened columns with arrangement of new reinforcing bars

Strengthening of columns includes: enlargement of cross section by addition of new reinforcing bars 4cm far from existing bars and a new cover with thickness of 5cm. The characteristic cross section of strengthened columns is shown in Fig (VIII-176)

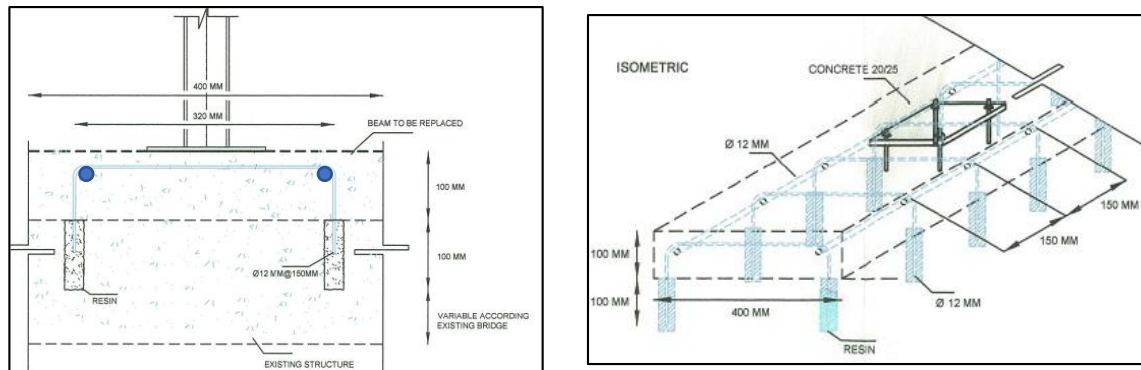
The third elements for structural repair are RC beams for fence. According to visual inspection, those beams were not seriously damaged, but it is supposed that the upper part of those beams will be damaged during the removal of the fence. Also, installation of new fence requires upgrading of the beams. The way of upgrading beams for fence can be seen in Figure (VIII-178).

Figure (VIII-178) Upgrading of beam for fence: arrangement of reinforcing bars and the way of fixing Π bars in “old” concrete

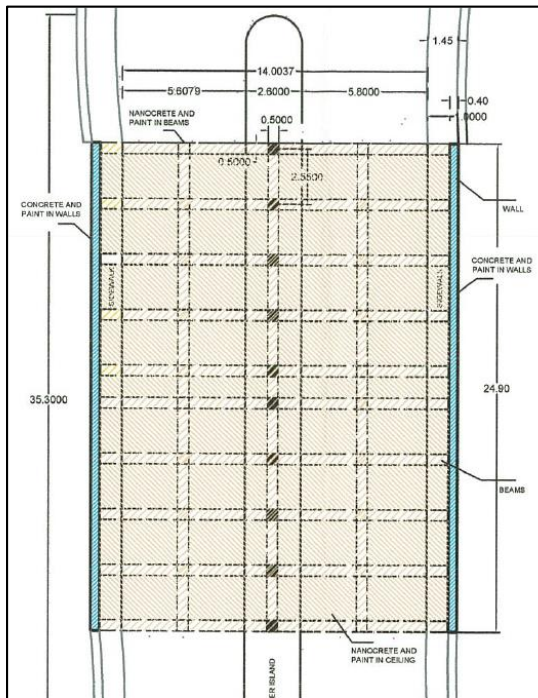
Figure (VIII-179) Layout of elements that have to be repaired with chosen repair materials

The concrete mixture, C30/37, with maximum aggregate grain size of 20mm and with appropriate workability should be used for reprofiling.

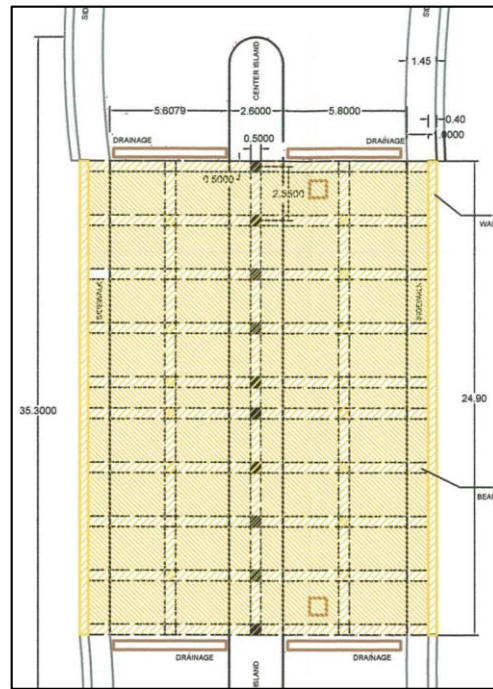
Figure (VIII-180) Layout of elements that have to be repaired (drainage system)

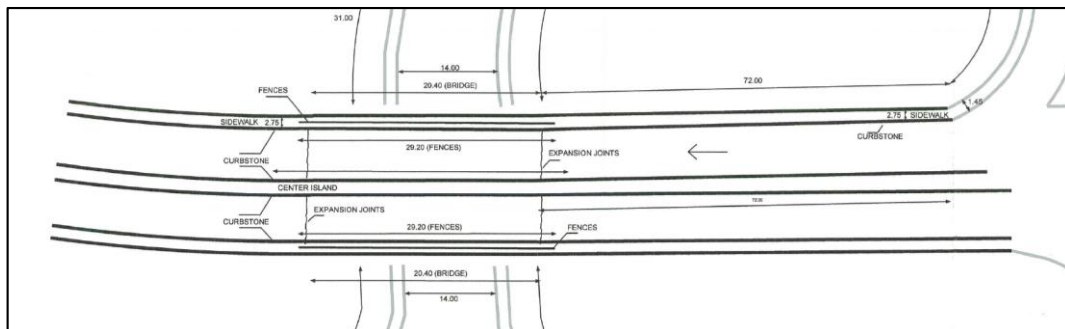
Figure (VIII-181) Layout of elements that have to be repair (expansion joints, curbs, and fence)

During visual inspection it was noticed that expansion joints were seriously damaged. In the text below a short description of measures recommended for their rehabilitation is given.

The processes of rehabilitation have to start with removal of old damaged asphalt layer by cutting with saw cutter and removing old asphalt by pick hammers. Then, the next operations should be done in next order:

- Cleaning and chipping of surface
- Fixing of shutters
- Casting of cementitious base grout for leveling down surface
- Fixing of steel shut over the joint
- Lining of waterproofing membrane to prevent leakage
- Cleaning and spreading of tack coat
- Placement and compaction of wearing asphalt course

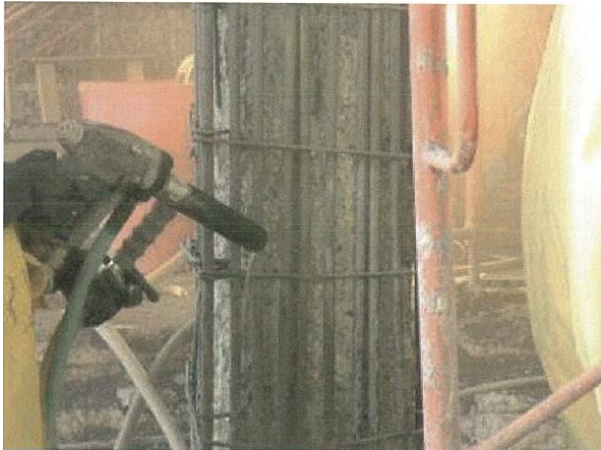
Figure (VIII-182) Column: Blasting of rebars with mix of sand and water

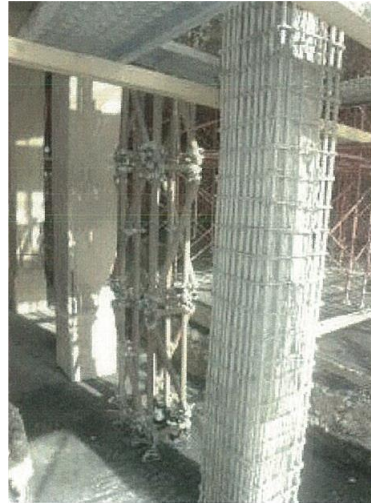
Figure (VIII-183) Column: Protection of rebars with cementitious materials

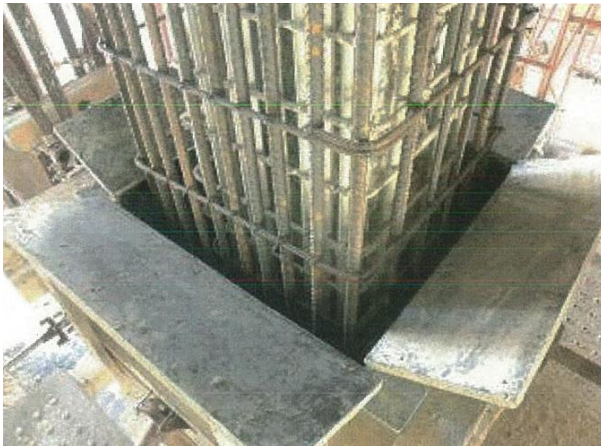
Figure (VIII-184) Prepared column with formwork ready to cast

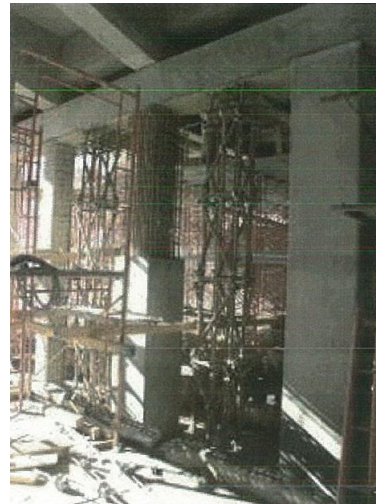
Figure (VIII-185) View of repaired column and column in 2nd phase of repair

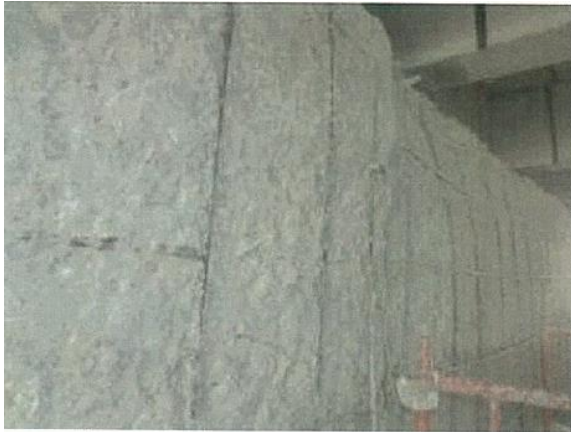
Figure (VIII-186) The view of abutment after removal of all damaged concrete

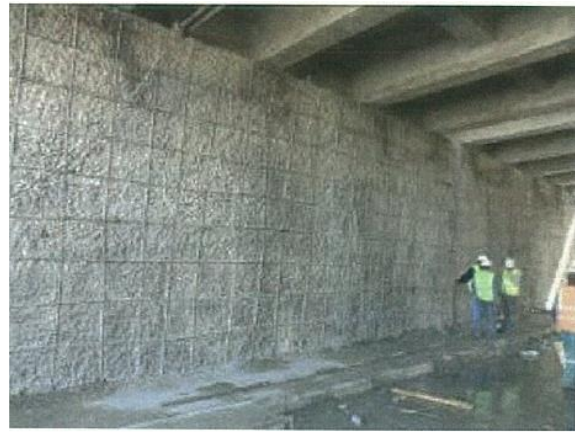
Figure (VIII-187) Reinforcing rebar covered with cementitious protecting material

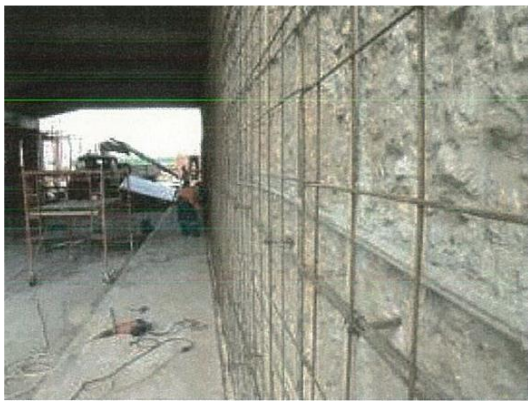
Figure (VIII-188) Repairing of abutment: steel mesh for shrinkage control

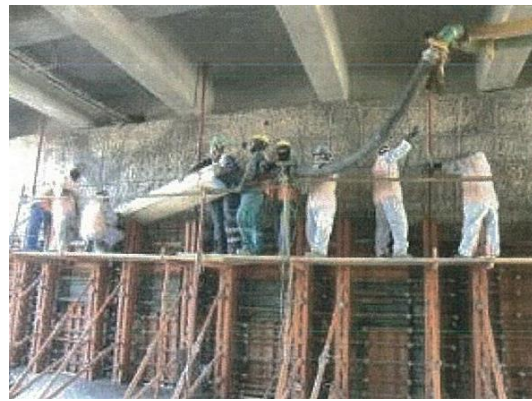
Figure (VIII-189) Repairing of abutment: placing of new concrete, 1st phase

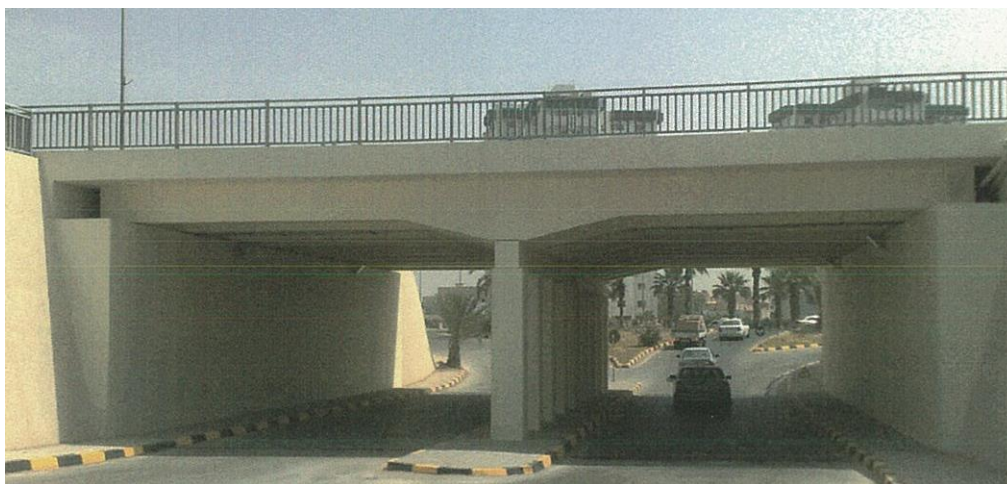
Figure (VIII-190) The view of the concrete bridge elements after application of all recommended measures and materials

After finishing of preparation of concrete surfaces on beams for fence, down surfaces of deck ceiling beams and top slab and application of bond agent, the chosen pre-mixed repair mortar is applied by spray technique. Then, on all repaired surfaces the curing agent is applied. After curing period, final protecting coating is applied in two layers.

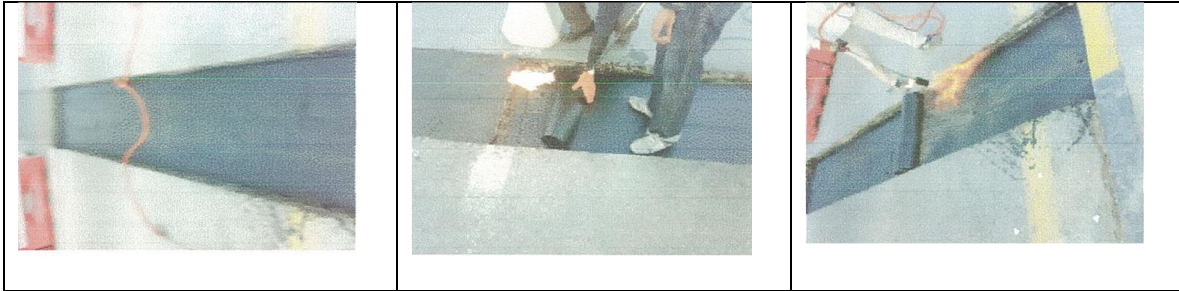
Figure (VIII-194) fixing of water proofing membrane

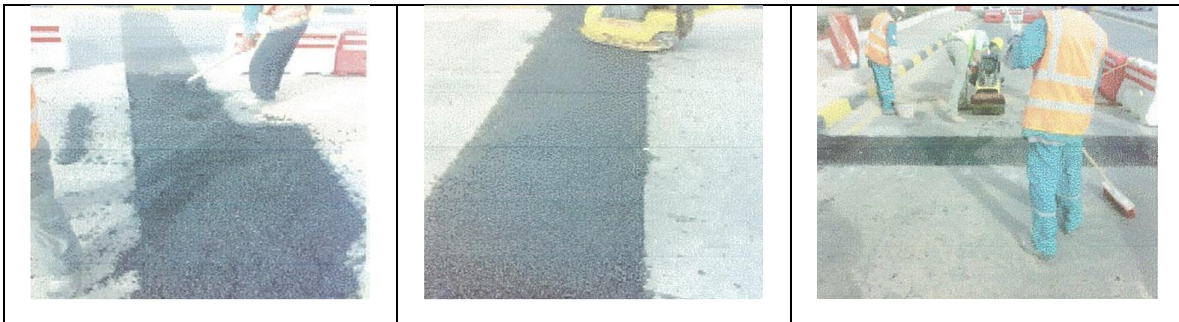
Figure (VIII-195) Placement and compaction of wearing asphalt course

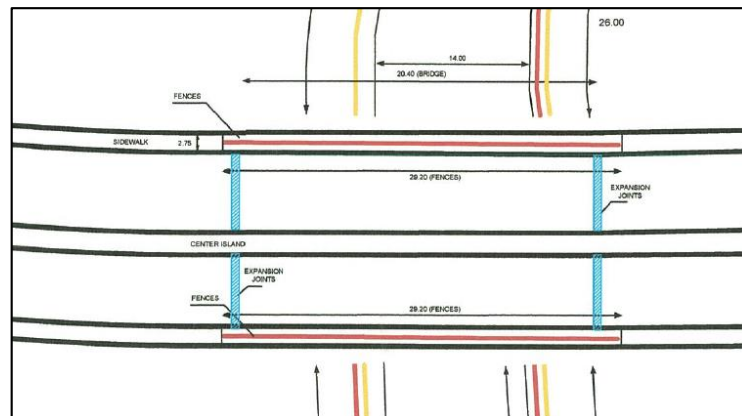
Figure (VIII-196) Disposition of the expansion joints

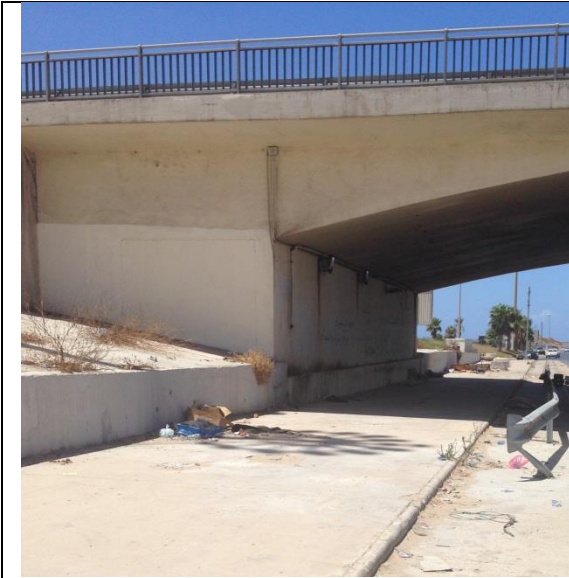
Figure (IX-3) A View of supporting part of lateral beam of arch slab, east side.

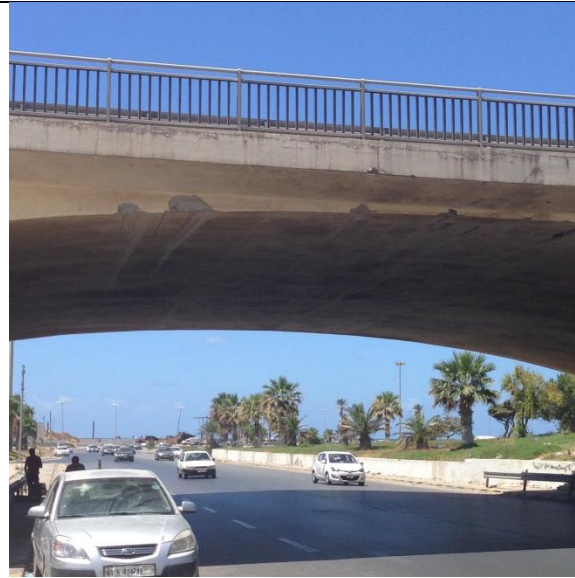
Figure (IX-4) A View of lateral beam of arch slab and cantilever slab, east side.

- Traces and stains of water (Fig IX-4 –IX-6, and IX-11)
- Peeling of protecting painting (Fig IX-4 – IX-6, and IX-11) and
- Horizontal and vertical cracks (Fig IX-11)

Traces and stains of water are characteristic for whole side surface of cantilever slabs due to bad drainage.

On the basis of those descriptions, it can be concluded that registered damages are in initial phase, but to avoid appearance of new damages, the drainage of atmospheric water should be improved.

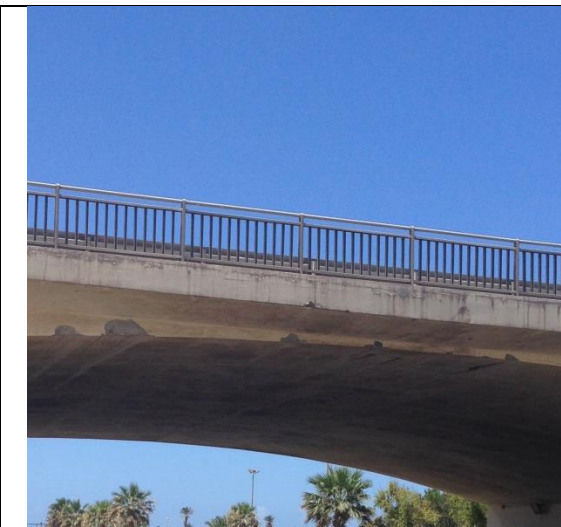
Figure (IX-5) A View of lateral beam of arch slab and cantilever slab, east side.

- Traces and stains of water (Fig IX-5 and IX-6)
- Spalling off of repair mortar (Fig IX-5 and, IX-6) and
- Net like cracks (Fig IX-6)

The traces and stains of water are noticed in the middle part of lateral beam, as well as several local spalling off of repair mortar which were caused by hitting by bullets.

The noticed local spalling off of repair mortars are shallow and no reinforcing bars have been visible, yet.
