**COMPARATIVE ANALYSIS OF DURABILITY AND
RANKING OF CONCRETE BRIDGES IN HOT
CLIMATES**

DOCTORAL THESIS

Novi Sad, 2022.

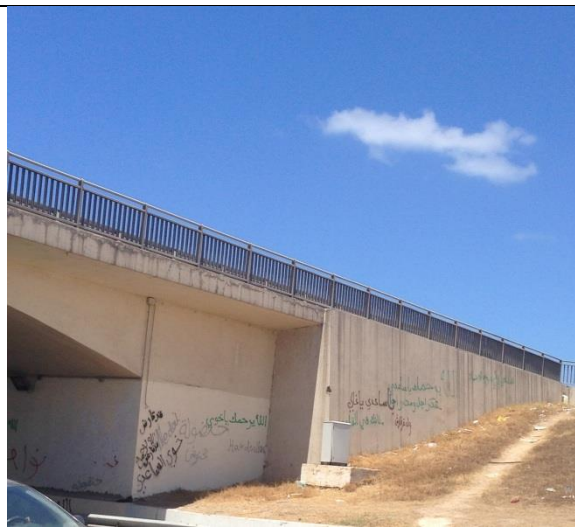
Figure (IX-6) A View of supporting part of lateral beam of arch slab, west side

- Traces and stains of water (Fig IX-5 and IX-6)
- Spalling off of repair mortar (Fig IX-5 and, IX-6) and
- Net like cracks (Fig IX-6)

The characteristic damage of the down side of lateral beams is net like cracks caused by drying shrinkage of repair mortar.

In the middle part of span on down side of lateral beam several transversal and very straight local zones of spalling off of repair mortar were appeared (Fig IX-6).

The net like cracks are the most serious damage due to the possibility of corrosion of reinforcement. This damage might cause the reduction of durability.

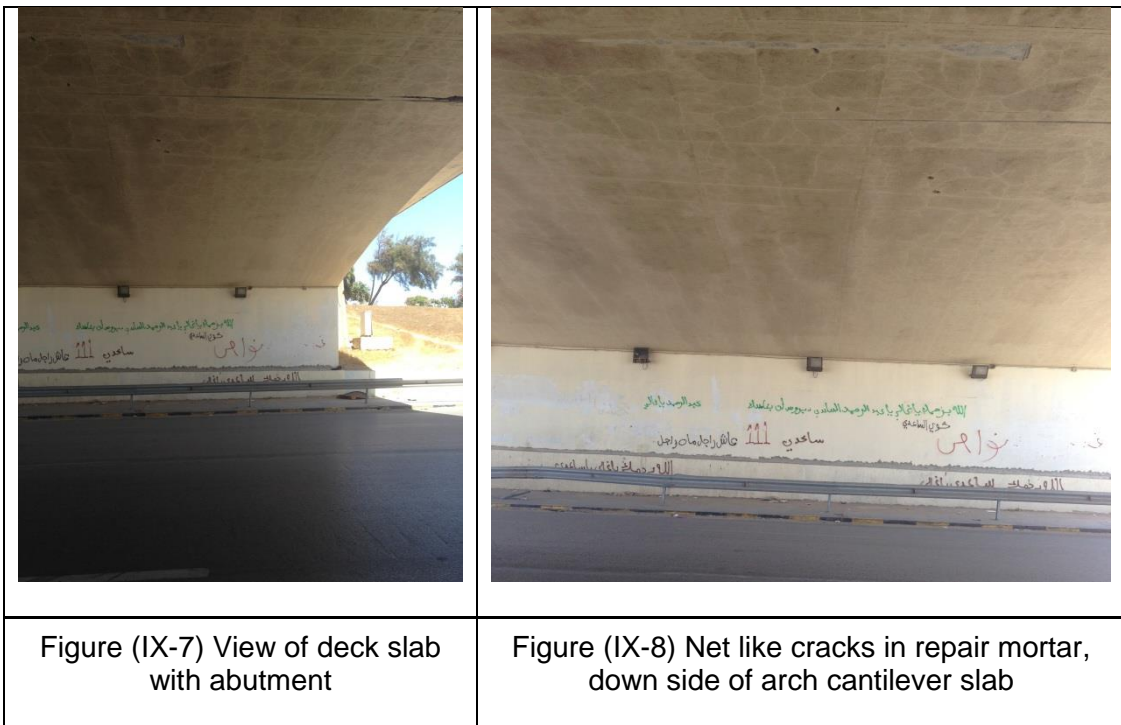
- Traces and stains of water (Fig IX-8)
- Spalling off of repair mortar (Fig IX-7 and IX-10) and
- Net like cracks (Fig IX-7-IX-8)

The traces and stains of water are noticed in the middle part of deck slab near the lateral beams.

The characteristic damage of the down side of deck slab is net like cracks caused by drying shrinkage of repair mortar. Described damage is noticed on the whole down side of deck slab (Fig IX-7-IX-10).

Spalling off of repair mortar (cover) was appeared in the middle of the bridge deck span – on simple beam slab. This damage is shallow, the reinforcement is not visible and is caused by bad bonding between concrete and repair mortar (Fig IX-8).

On the place of connection between cantilever arch slabs and simple beam slab the “channel” was formed by cutting of repair mortar due to release of surface stresses and because of different moving of these elements, also (Fig IX-8).

The net like cracks are the most serious damage due to the possibility of corrosion of reinforcement. This damage might cause the reduction of durability.

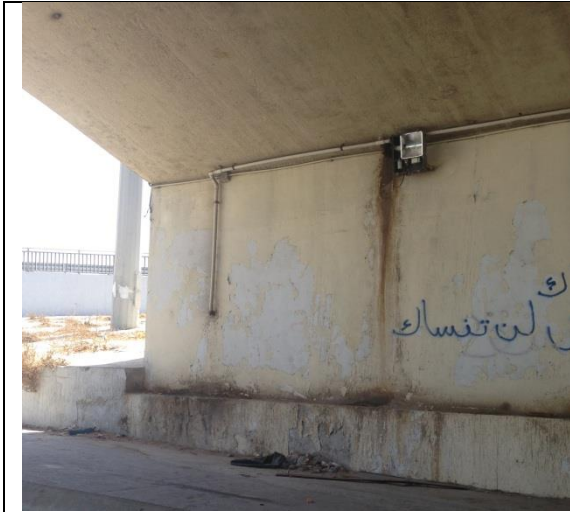
Figure (IX-12) View of supporting wall

- Traces and stains of steel corrosion (Fig IX-12 and IX-13)
- Peeling off of protecting painting (Fig IX-12-IX-14) and
- Vertical and horizontal cracks (Fig IX-14)

Traces and stains of steel corrosion have been noticed on the places where metal parts of some installation were fixed for wall.

Peeling off of surface protecting paint is characteristic damage and it has been registered on approximately 50% of wall surface.

On the basis of those descriptions, it can be concluded that supporting walls are in good condition. Registered peeling off of protecting painting could be easily repaired, by changing it.

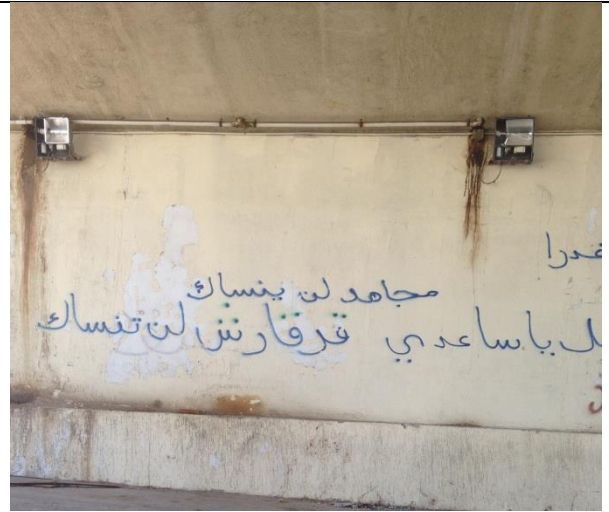
Figure (IX-13) View of supporting wall

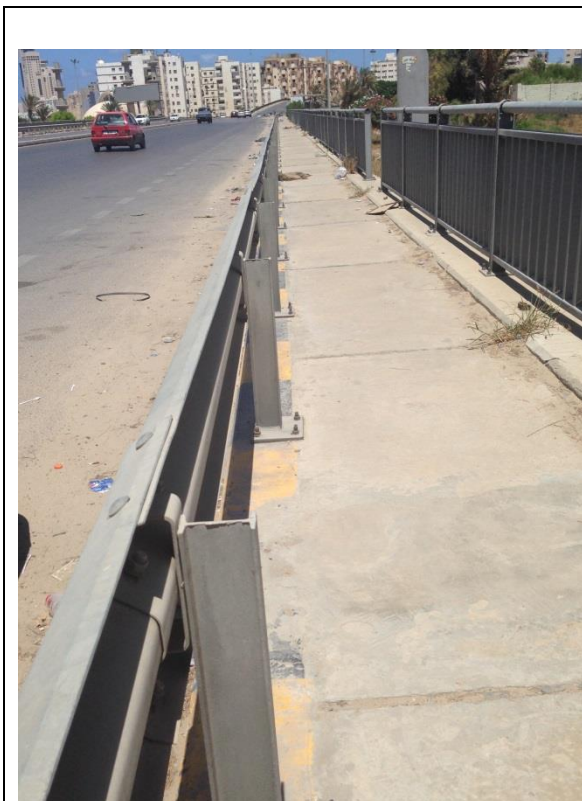
It could be concluded that initial damages have occurred on pedestrian path surface and some prevention measures for slowing down appearance of new and progress of numbered damages should be undertaken.

Figure (IX-15) A general view of Pedestrian path on bridge

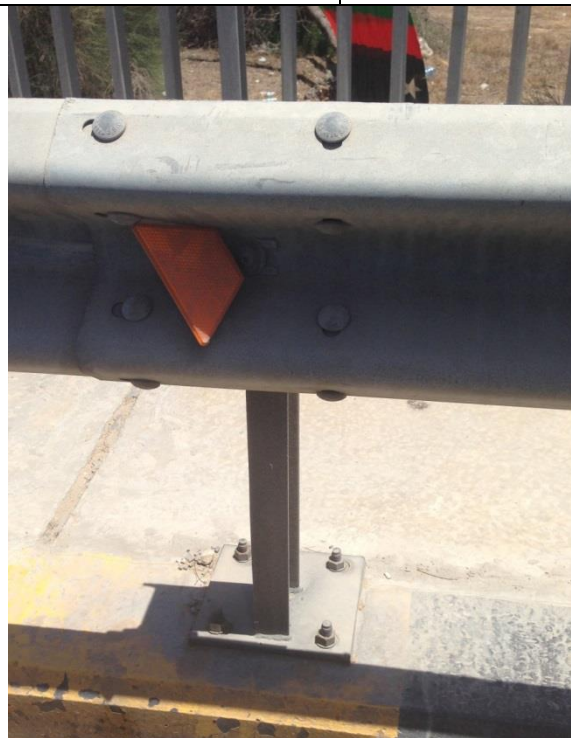
Figure (IX-21) A general view of reflective sign in guardrail

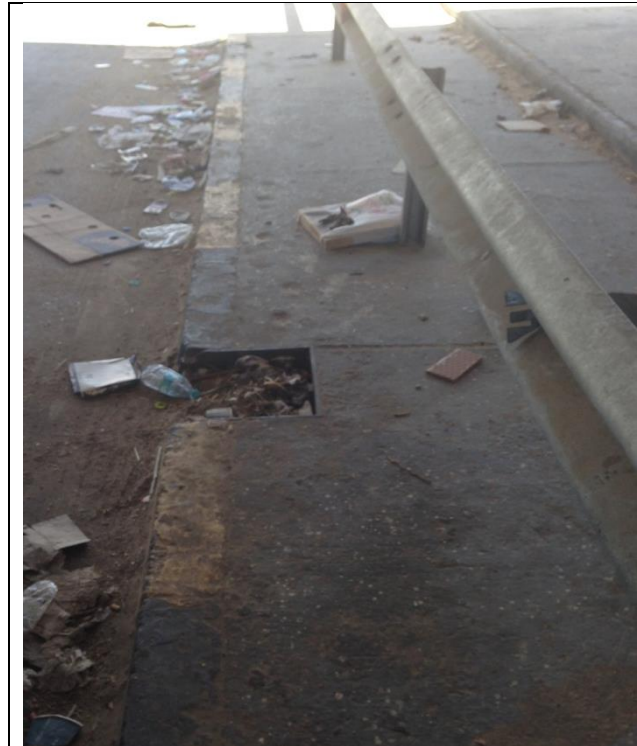
Blockage of drainage channels under the bridge with garbage, dust and sand, which causes the rainwater to not be drainage.

Figure (IX-22) A general view of catch pit under the bridge

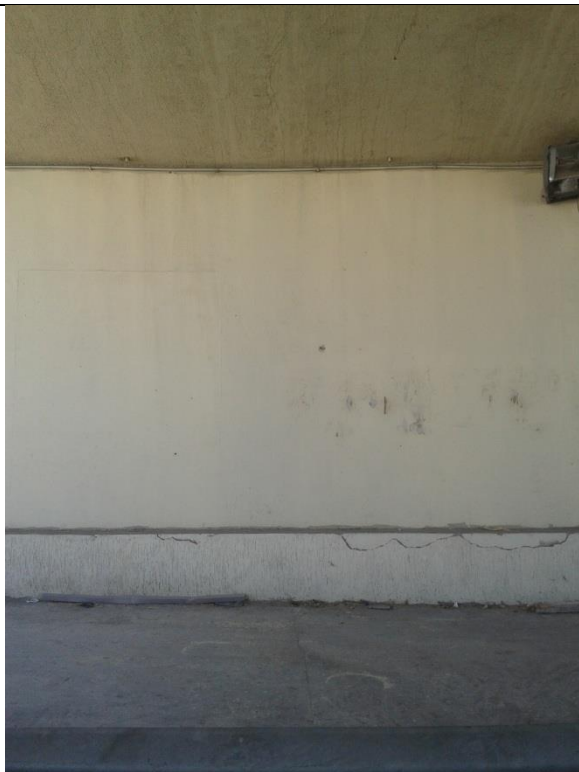
Figure (IX-31): View of supporting wall, damages of plinth

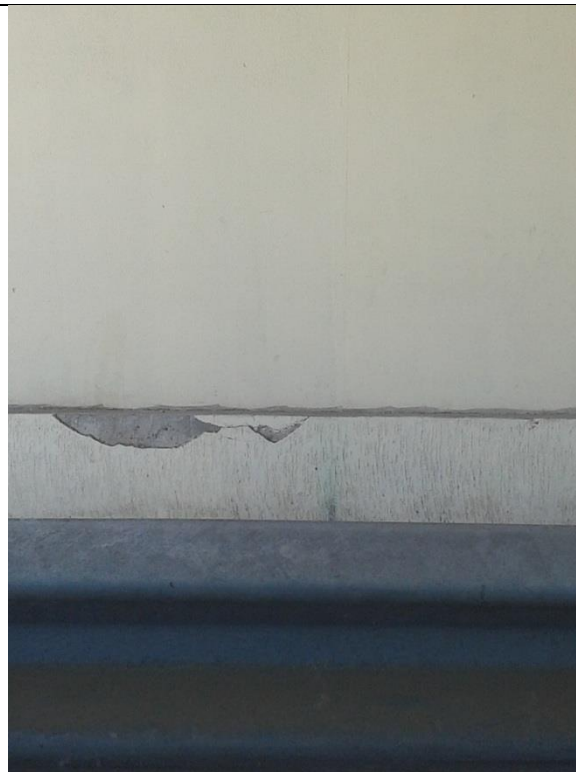
Figure (IX-32): Supporting Wall, the detail of damage of plinth

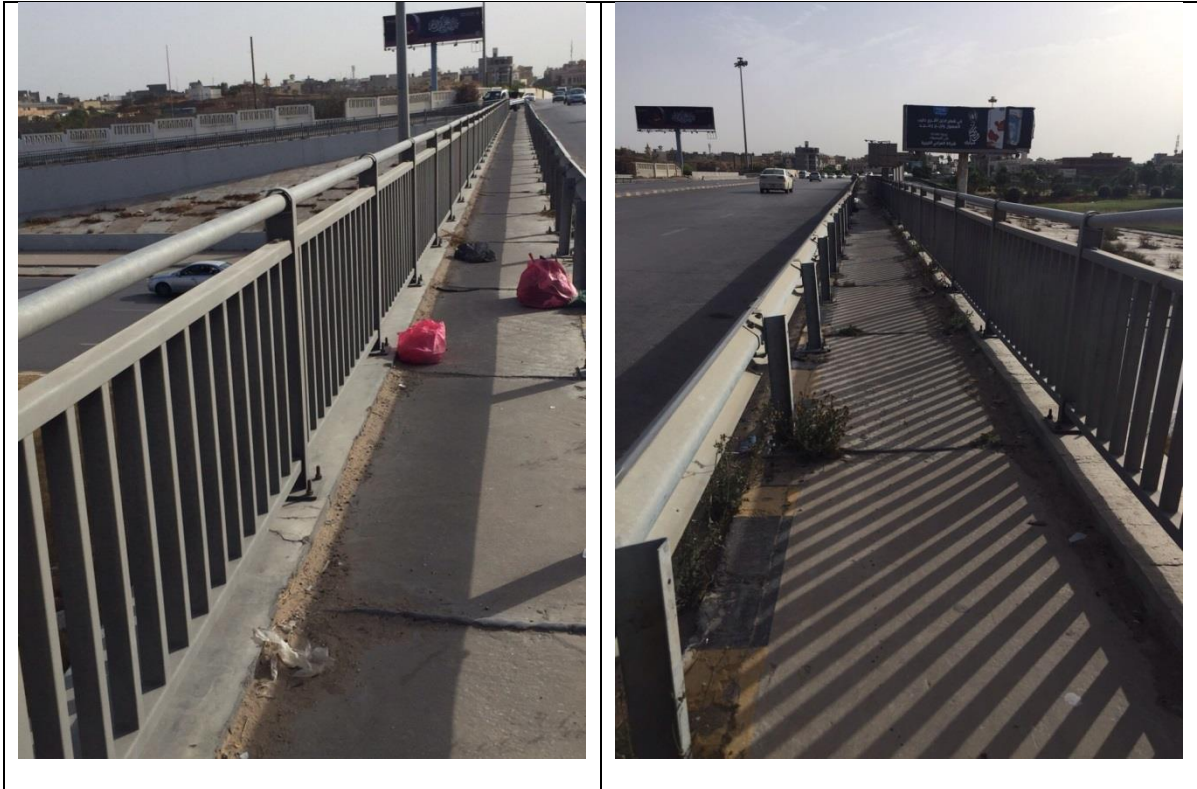
On concrete surfaces between cold joints the shallow pits were spotted. It is supposed that they were caused by mechanical action. (Fig IX-36)

It could be concluded that initial damages have occurred on pedestrian path surface and in cold joints. Some prevention measures for slowing down appearance of new and progress of numbered damages should be undertaken.

Figure (IX-35): View of pedestrian path

Figure (IX-36): View of pedestrian path

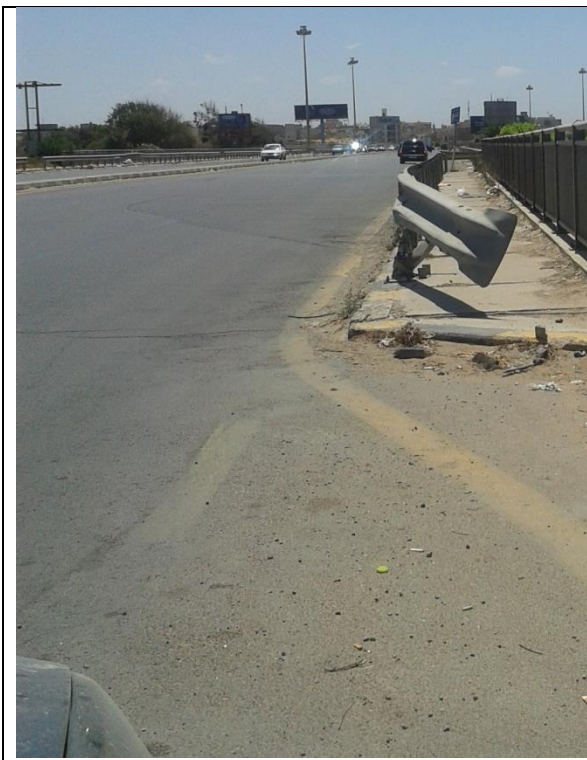
Figure (IX-37): A general view of asphalt wearing layer, transversal crack

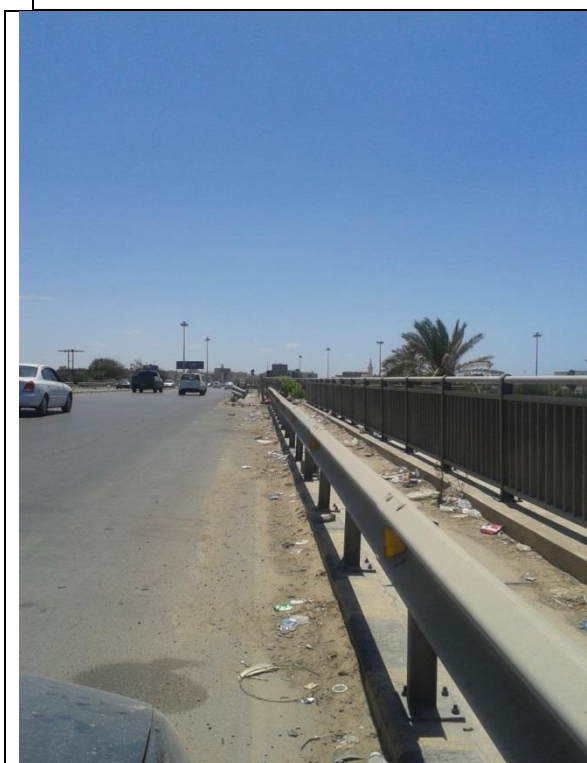
Figure (IX-38): Detail of asphalt wearing layer with longitudinal crack

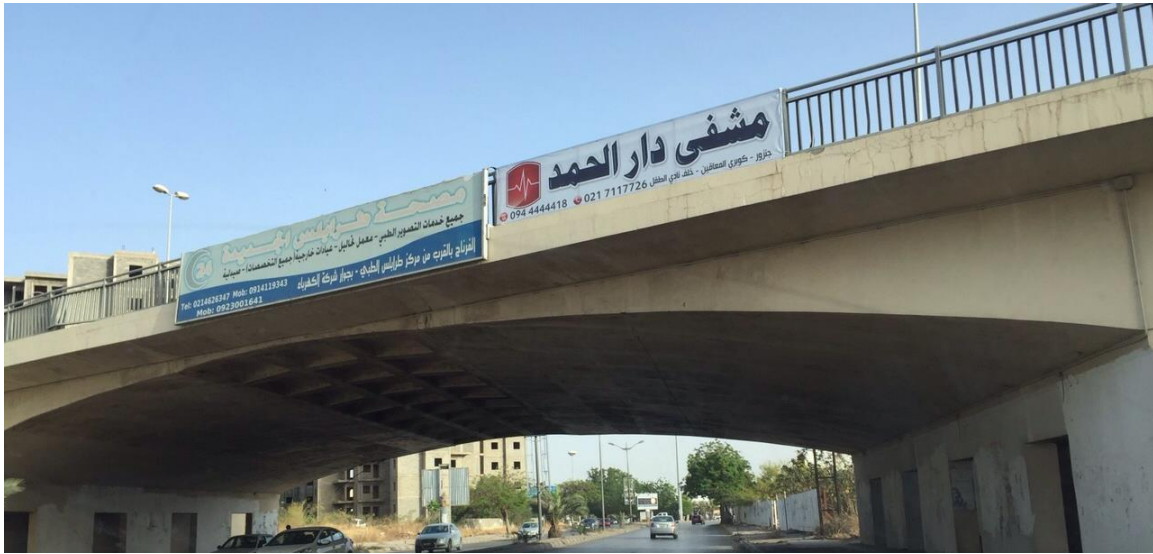
Figure (IX-45) A View of Lateral beams

- Traces and stains of water (Fig IX-45, IX-48 and IX-50)
- Local spalling off concrete and (Fig IX-45 and IX-50)
- Net like, horizontal and vertical cracks (Fig IX-45 and IX-50).

Traces and stains of water are characteristic for whole side and down surface of cantilever slabs. They occurred due to bad drainage of rain water (Fig IX-45, IX-48 and IX-50). White traces of leakage are noticed in joint between two parts of superstructures of the bridge.

The horizontal crack was appeared between two layers of concrete and it stretches along the whole length of slab (Fig IX-45 and IX-50).

Vertical cracks are characteristic damage on side surface of cantilever slab. They were caused by drying shrinkage of concrete and/or by corrosion of reinforcement (Fig IX-45 and IX-50).

Net like cracks are also characteristic for side surface of analysed element (Fig IX-45 and IX-50).

Spalling off of concrete is very local, shallow and it was spotted on side surfaces (Fig IX-45 and IX-50).

On the basis of those descriptions, it can be concluded that described cracks on side surface of cantilever slabs, particularly vertical cracks, could cause reinforcement corrosion. Because of that, execution of new concrete/mortar cover is recommended. Also, to avoid appearance of new damages, the drainage of atmospheric water should be improved.

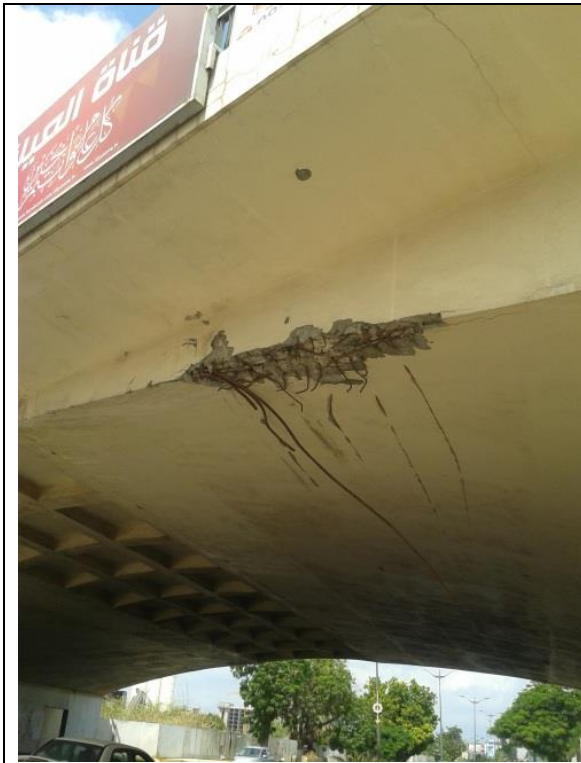
Figure (IX-46) Mechanical damage of lateral beam

The serious mechanical damage is registered on the down side of lateral beam (Fig IX-46). On that place concrete and repair mortar were broken and fallen down, two main reinforcing bars were pulled out and deformed and stirrups were broken and deformed. Described damage is the most serious as it reduce mechanical resistance of lateral beam.

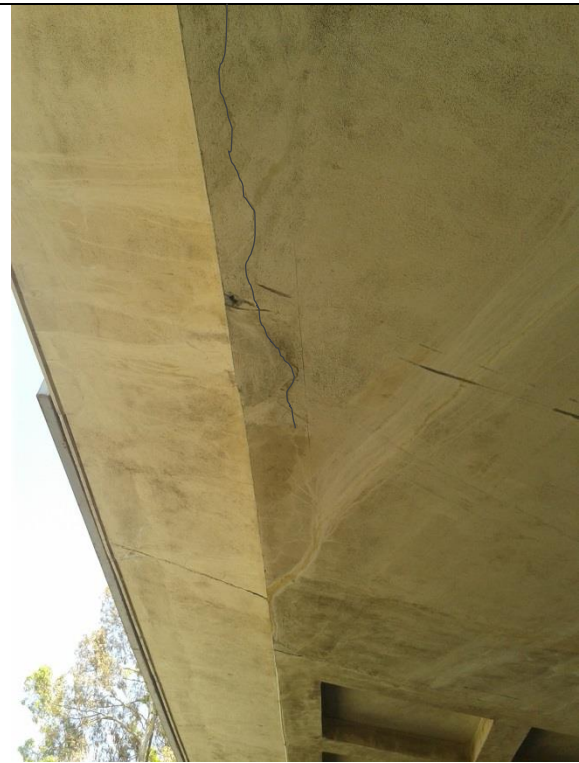
Figure (IX-47) Crack along the edge of lateral beam, water traces

The traces and stains of water are noticed on down side lateral beam. They are caused by leakage of water through joint between arc cantilever slabs and simple beam slab.

The longitudinal crack was spotted along the external edge of lateral beam (Fig IX-47). This damage may be caused by corrosion of main reinforcing bar.

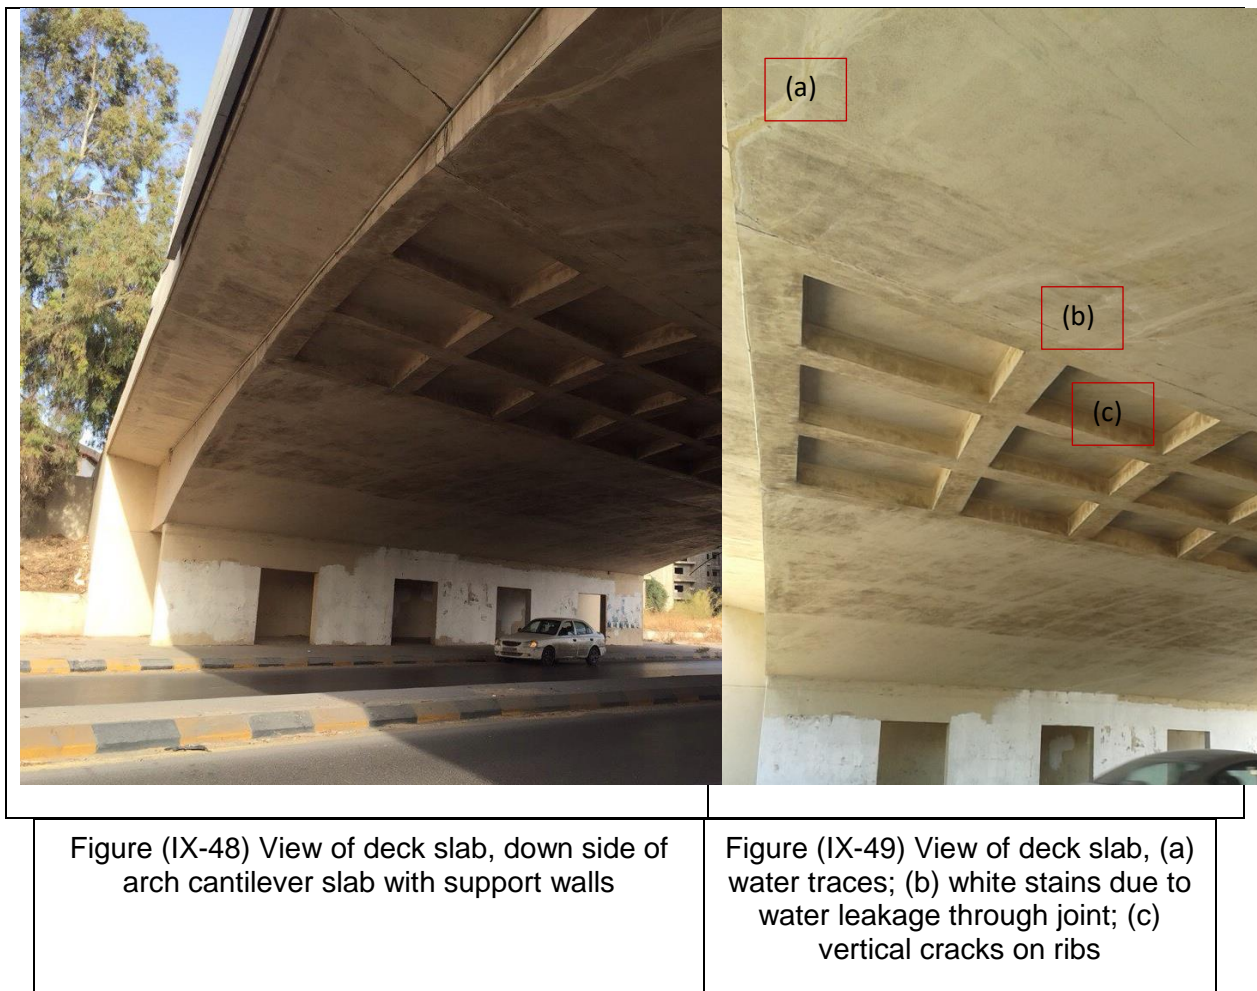
- Traces and stains of water (Fig IX-48 and Fig IX-49 (a) and (b))
- Vertical cracks (Fig IX-49 (c))
- Local spalling off mortar cover.

The characteristic traces are white coloured and they are caused by rain water leakage through the support place of simple beam slab on arch cantilever slab (Fig IX-49 (b)).

The vertical cracks are characteristics for side surfaces of ribs of simple beam slab (Fig IX-49 (c)). The reason for their appearance is drying shrinkage or insufficient thickness of mortar cover.

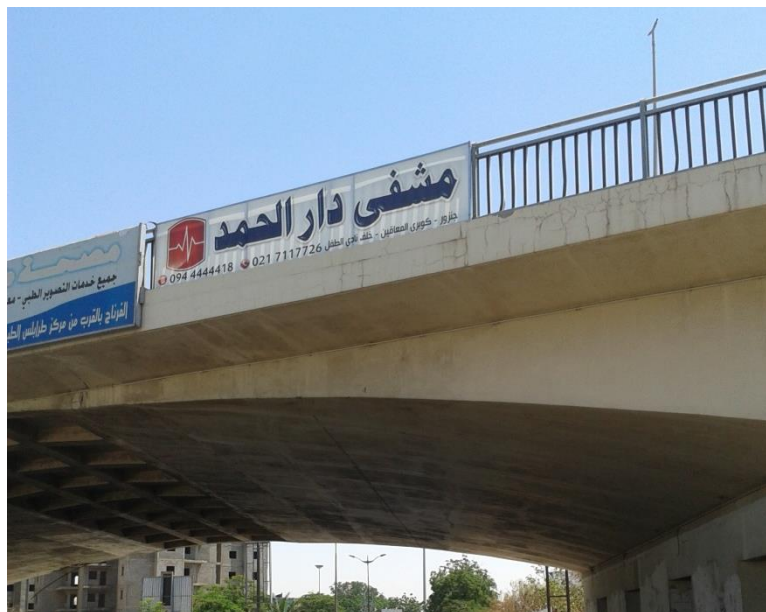
Figure (IX-50) View of cantilever slab, vertical and horizontal cracks

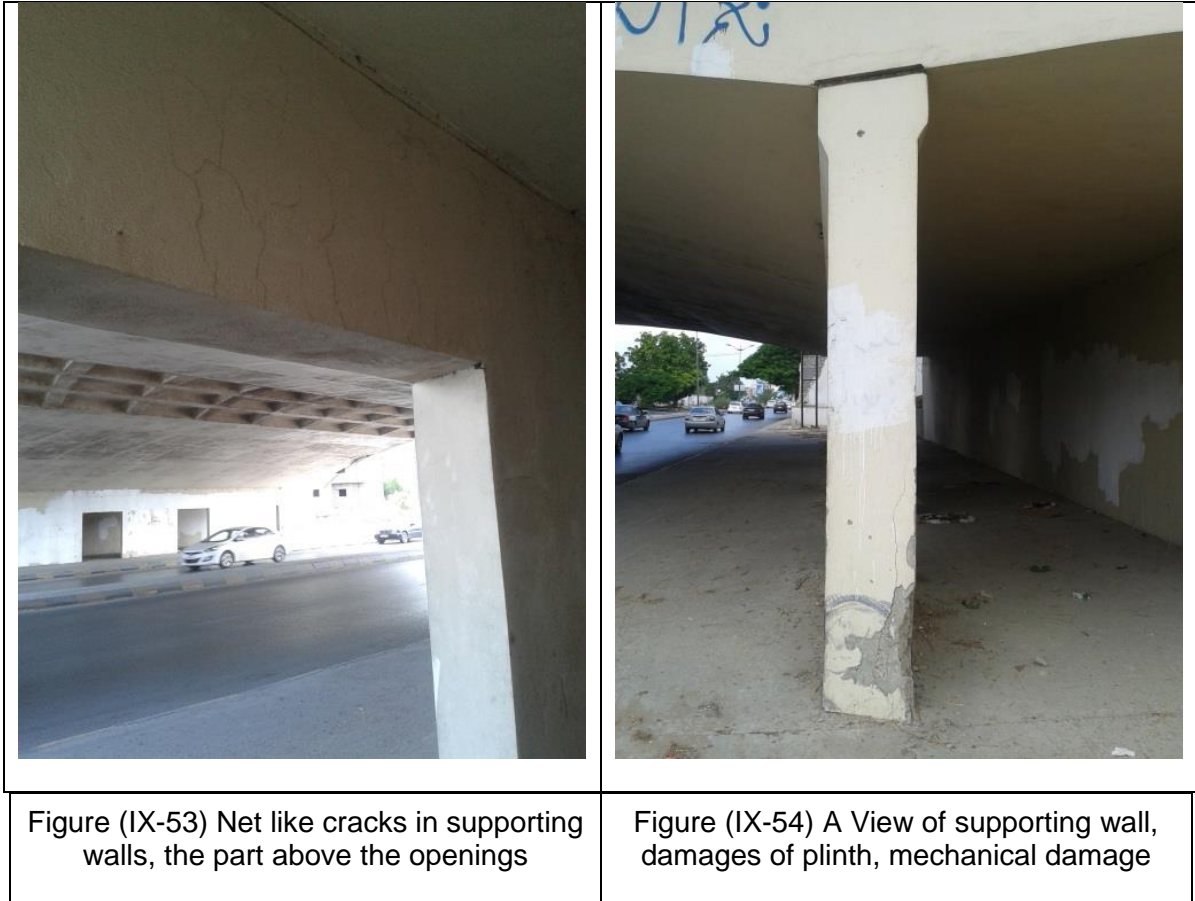
Figure (IX-51) View of supporting wall with ceiling, peeling off protective painting

Figure (IX-52) View of supporting wall, net like cracks

Separation and spalling off of protecting mortar layer is characteristic for plinth. There are two causes for this damage appearance. The first reason is bad adhesion between concrete substrate and mortar protecting layer and the second one it is mechanical impact (Fig IX-54).

Net like cracks are characteristic damage of inspected walls. They were occurred in repair mortar cover due to their drying shrinkage (Fig IX-52 and IX-53)

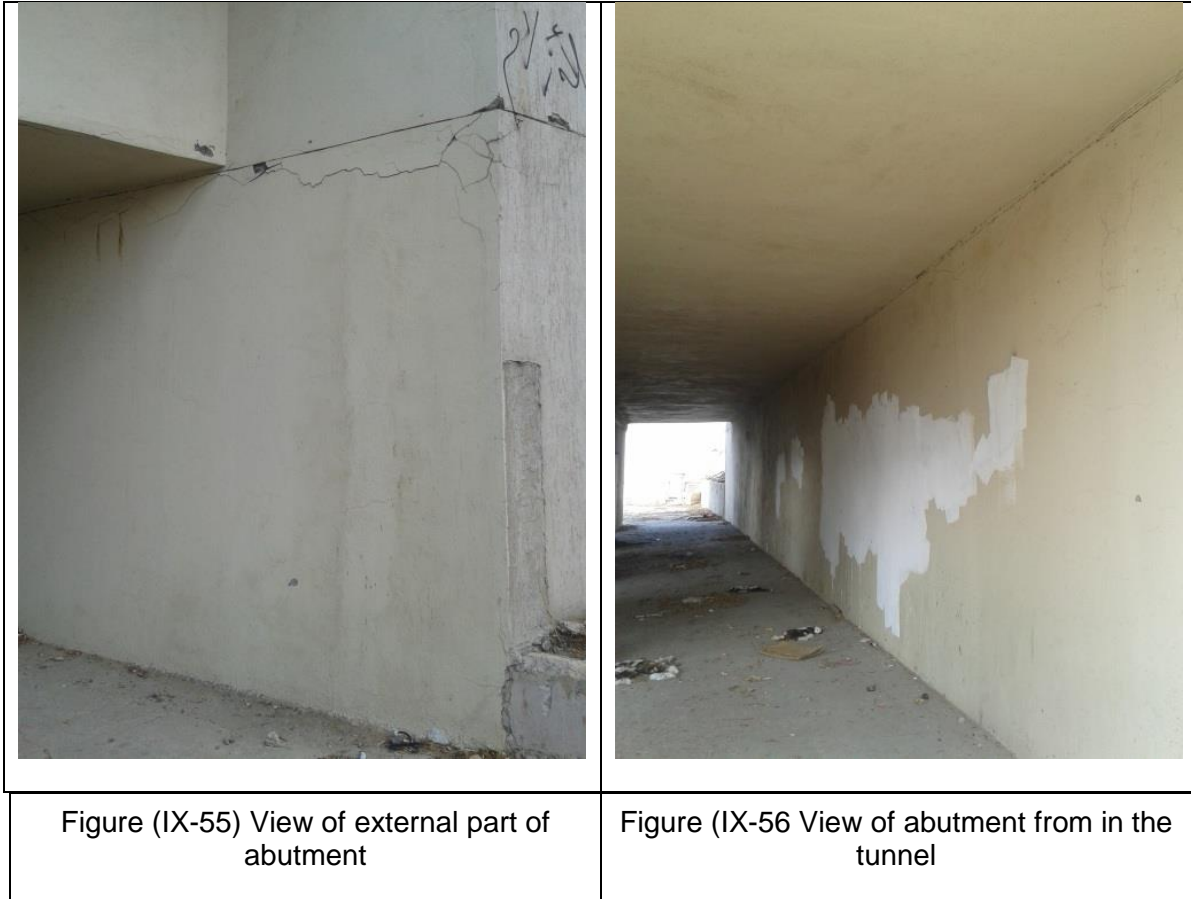
- Traces and stains of rust (Fig IX-55).
- Net like cracks (Fig IX-50 and IX-56) and
- Separations of mortar cover (Fig IX-55).

The characteristic damage of abutment walls is net like cracks. They are registered on almost all visible surface of abutment. The cracks are very thin, except on upper part of external part of abutment wall, where they are much stressed and significantly wider. These cracks are followed by separation of mortar cover and they are about to fall down (Fig IX-55).

Traces and stains of rust have been noticed on only two places near external part of abutment wall.

The most damaged part of abutments is external part in which serious cracks have been appeared, followed by separation of mortar cover. This damage could cause the corrosion of reinforced bars.

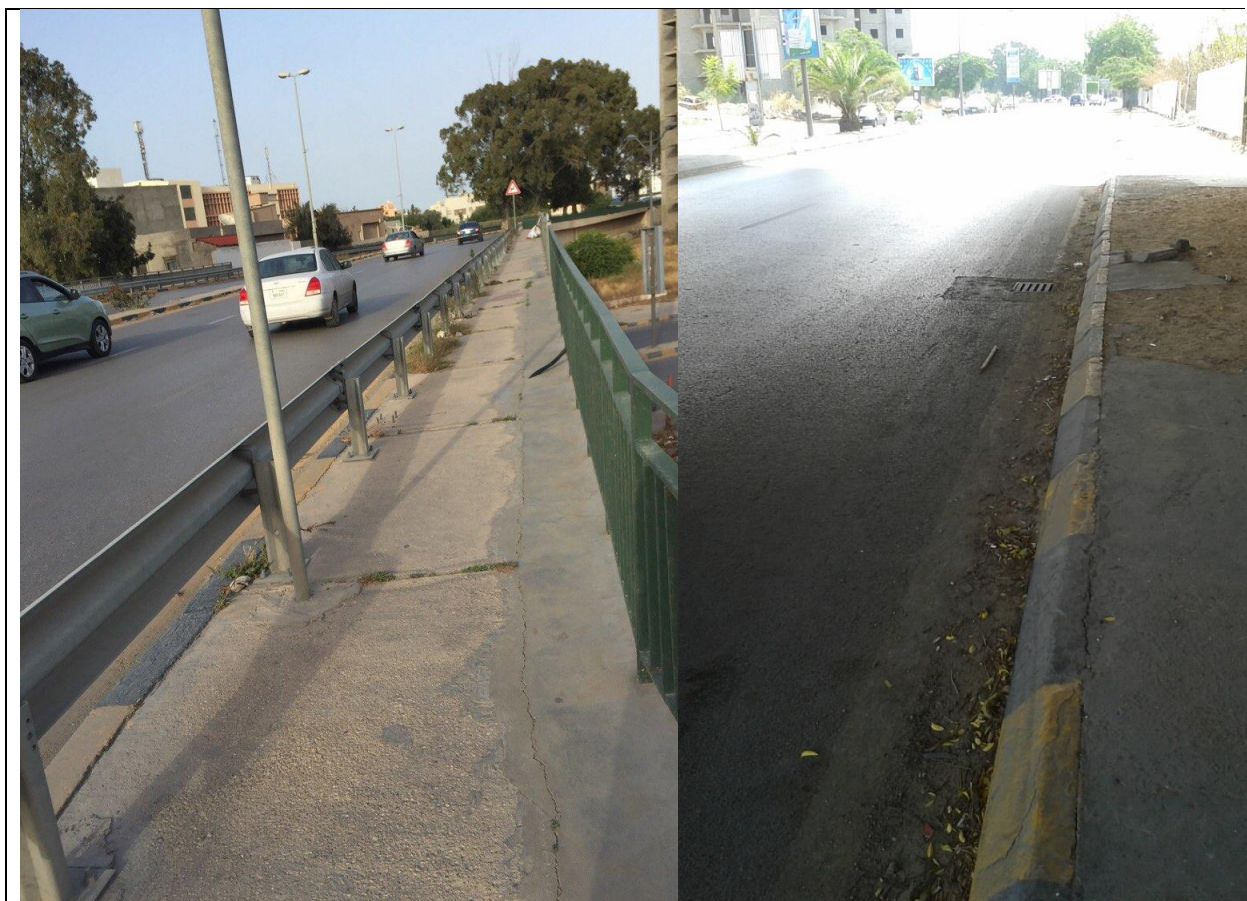
It was observed that the cold joints are very uneven, sometimes with surplus of in filled material, some times without it and sometimes with plants which grow from joints (Fig IX-57).

On concrete surfaces between cold joints the shallow pits and erosion caused wearing were spotted. It is supposed that they were caused by mechanical action. (Fig IX-57)

The large missing part of concrete layer is spotted in the pedestrian path under the bridge (Fig IX-58)

It could be concluded that initial damages have occurred on pedestrian path surface and in cold joints. Some prevention measures for slowing down appearance of new and progress of numbered damages should be undertaken.

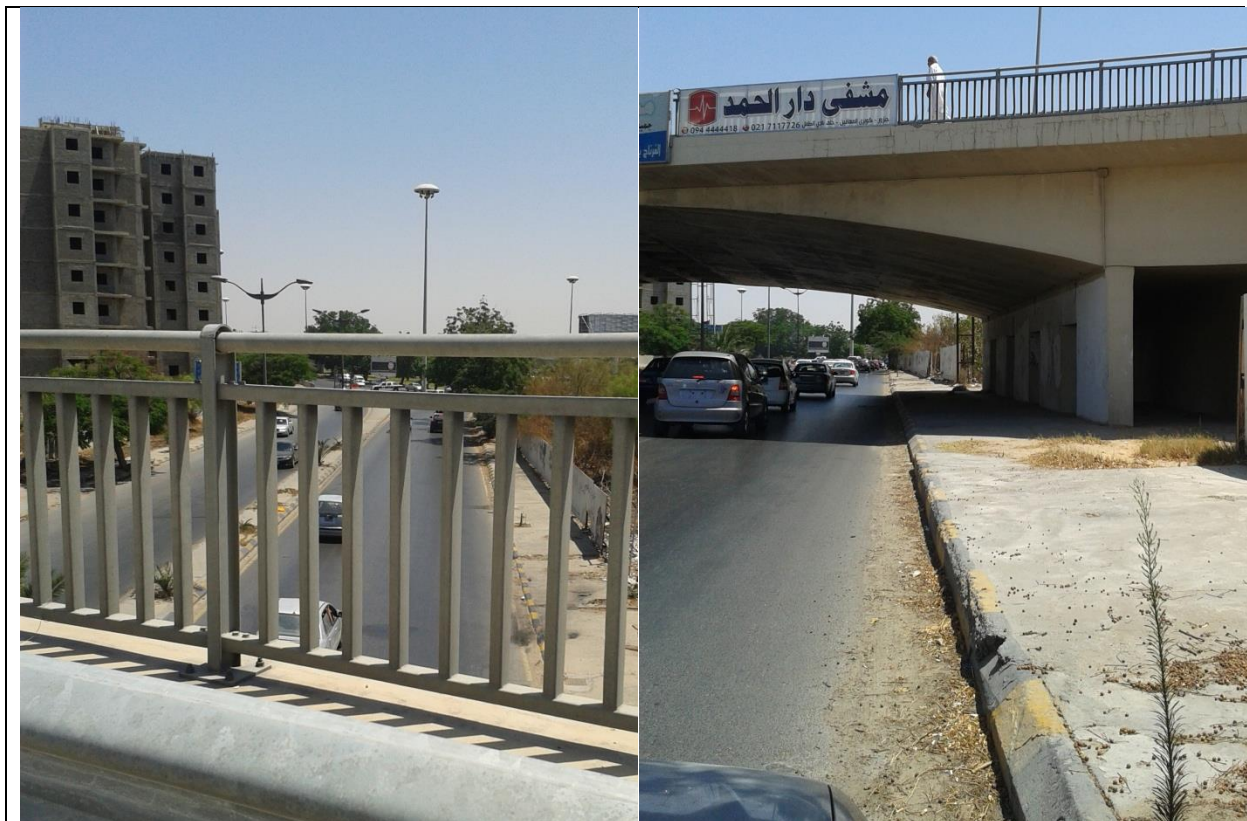
The corner spalling off of concrete and peeling off black and yellow colour were spotted as typical damages. The corner spalling off is caused by hitting by car.

Figure (IX-62) A general view of curbs

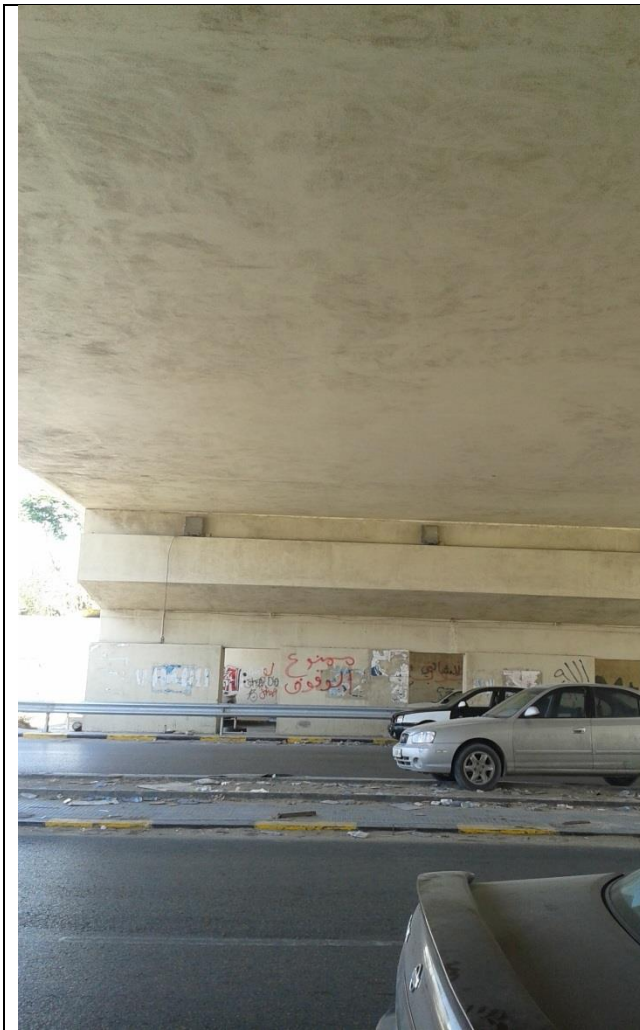
Both, traces and stains of water and net like cracks, are not characteristic damages for whole visible part of deck ceiling slab. The main part of deck ceiling slab is undamaged (Fig IX-69).

Figure (IX-69) View of deck slab with support walls, undamaged surface

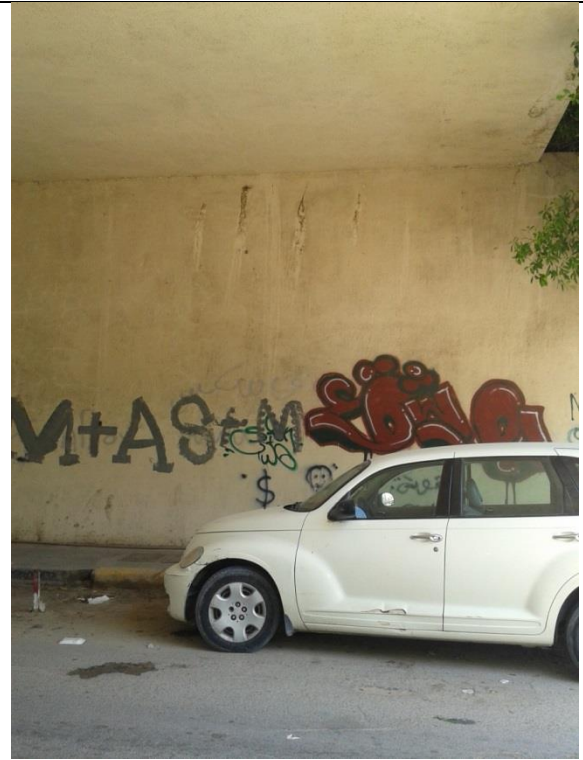
Figure (IX-80): View of abutment, water stains

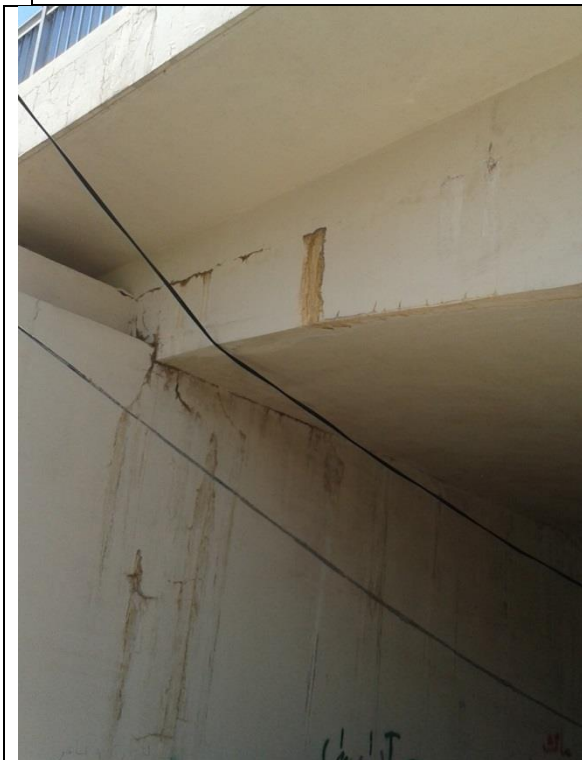
In the external part of abutment, the cracks of different directions were appeared (Fig. IX-81). They are very wide, and followed with dark stains. The cause of their appearance is unknown.

Figure (IX-81) View of external part of abutment, cracking of wall

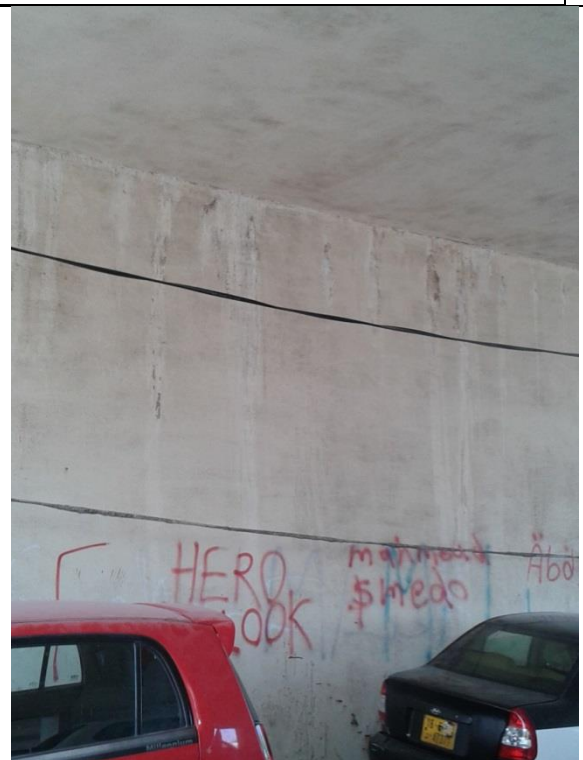
Figure (IX-82) View of abutment, leakage through horizontal crack

On the basis of those descriptions, it can be concluded that registered cracks in the external part of abutment might cause further development of damages, such as the corrosion of reinforced bars. The leakage through horizontal crack should be stopped by repairing or changing the dilatation device between the bridge and the approached structures.

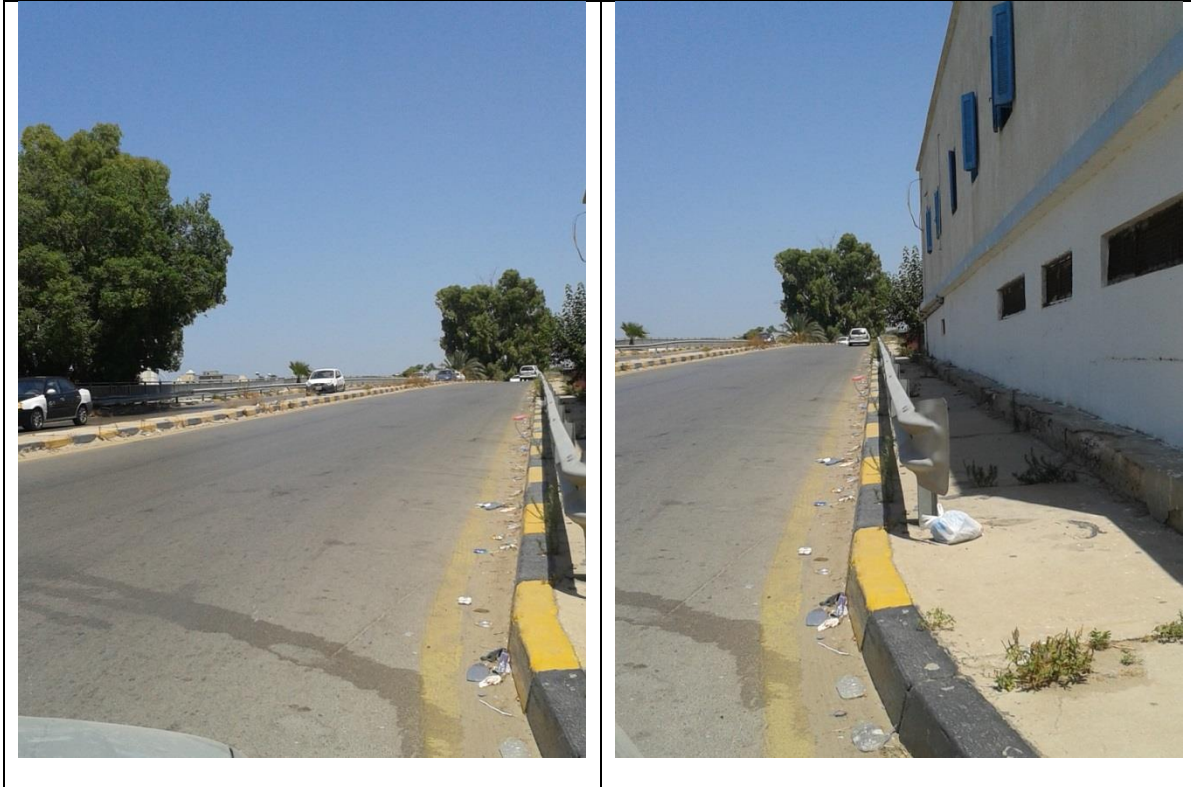
On visible part of asphalt wearing layer, only one longitudinal crack and a few local surface pits were spotted.

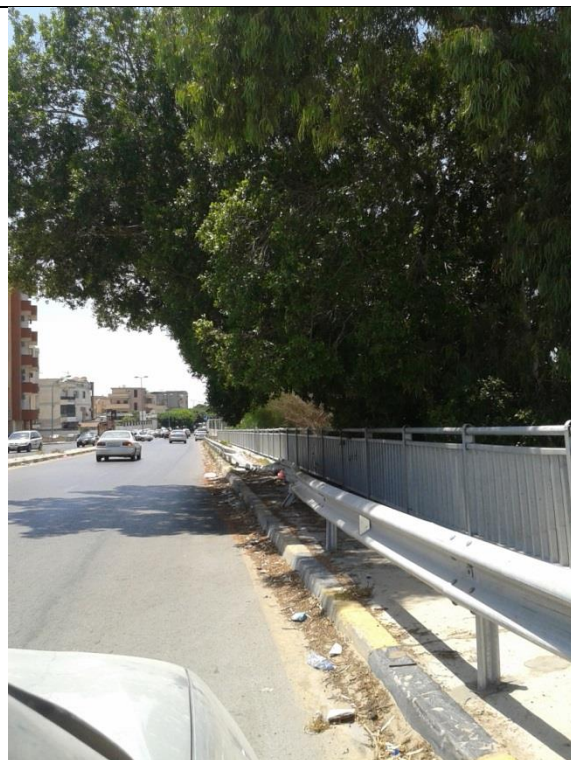
Generally, the guardrails are in good condition as they have not been caught by corrosion, but a few mechanical damages were spotted. On these places, the guardrail is missing or is deformed and broken due to car accident (Fig IX-88). The reflective sign in guardrail is good condition.

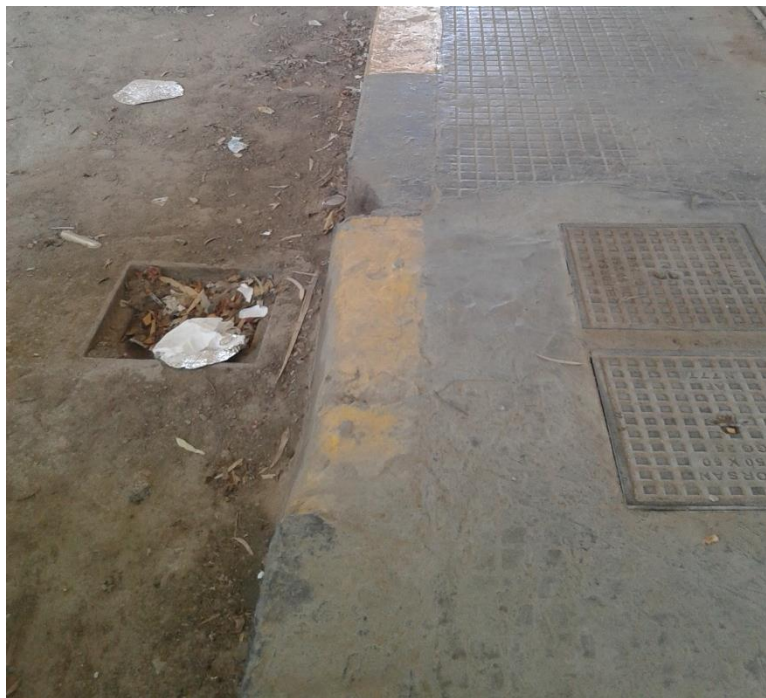
The Blockage of drainage channels under the bridge with garbage, dust and sand were noticed. Due to that the rainwater does not be drainage.

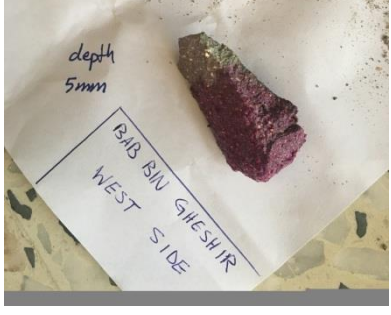
Abutment (west side)	Repair material – mortar	5

By the analyzing obtained results it is concluded that process of carbonation has already started on almost all RC elements. The largest value of carbonation was measured on Abutment (west side) (5mm). This value is almost double than expected. The rate of carbonation is usually 0,5mm/year and with that speed the depth of carbonation should have been about 3,5mm. Some measures to slow down the rate of carbonation should be considered.

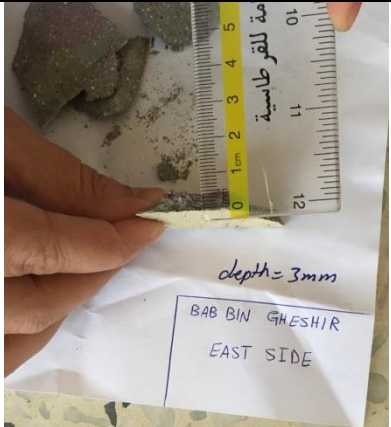
Abutment (east side)	Repair material – mortar	3

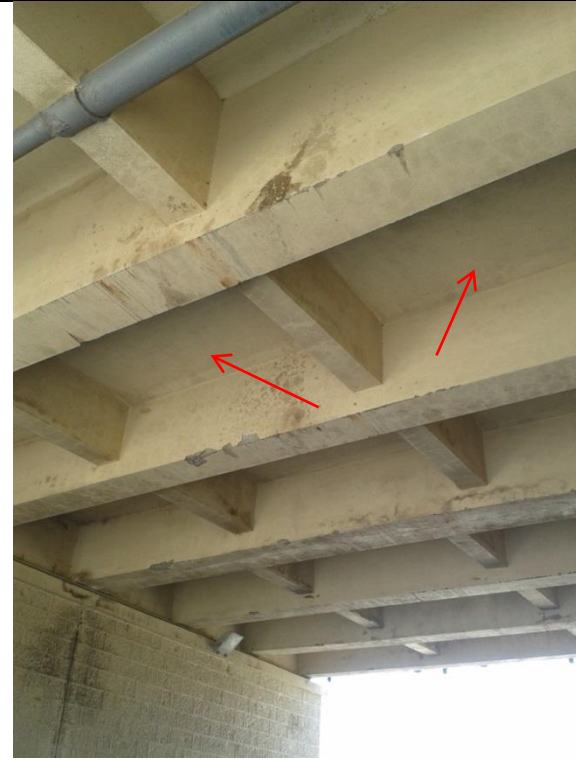
Figure (IX-92) View of deck slab with support walls, longitudinal and transversal supporting beams

By the visual inspection no damages were spotted on down surface of deck slab, only traces of dust were noticed.

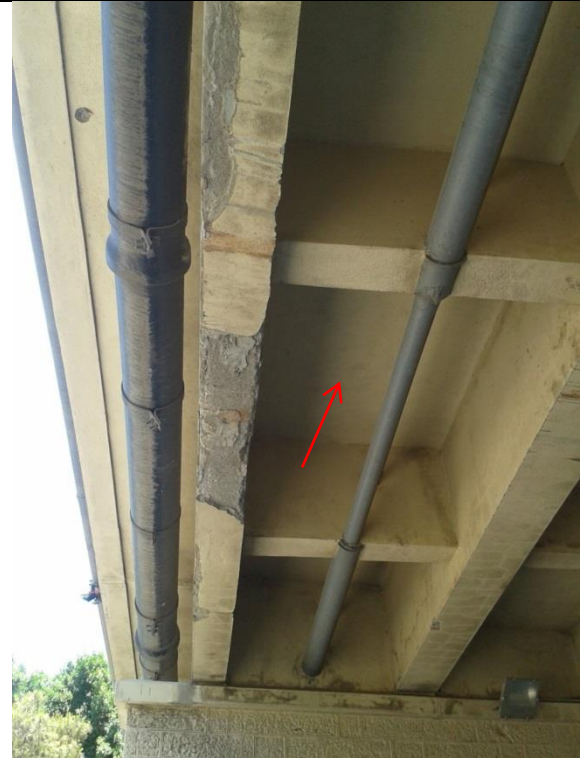
Figure (IX-93) View of deck slab, longitudinal and transversal supporting beams

The surface and corner spalling off are local, shallow and cover very small surfaces, except on external longitudinal beam (Fig IX-93), where described damage overspread the whole width of the girder. The cause of their appearance are supposed to be mechanical damage or bad adhesion between concrete surface and repair mortar.

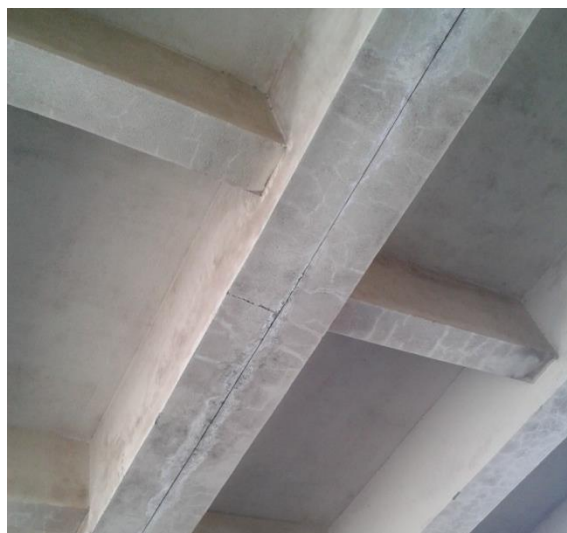
The traces of water leakage were spotted in the place of expansion joint in superstructure of the bridge (Fig. IX-96).

Figure (IX-96) Expansion joint in superstructure of the bridge: water leakage, white stains

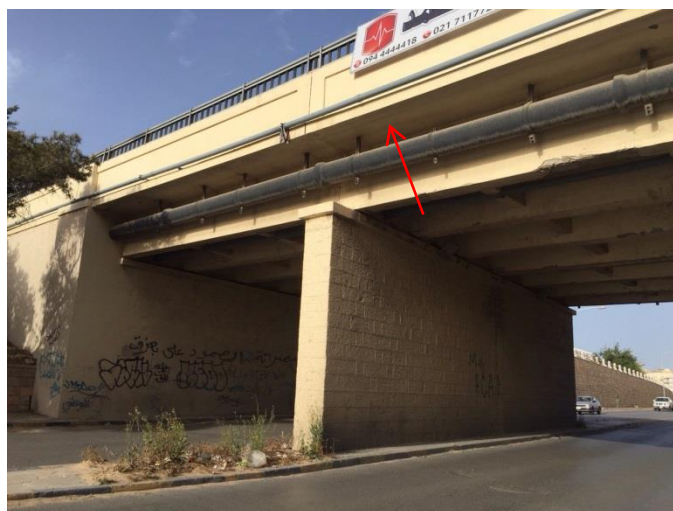
Figure (IX-97) View of cantilever slab

Both noticed types of damage are not characteristic as they cover very small surfaces.
