**COMPARATIVE ANALYSIS OF DURABILITY AND
RANKING OF CONCRETE BRIDGES IN HOT
CLIMATES**

DOCTORAL THESIS

Novi Sad, 2022.

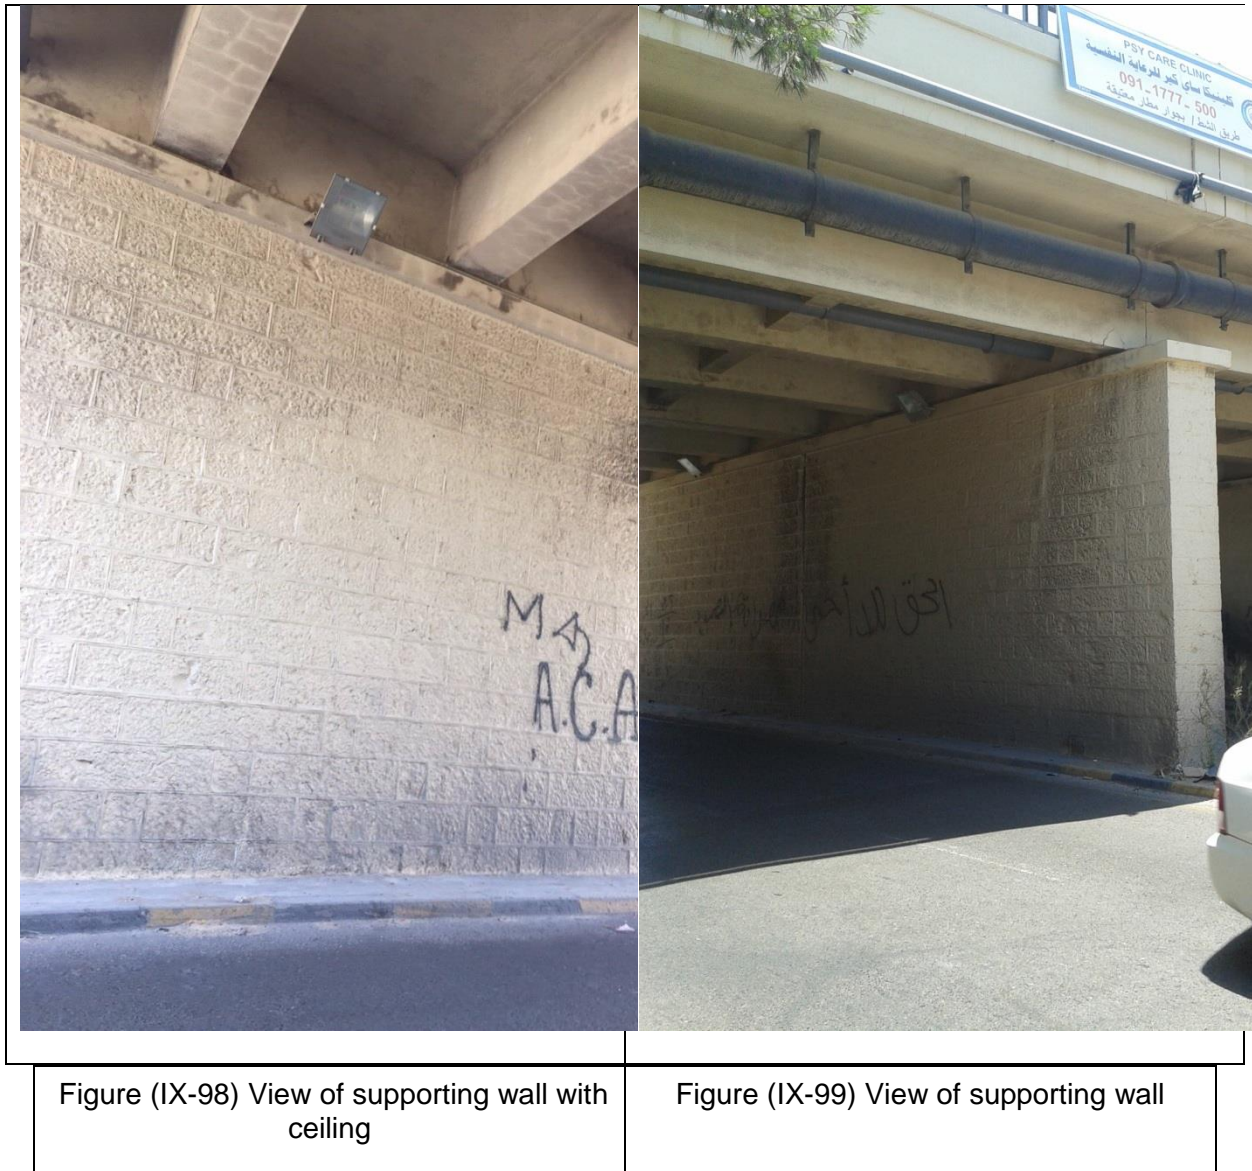
- Traces and dark stains of water (Fig IX-98, and IX-99)

Neither cracks, nor buckling nor disintegration of stone part wall was seen.

Only traces of water were spotted on the place of expansion joint in sub structure and along the RC cornice.

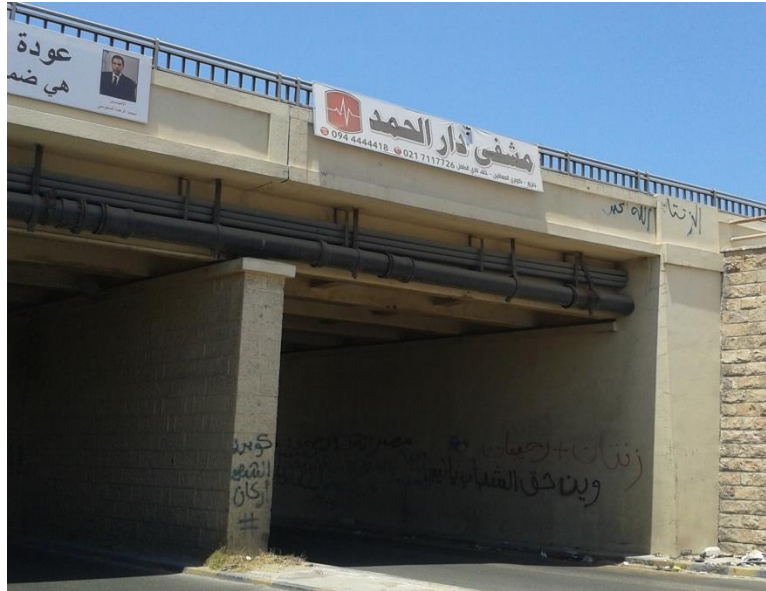
Figure (IX-100) View of abutment

- Net like cracks and other cracks caused by drying shrinkage (Fig IX-100).
- Peeling of protecting painting (Fig IX-100)

The cracks caused by drying shrinkage are mostly expressed on side (external) surface of abutment wall. They have horizontal direction.

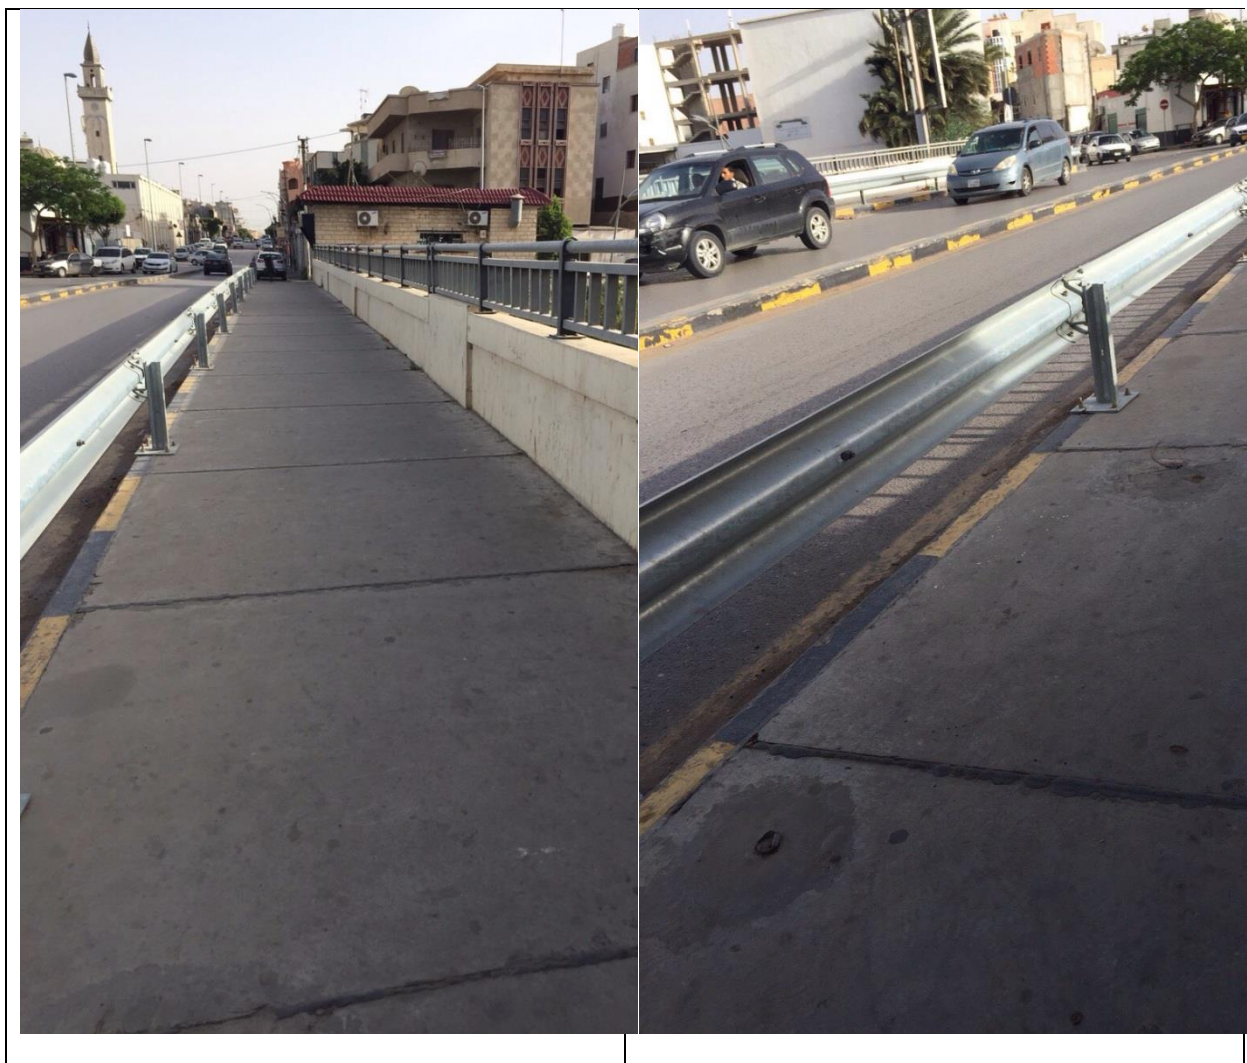
It was observed that the cold joints are very uneven, sometimes with surplus of infilled material, some times without it (Fig IX-101-IX-102).

On concrete surfaces between cold joints the shallow pits and erosion caused wearing were spotted. It is supposed that they were caused by mechanical action.

It could be concluded that initial damages have occurred on pedestrian path surface and in cold joints. Some prevention measures for slowing down appearance of new and progress of numbered damages should be undertaken.

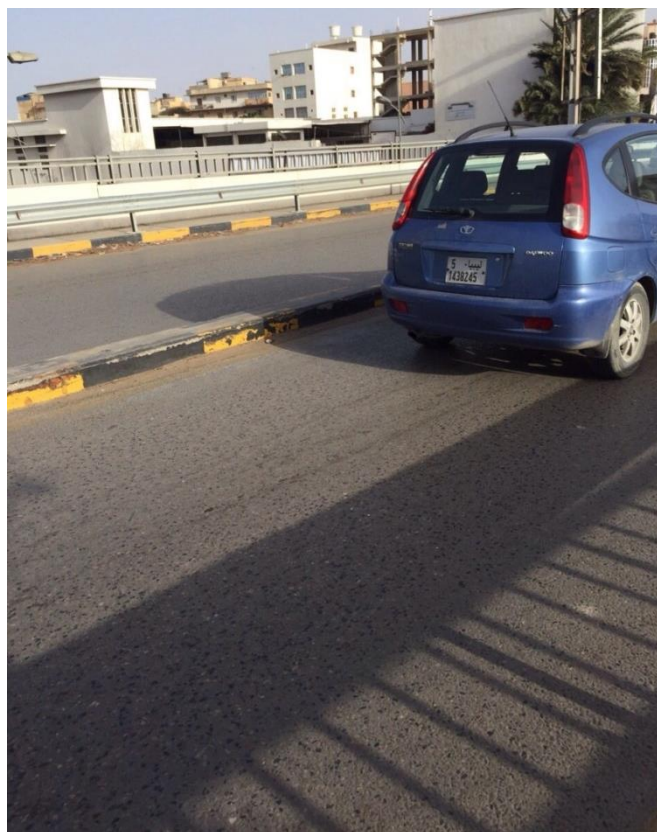
Figure (IX-104) Detail of asphalt wearing layer

The erosion of upper asphalt layer, caused by wearing, is the main type of damage that has been spotted (Fig IX-104).

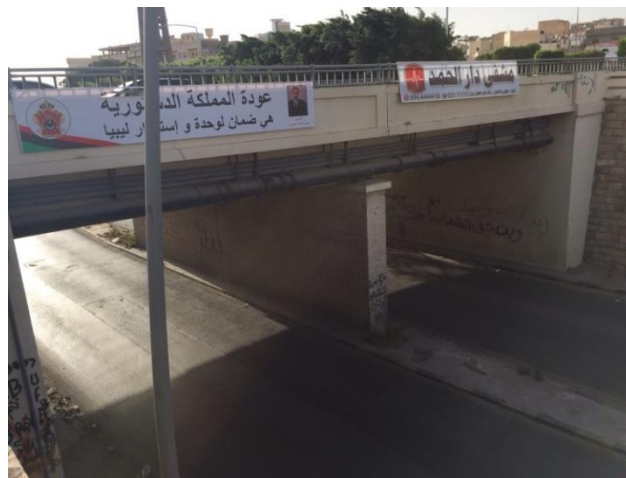
Figure (IX-107) A general view of concrete part of fences

The concrete part of fences can be seen in Fig IX-107. The characteristic damage is net like cracking caused by drying shrinkage. This crack does not represent any serious damage of concrete.

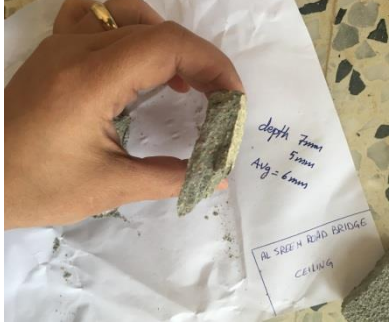
Elements	description	Depth of carbonation (mm)	
ceiling	Repair material – mortar	6

By the analyzing obtained results it is concluded that process of carbonation has already started on almost all RC elements. The largest value of carbonation was measured on ceiling (6mm). This value is almost double than expected. The rate of carbonation is usually 0,5mm/year and with that speed the depth of carbonation

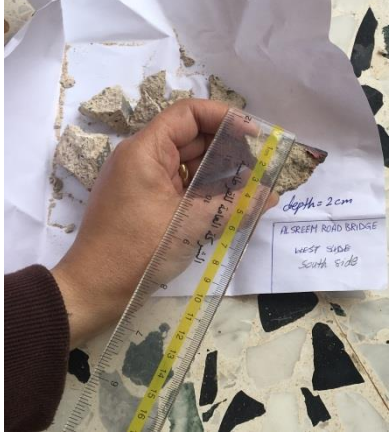
Abutment (south side)	Repair material – mortar	20

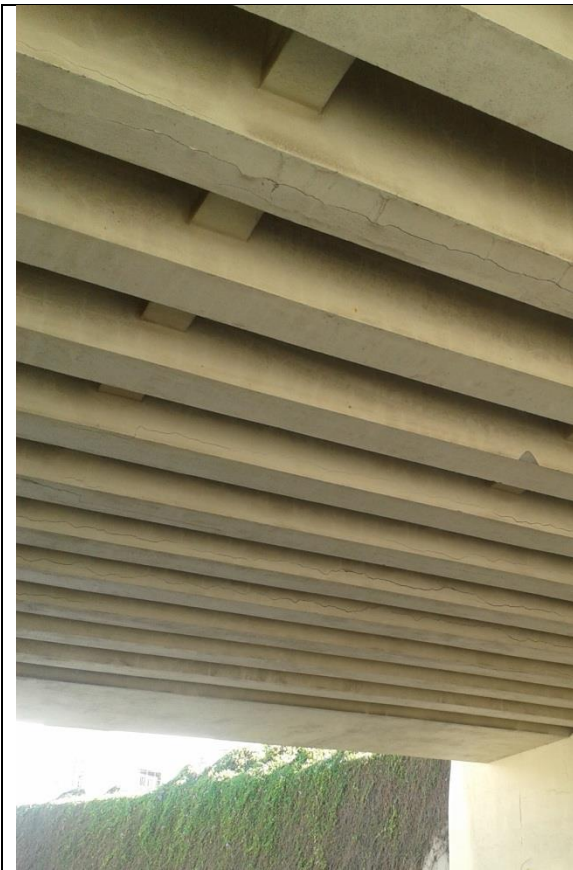
The longitudinal cracks are very serious damage due to reinforcement corrosion. For the evaluation of the degree of reinforcement corrosion the further investigation should be done. As the spalling off of protecting cover has not appeared yet, it is supposed that corrosion of reinforcement was not grabbed a large part of cross section of reinforcing bars. Other noticed damages are negligible. The changing of protecting cover and cleaning of reinforcing bars are necessary activities. The further investigation will show if an additional reinforcing bar are necessary.

Figure (IX-113) Longitudinal and transversal supporting beams, longitudinal and transverse cracks in longitudinal beams, spalling off, traces of dust

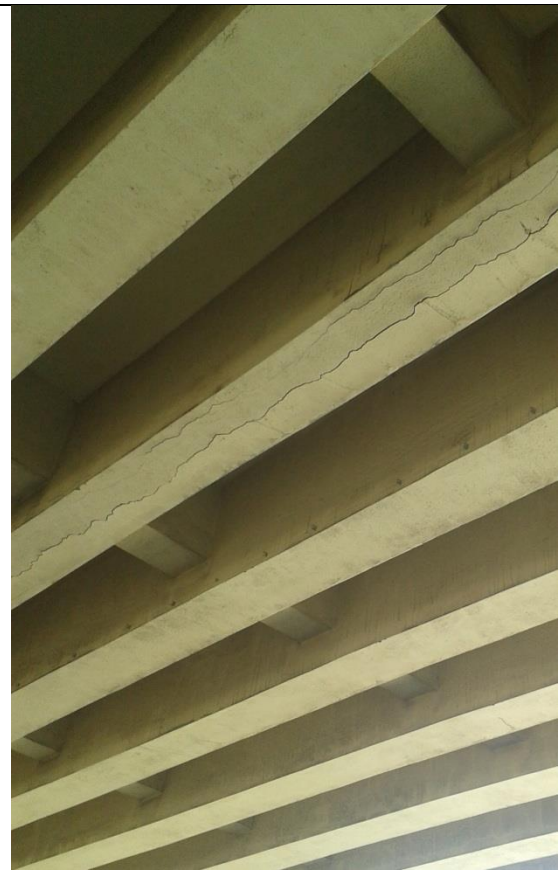
Figure (IX-114) Longitudinal and transverse cracks in longitudinal beams

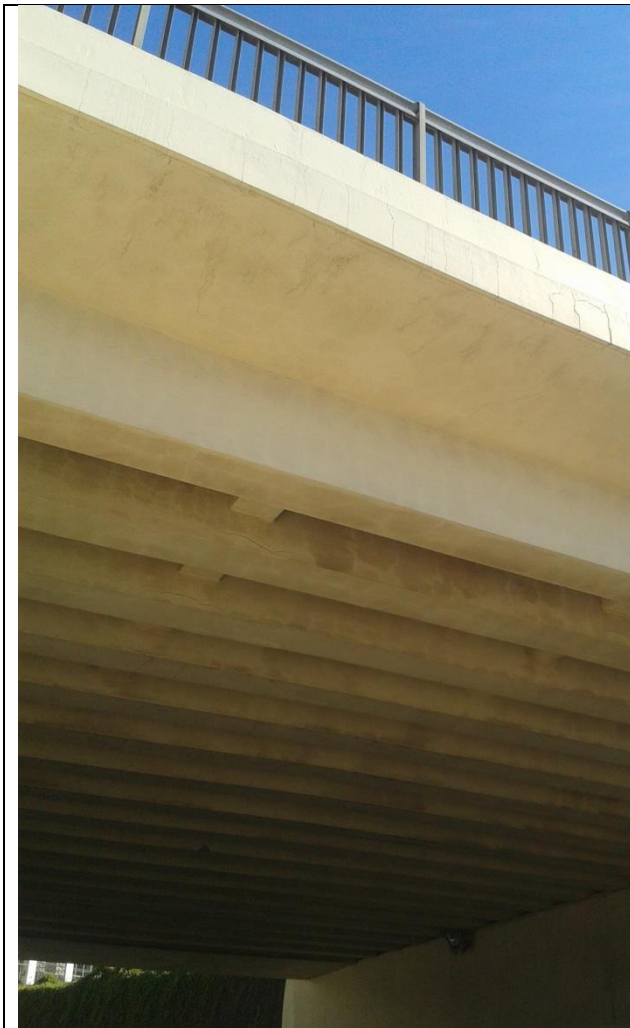
- Local spalling off of mortar and (Fig IX-115) and
- Vertical and horizontal cracks (Fig IX-116),
- Traces of water (Fig IX-115).

Figure (IX-115) A view of cantilever slab lateral and lower part (north side)

Traces and stains of water are characteristic for whole side and down surface of cantilever slabs. They occurred due to bad drainage of rain water. (Fig IX-115 and IX-116).

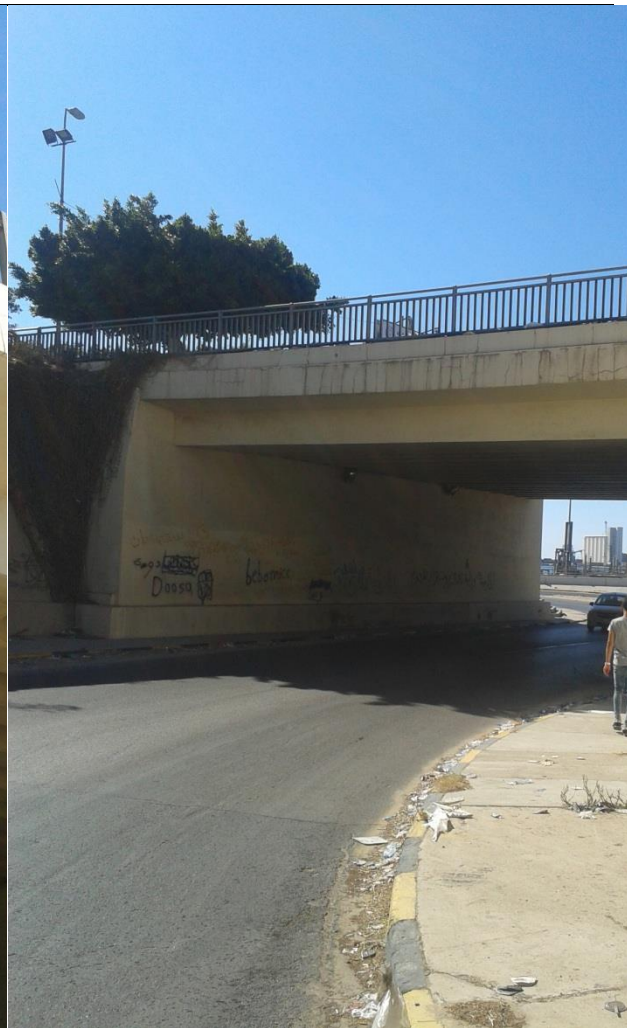
Vertical and horizontal cracks are followed with traces of rust.

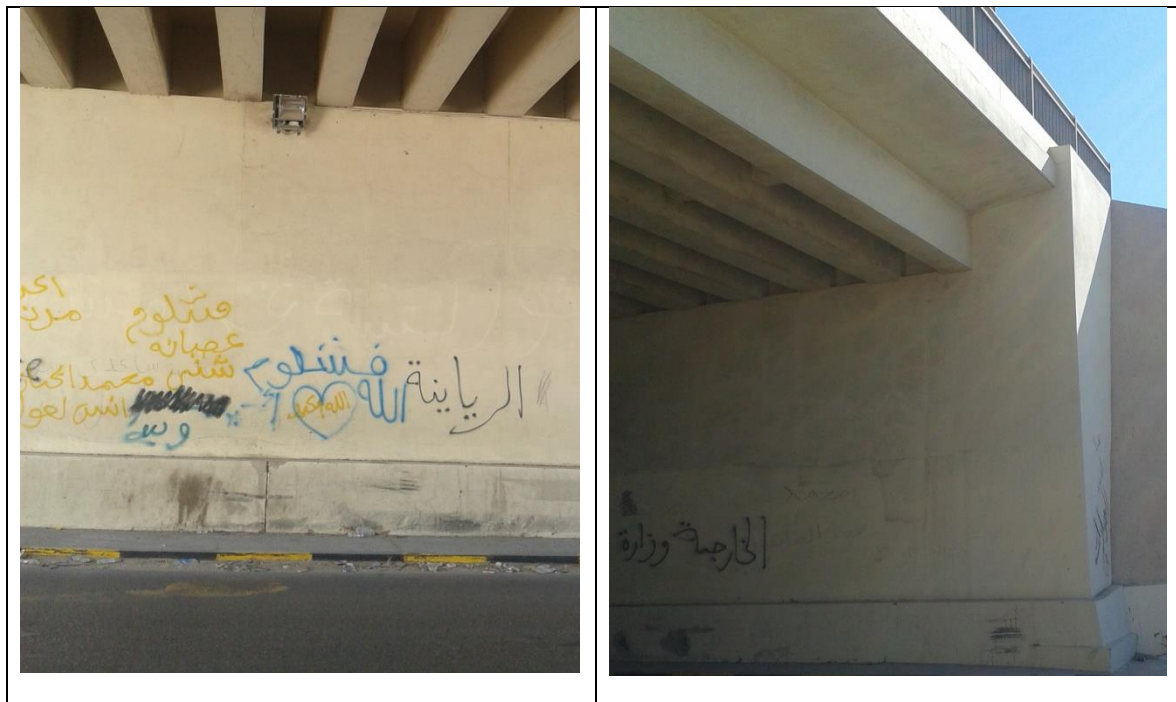
Figure (IX-117) View of abutment with ribbed deck slab	Figure (IX-118) View of abutment, west side

- Net like, vertical and horizontal crack (Fig IX-117 – IX- 120)
- Spalling off of mortar (Fig IX-119)
- Traces and stains of water (Fig IX-118 and IX-120)

It is supposed that the vertical and horizontal cracks on longitudinal sides of abutments are caused by reinforcement corrosion. Vertical cracks are more pronounced, and they are located on the places of vertical rebars. Some vertical and horizontal cracks are uneven or net like and they are caused by drying shrinkage of repair mortar. On lateral sides of abutments also horizontal and vertical cracks were registered. The horizontal cracks are predominant. It is supposed that they are caused by drying shrinkage of repair mortar.

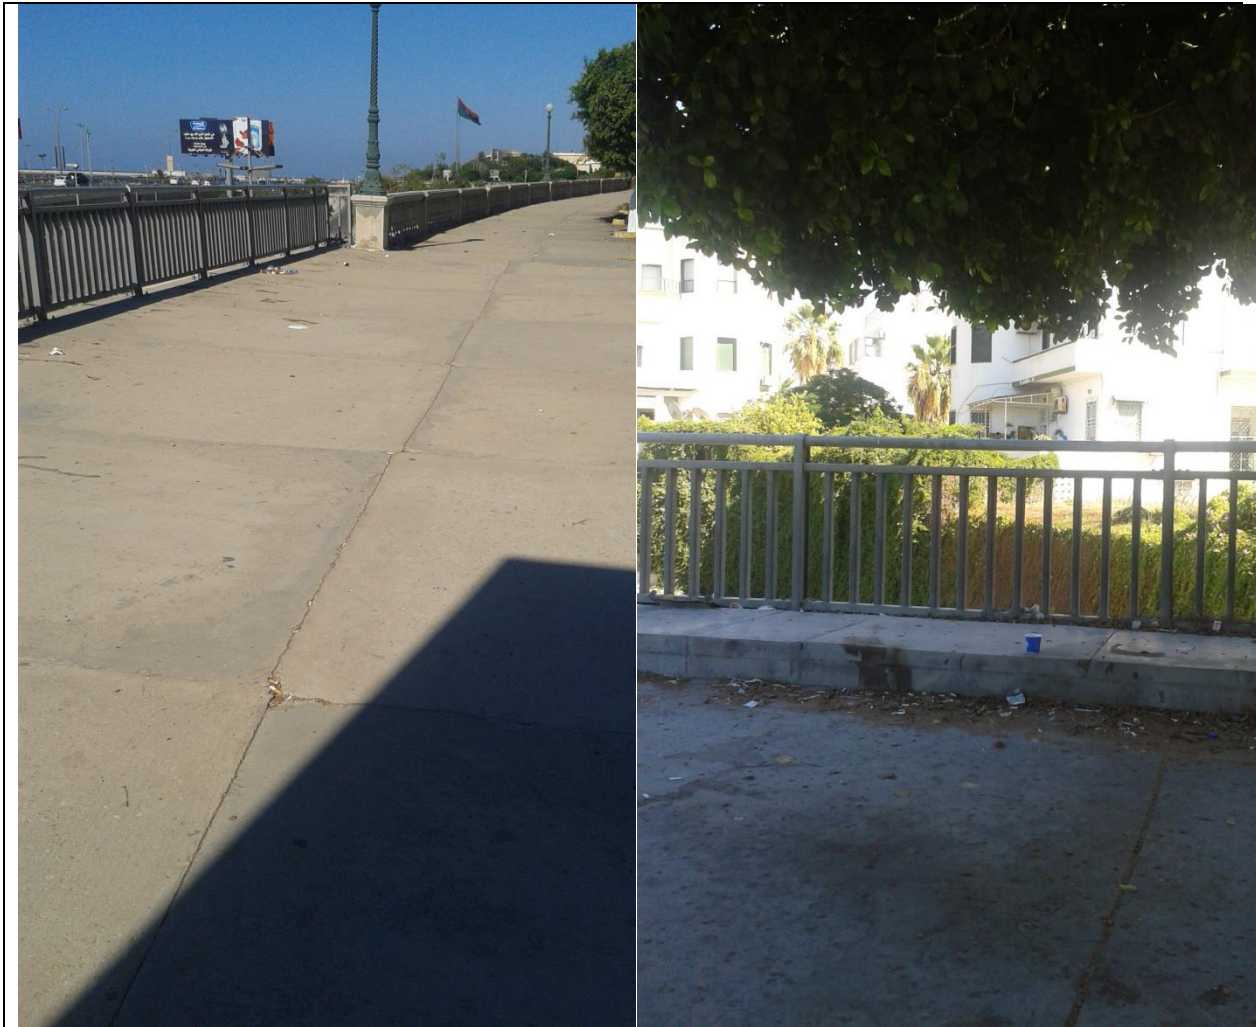
It was observed that the cold joints are very uneven, and they look like cracks (Fig IX-121-IX-122).

On concrete surfaces between cold joints the shallow pits and erosion caused wearing were spotted. It is supposed that they were caused by mechanical action.

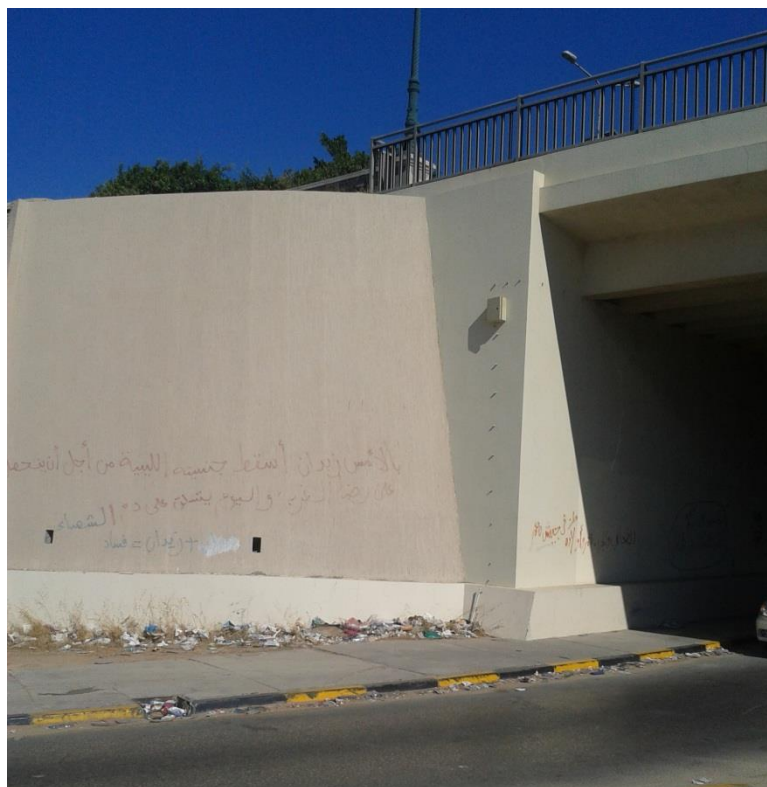
Figure (IX-129) A general view of catch pit under the bridge

The blockage of drainage channels under the bridge with garbage, dust and sand were noticed. Due to that the rainwater does not be drainage.

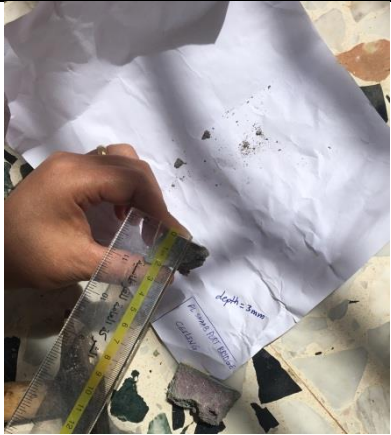
Elements	description	Depth of carbonation (mm)	
ceiling	Repair material – mortar	3

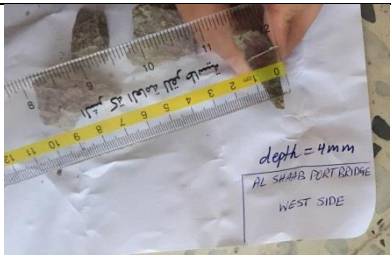
Abutment (west side)	Repair material – mortar	4

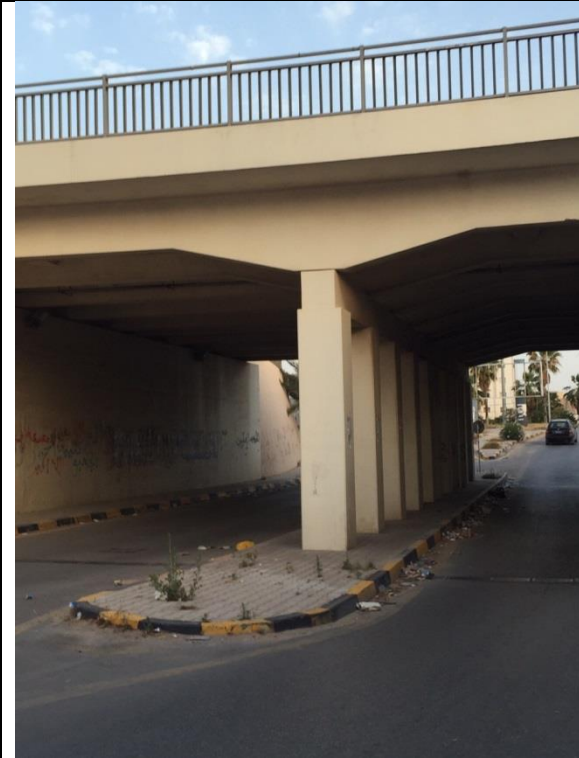
Figure (IX-132) A View of columns which were strengthened by enlarging cross sections

On the basis of result of visual inspections, it can be concluded that columns are in excellent conditions.

No cracks, neither crumbling of concrete nor falling off of concrete cover have been spotted.

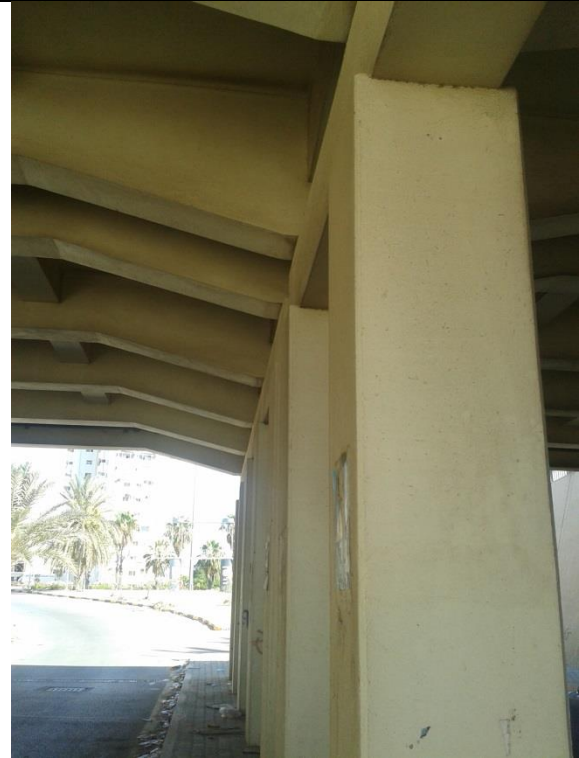
Figure (IX-133) Undamaged concrete surface of strengthened column

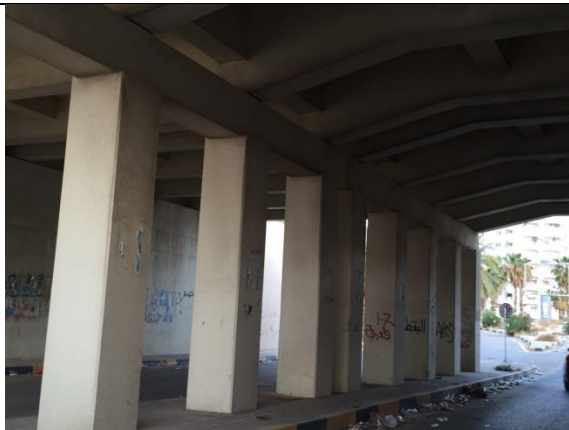
Figure (IX-134) A View of strengthened columns

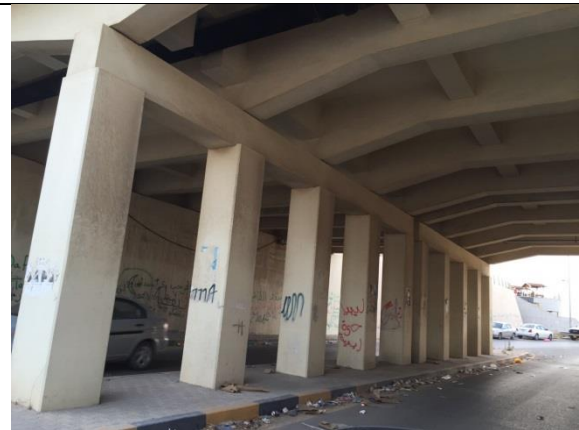
Figure (IX-135) A View of strengthened columns

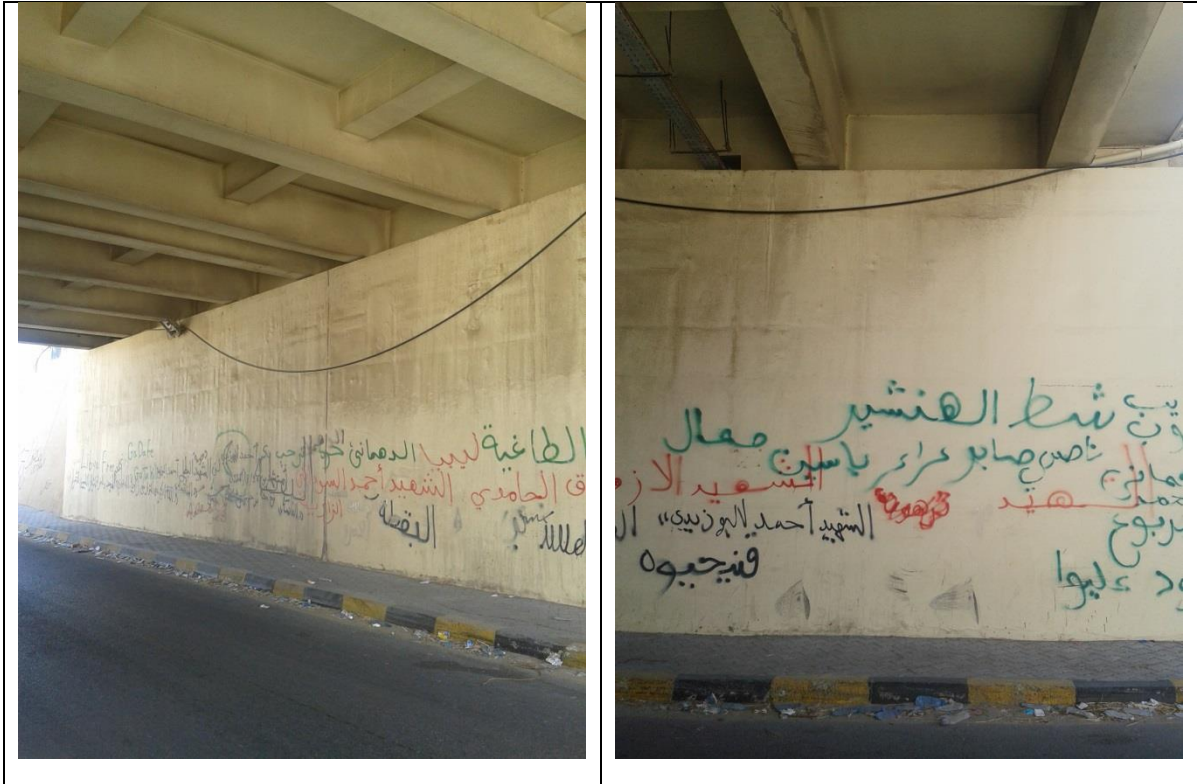
Figure (IX-136) View of strengthened abutment

Figure (IX-137) Uneven concrete surface of abutment

- Very uneven concrete surface (Fig IX-137 and IX-139)
- Peeling of protecting painting (Fig IX-136) and
- Cracks

Very uneven concrete surface is characteristic for all visible parts of abutments. This defect may reduce thickness of cover in some locations, but up to the period of visual inspection no damages due to reduction of cover have been noticed on any abutments.

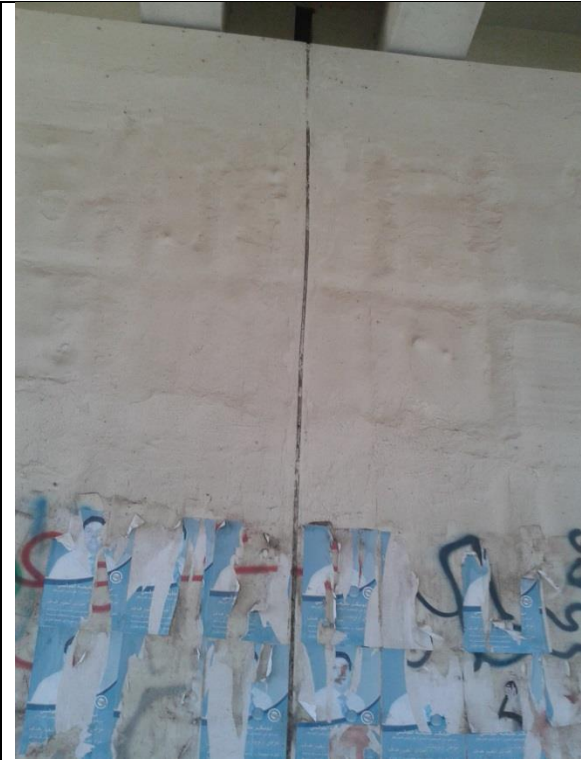
Figure (IX-138) Look of expansion joint between two abutments

- The expansion joint between deck slabs is cracked, but does not have traces of water leakage. Only, local surface spalling off infill materials had been seen. The expansion joint between abutments is in good condition.

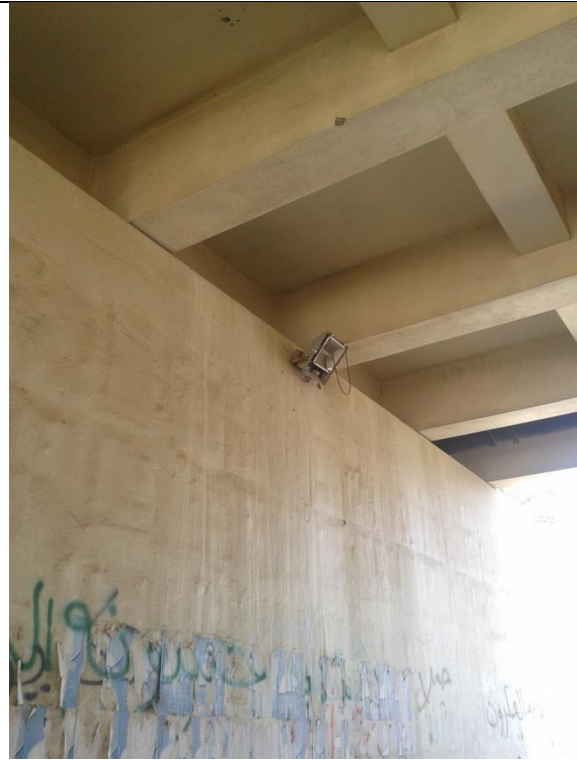
Figure (IX-139) Uneven concrete surface of an abutment, in detail

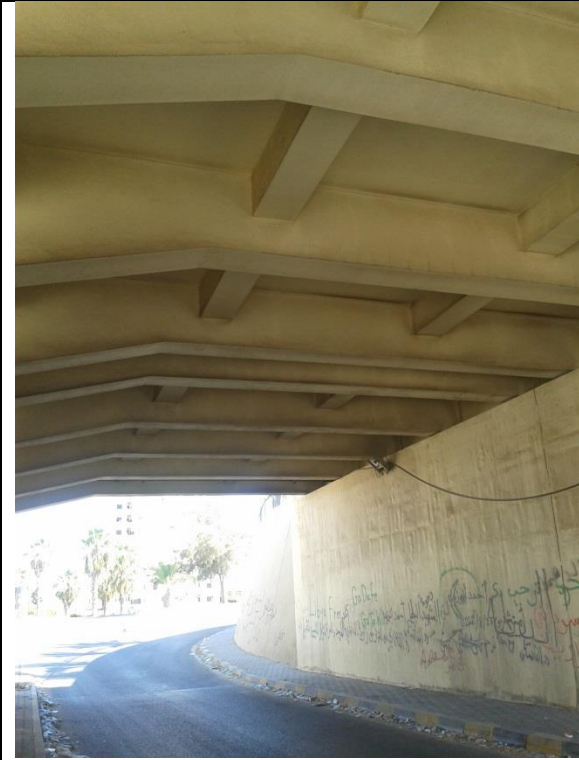
Figure (IX-140) A general view of main and secondary beams of superstructure of bridge

- Traces and stains of water (Fig IX-143)
- Cracking of new cover (Fig IX-140, IX-142 and IX-143)

Only a few longitudinal cracks, but a lot of transversal cracks have been noticed. Both types of cracks are very thin (dominantly 0, 1 mm, only a few up to 0,2mm).

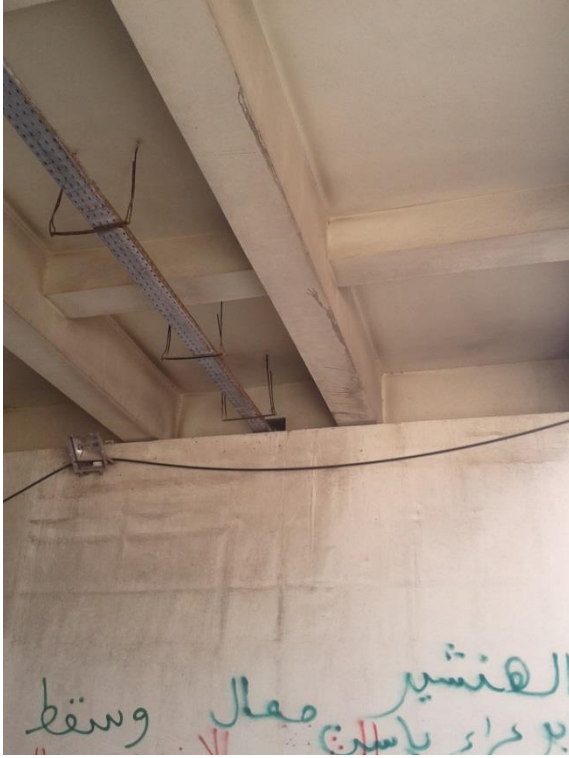
<p>Figure (IX-142) Main beams: The transverse thin cracks on side and down surfaces of beams</p>	<p>Figure (IX-143) Supporting part of main beams, a longitudinal crack in haunch; Traces of water leakage on secondary beam</p>

- Cracks along the main reinforcing bars near the edge of beams (longitudinal cracks) and
- Transversal cracks on side and down surfaces of beams

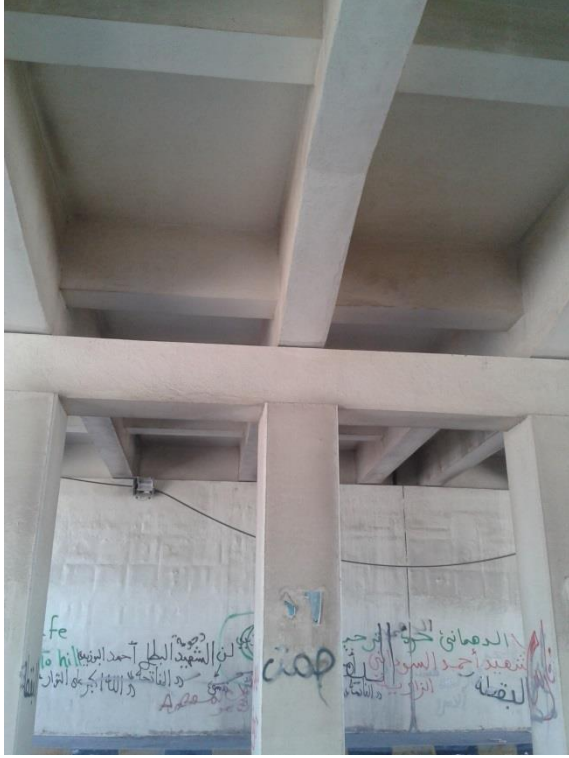
Traces and stains of water have been noticed on the side surfaces of several beams. They are caused by leakage of water through expansion joints in super structure of bridge, or by some problems in hydro-insulation layer.

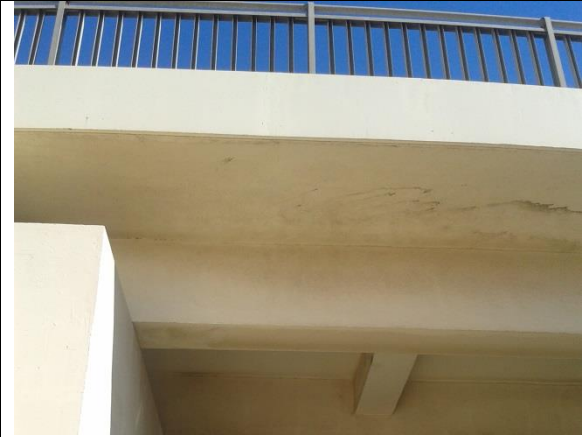
The condition of deck slab is illustrated in Fig IX-144– Fig IX-145). Neither net like cracks nor water stains had been spotted on visible parts of down surface of deck slab. Only, longitudinal cracks were seen on the contact between main and secondary beams and slabs, because of uneven change of geometry (Fig IX-145)

Figure (IX-145) A general view of down part of cantilever of superstructure of bridge

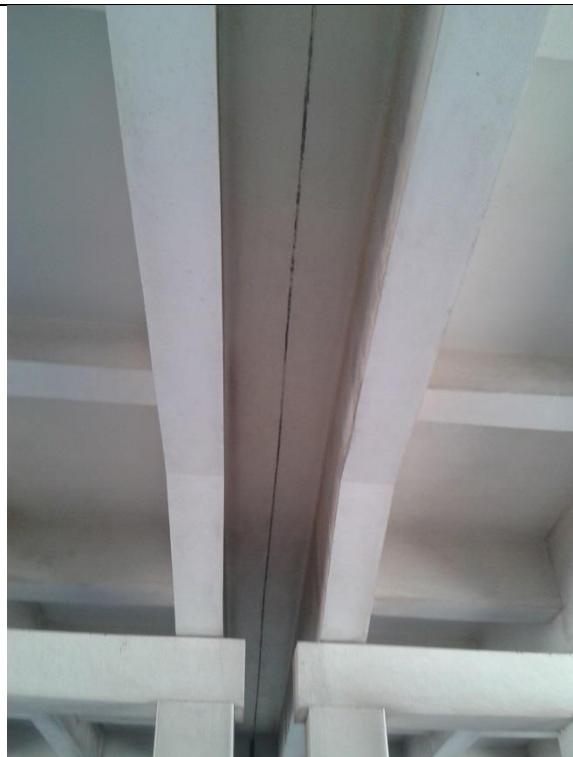
Figure (IX-146) A general view of expansion joint between deck slabs in superstructure of bridge

A general view of expansion joint between two deck slabs is shown in figure 9.146. Thin longitudinal crack was spotted by the visual inspection of expansion joint between decks slabs, but without any traces of water leakage. Only, local spalling off infill materials had been seen (figure IX-147).

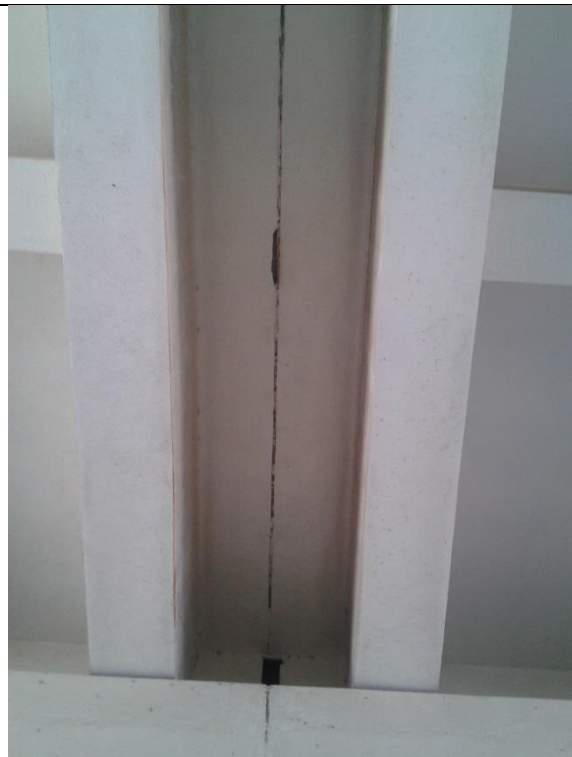
Figure (IX-147) View of characteristic part of expansion joints

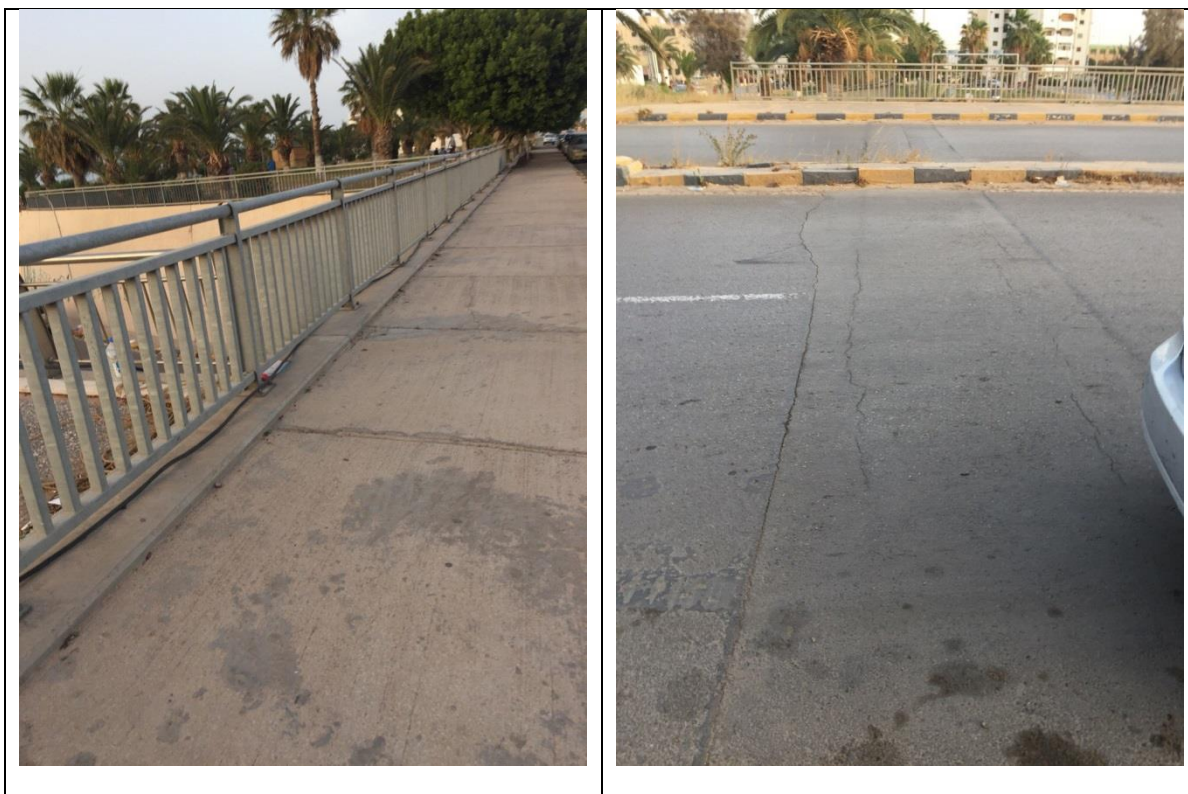
By the visual inspection it was noticed that cold joints are very rough and cracked. Also, longitudinal cracks and surface peeling off of thin concrete layer have been appeared in parts between cold joints.

It could be concluded that initial damages have occurred on pedestrian path surface and some prevention measures for slowing down appearance of new and progress of numbered damages should be undertaken.

The characteristic damages of wearing layer of traffic lanes are transversal cracks. The cracks are dashed with wideness of several mm.

The growth of some plants between the two lanes, as well as, the presence of dust on the road and the disappearance of traffic signs, including intermittent lines that allow the vehicle to cross, and the side lines, were noticed.

Figure (IX-148) A general view of Pedestrian path on bridge

Figure (IX-149) A general view of Asphalt wearing layer

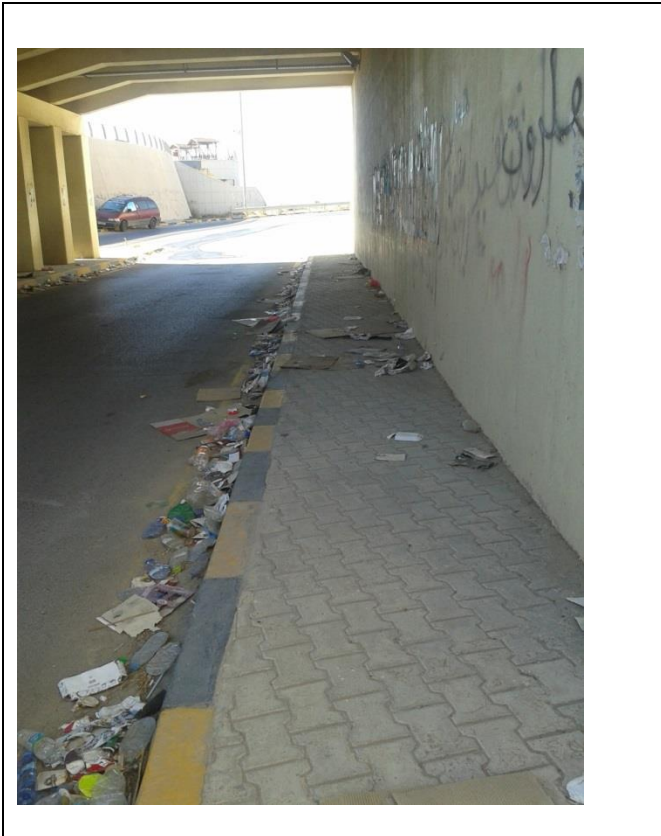
Some minor cracks as well as having dirt near the curbs were spotted.

Figure (IX-152) A general view of curbs under the bridge

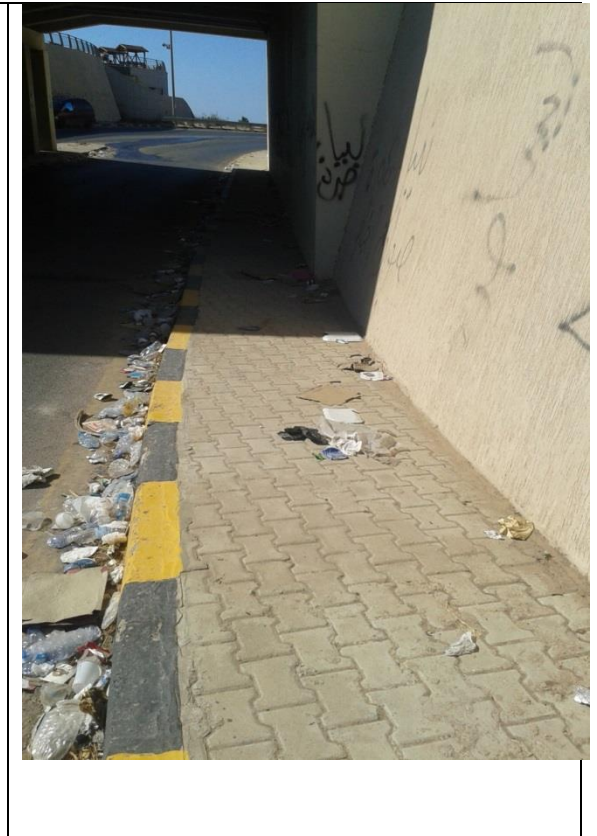
Figure (IX-153) A general view of curbs

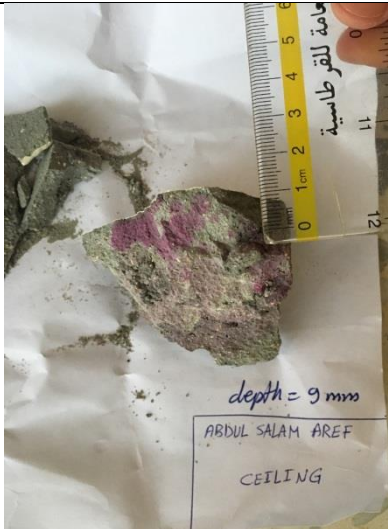
ceiling	Repair material – mortar	9

By the analysing obtained results it is concluded that process of carbonation has already started on almost all RC elements. The largest value of carbonation was measured on ceiling (9mm). This value is almost double than expected. The rate of carbonation is usually 0,5mm/year and with that speed the depth of carbonation should have been about 3,5mm. Some measures to slow down the rate of carbonation should be considered.

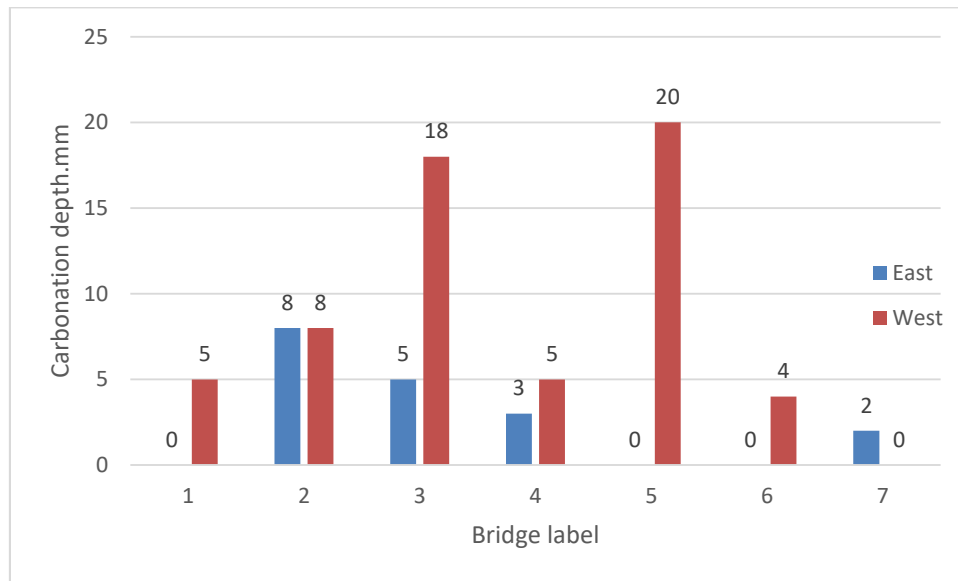
Figure (X-15) Measured values of Carbonation depth for substructure elements

Carbonation was registered on the elements of the super and substructure of the bridges. On the lower surface of the bridge slabs, the depth of carbonation ranges from 1mm to 12.5mm, while on the elements of the substructures it was measured from 0 to 20mm. If we take into account that the highest expected value of carbonation depth for 5 years is 5mm, it can easily be concluded that carbonation is progressing faster than assumed, even though factory-produced repair materials were used for reprofiling, and all repaired elements were additionally treated with protective coatings. This statement once again confirms that carbonation is the main cause of decreasing the durability of RC bridges in hot climates.

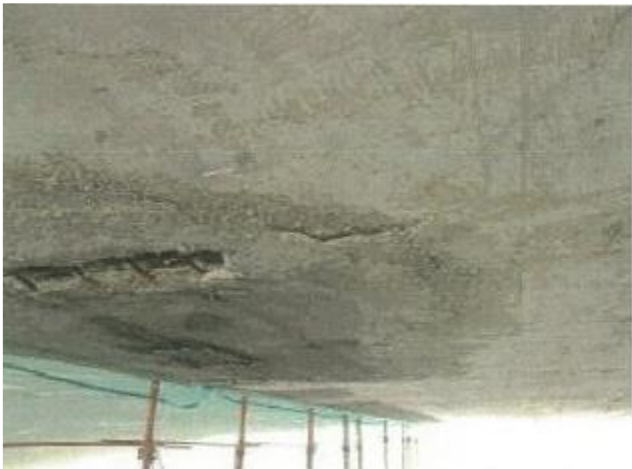
<p>Bridge slab:</p> <p>Corrosion of reinforcing bars, delamination and falling down of concrete cover, wet stains</p>	<p>Carbonation of concrete and water leakage</p>

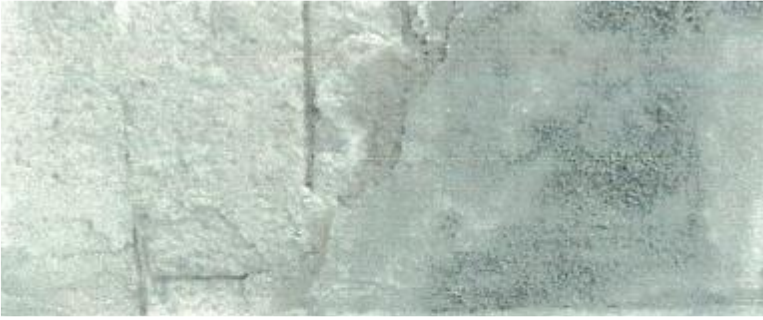
<p>Cantilever slab:</p> <p>Bared and corroded reinforcing bars, falling off of concrete cover and plaster layer</p>	<p>Poor concrete works, porous concrete cover and improper repair with ordinary plaster; Carbonation</p>

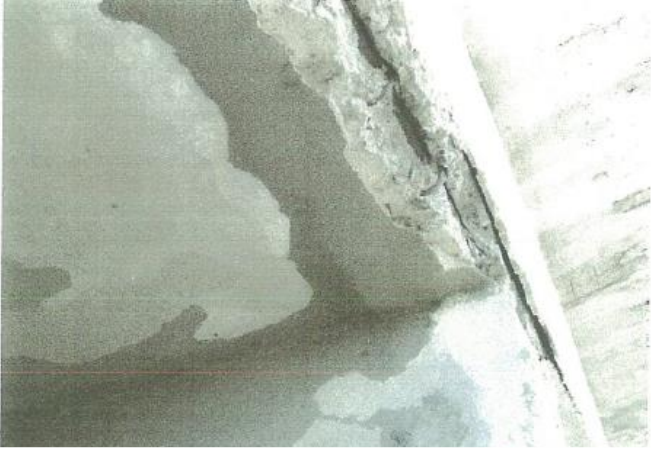
<p>Bridge slab:</p> <p>Corrosion of reinforcing bars, falling off of concrete cover, reduced adhesion between reinforcement and concrete</p>	<p>Carbonation, Water leakage through cantilever slab</p>

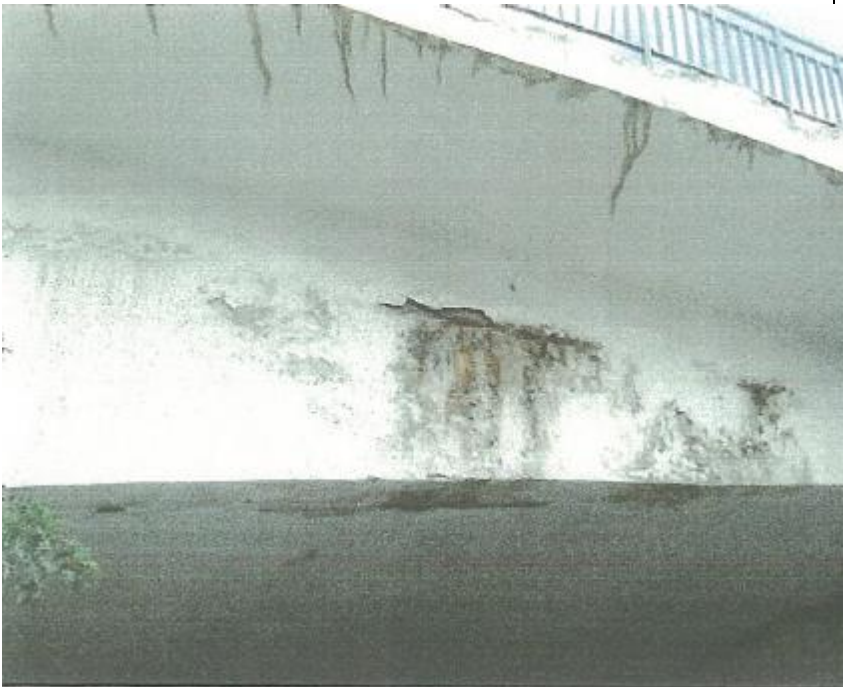
<p>Cantilever slab and lateral beam:</p> <p>Traces of water leakage, corrosion of reinforcing bars, local spalling of concrete</p>	<p>Carbonation, Water leakage</p>

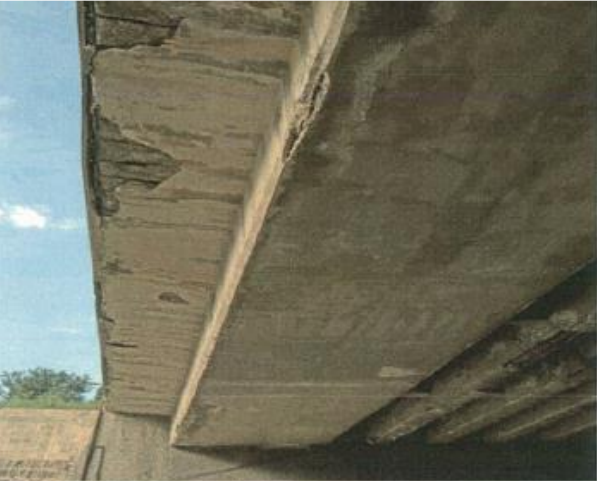
<p>Cantilever slab:</p> <p>Corrosion of reinforcing bars, spalling of concrete cover, delamination of concrete, wet stains</p>	<p>Carbonation and cycling drying and wetting</p>
