**COMPARATIVE ANALYSIS OF DURABILITY AND
RANKING OF CONCRETE BRIDGES IN HOT
CLIMATES**

DOCTORAL THESIS

Novi Sad, 2022.

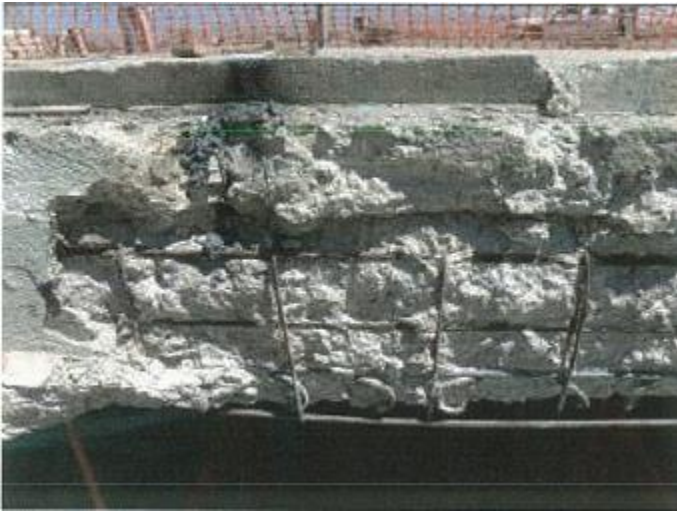
<p>Cantilever slab:</p> <p>Bad adhesion between reinforcing bars and concrete</p>	<p>Carbonation and cycling drying and wetting</p>

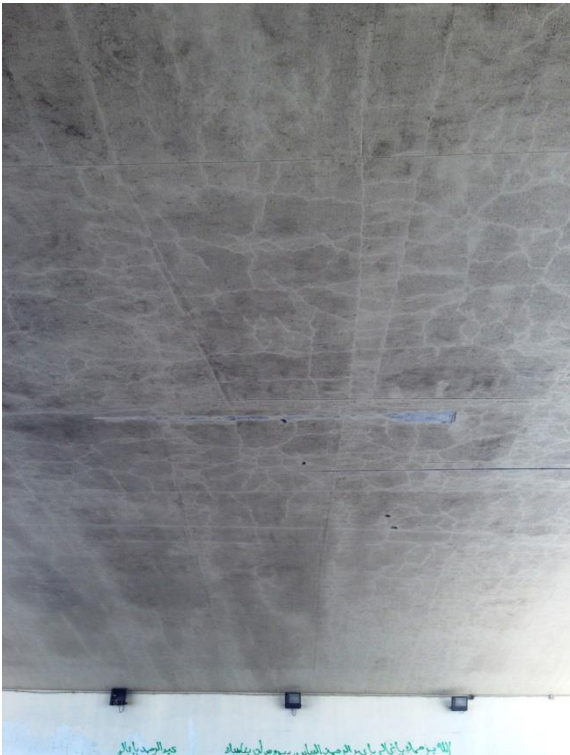
<p>Bridge slab:</p> <p>Net like cracks, local spalling off of repair mortar (cover)</p>	<p>Drying shrinkage of repair mortar</p>

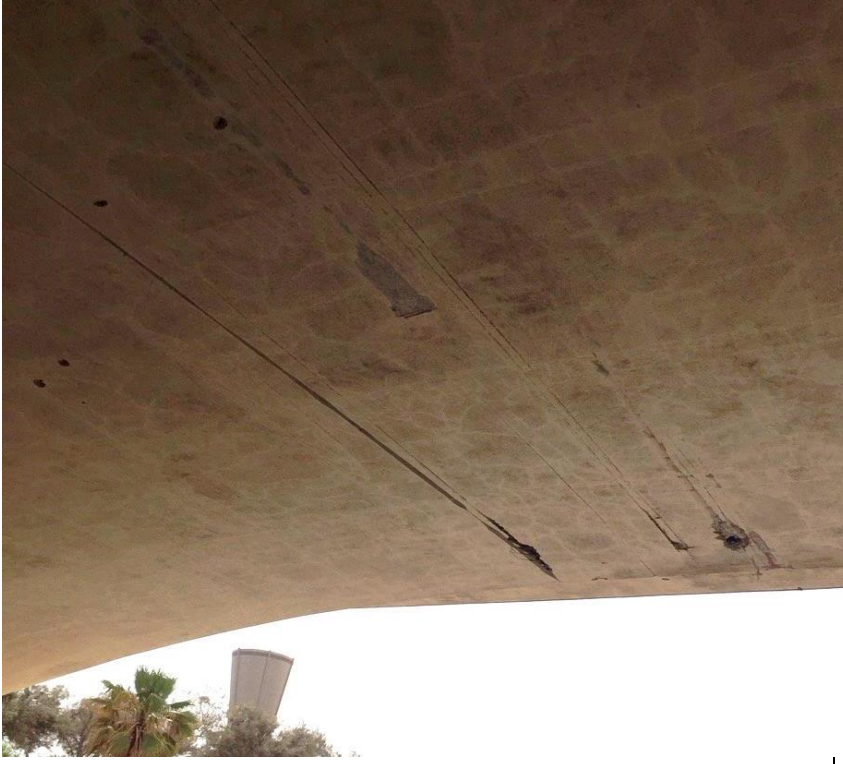
<p>Bridge slab:</p> <p>Local spalling off of repair mortar</p>	<p>Mechanical damage</p>
BEAMS

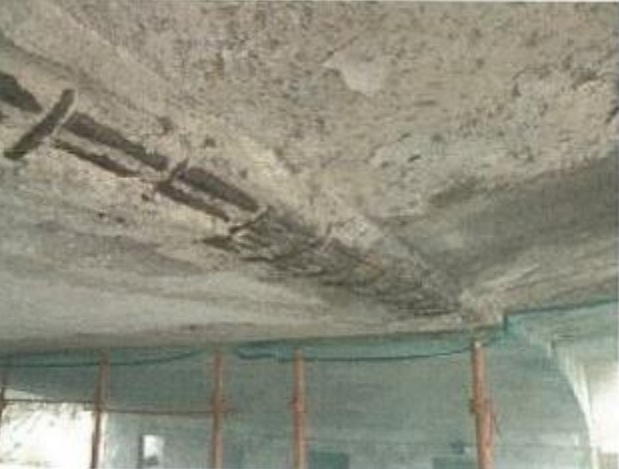
<p>RC beam:</p> <p>Bared reinforcing bars, corrosion of bars, falling down of cover and plaster coating</p>	<p>Carbonation and cycling drying and wetting</p>

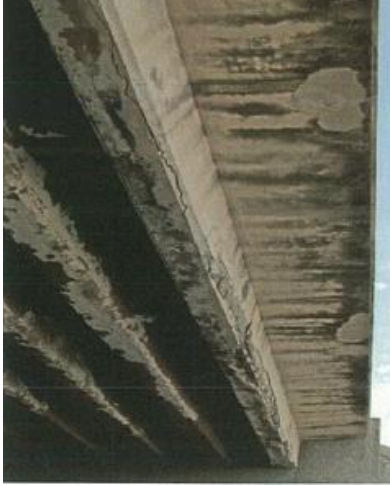
<p>Longitudinal RC beams:</p> <p>Longitudinal cracks along the corner rebars, dark and white stains</p>	<p>Carbonation and periodical wetting and drying through cantilever slab</p>

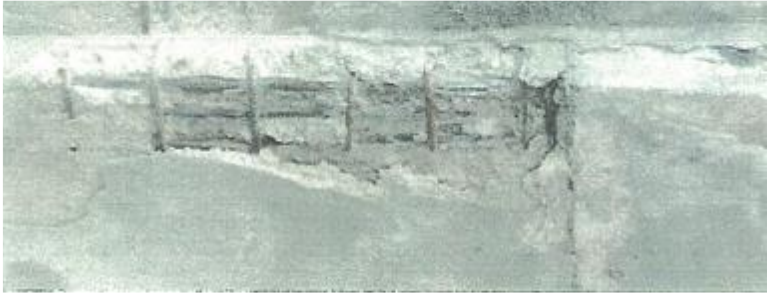
<p>Lateral beam of arch slab:</p> <p>Bared and corroded reinforcing bars, falling off of concrete cover and plaster layer</p>	<p>Poor concrete works, porous concrete cover and improper repair with ordinary plaster; Carbonation</p>

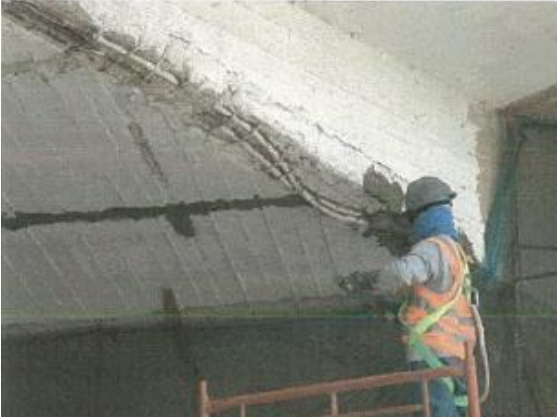
<p>Edge RC beam:</p> <p>Bared, deformed and twisted reinforcing bars</p>	<p>Mechanical damage</p>

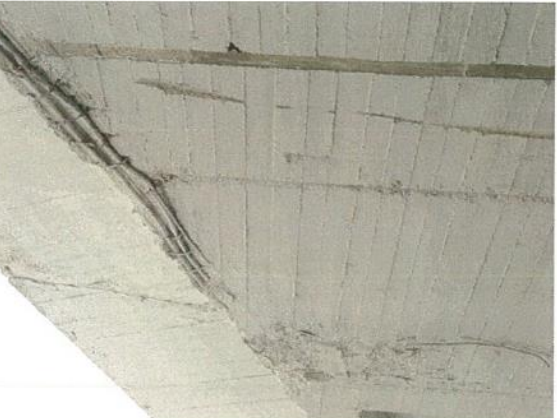
<p>Edge RC beam:</p> <p>Bared, deformed and twisted reinforcing bars</p>	<p>Mechanical damage</p>

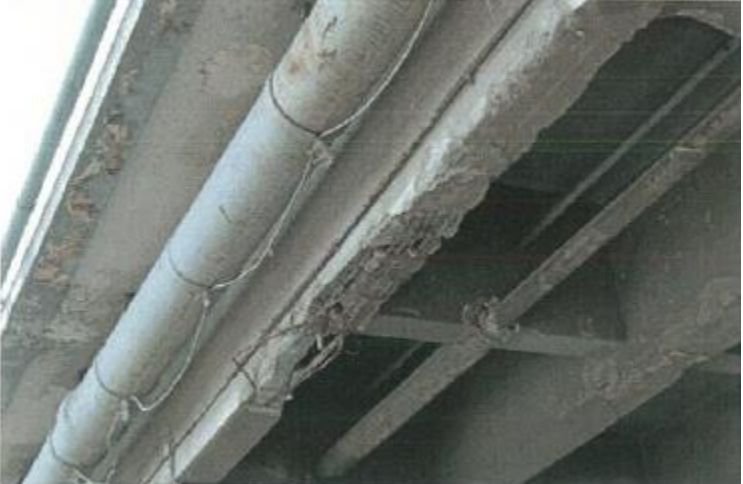
<p>RC longitudinal beam:</p> <p>bared, deformed and twisted rebar, crashed and cracked concrete</p>	<p>Mechanical damage</p>

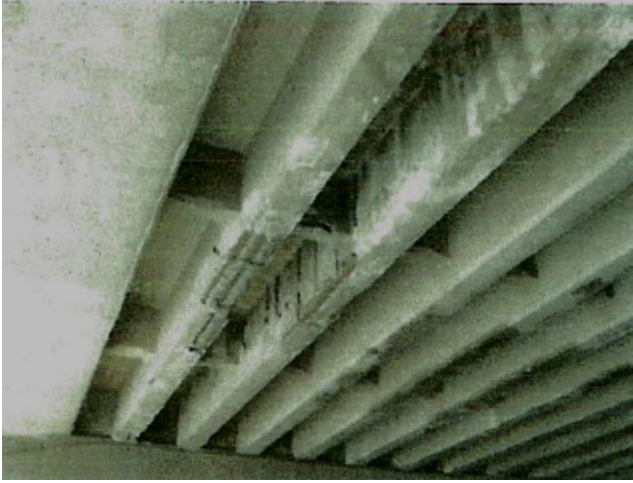
<p>RC longitudinal beams:</p> <p>Bared and corroded reinforcing bars</p>	<p>Insufficient concrete cover, water leakage and concrete carbonation</p>

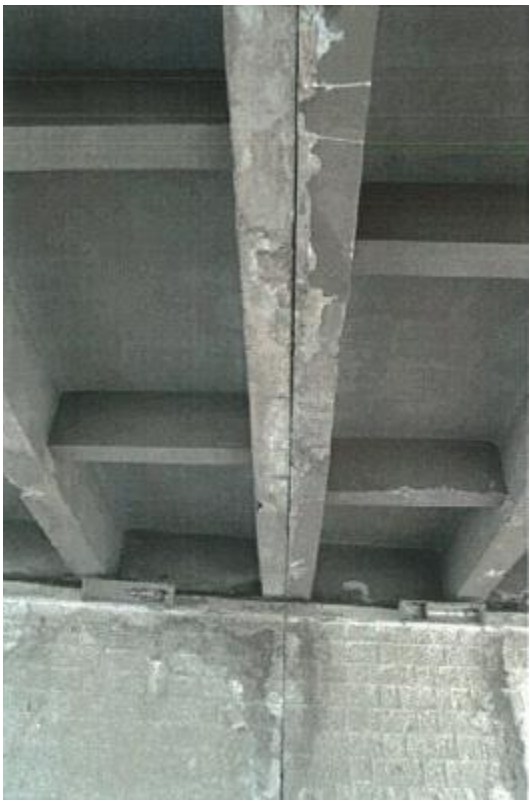
<p>RC longitudinal beams:</p> <p>Water leakage through joint between two deck slabs, spalling of mortar layer, white and dark stains</p>	<p>Water leakage</p>

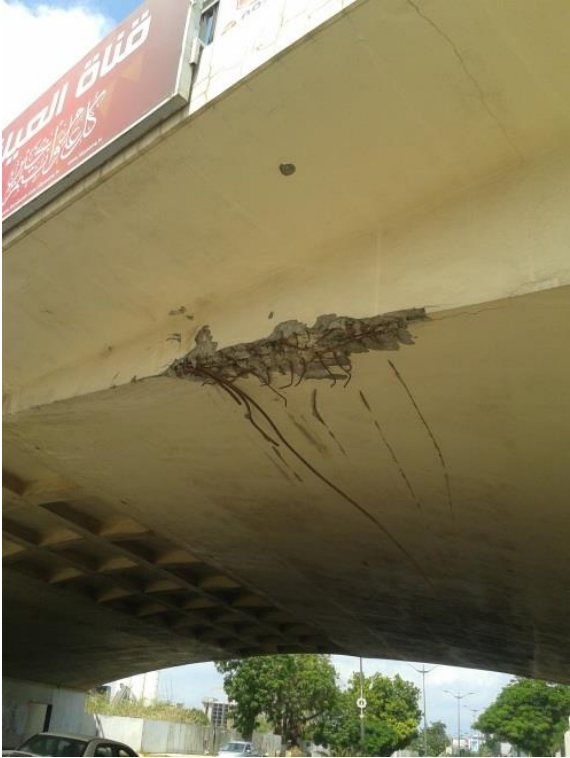
<p>Edge beam:</p> <p>Bared, deformed and broken rebars, crashed and cracked concrete</p>	<p>Mechanical damage</p>

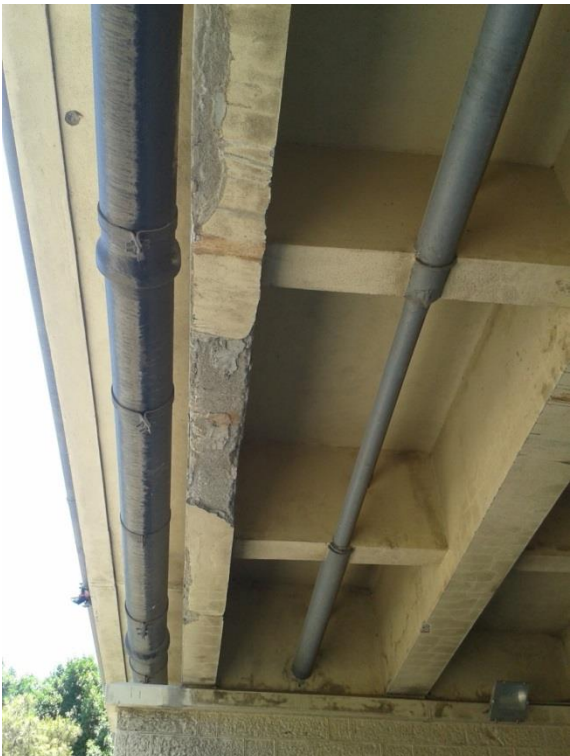
<p>RC longitudinal beams:</p> <p>Delamination and falling off of repair mortar</p>	<p>Poor adhesion between substrate and repair mortar</p>

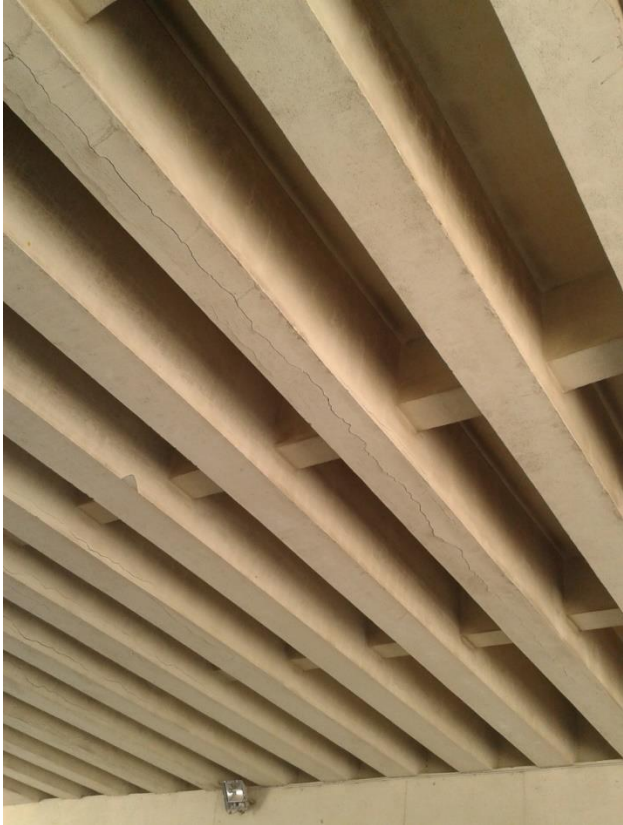
<p>RC longitudinal beams:</p> <p>Cracks along main reinforcement</p>	<p>Corrosion of main reinforcing bars</p>
COLUMNS

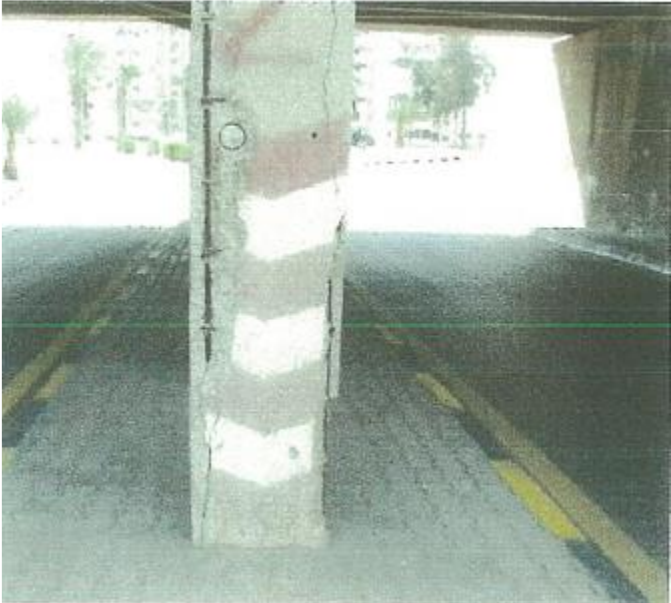
<p>RC column:</p> <p>Bared reinforcing bars, corrosion of rebars, cracking of concrete along the edge rebars, spalling off of corner concrete</p>	<p>Carbonation and periodical wetting and drying</p>

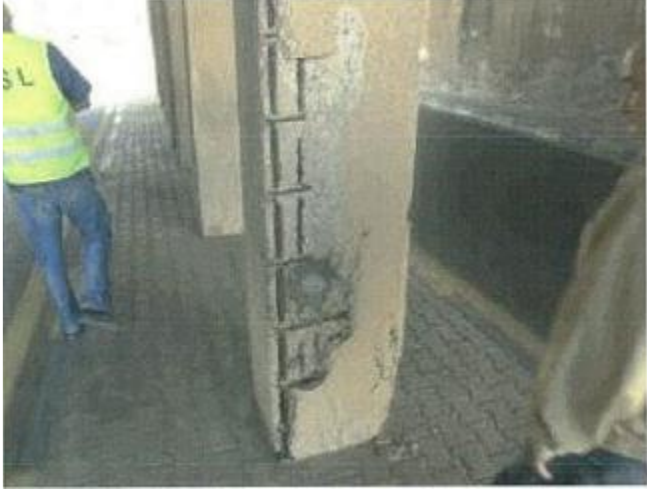
<p>RC column:</p> <p>Large delamination and spalling off of cover, Bared and corroded reinforcing bars</p>	<p>Poor concrete works. Carbonation and periodical wetting and drying</p>
<p>SUPPORTING WALLS AND ABUTMENTS</p>

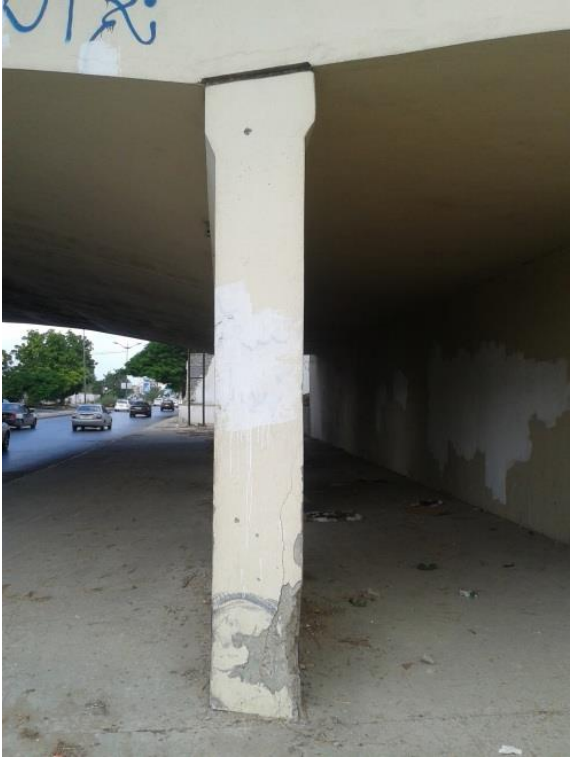
<p>Supporting wall:</p> <p>Cracking and falling off of edge concrete</p>	<p>Mechanical damage</p>

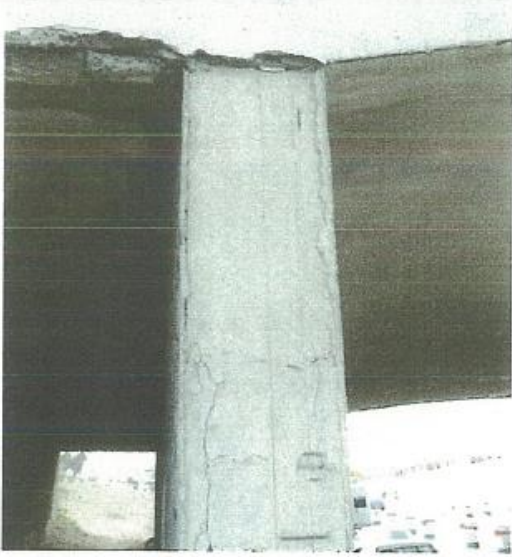
<p>RC wall:</p> <p>Longitudinal cracks near edges due to corrosion of reinforcing bars</p>	<p>Carbonation and periodical wetting and drying</p>

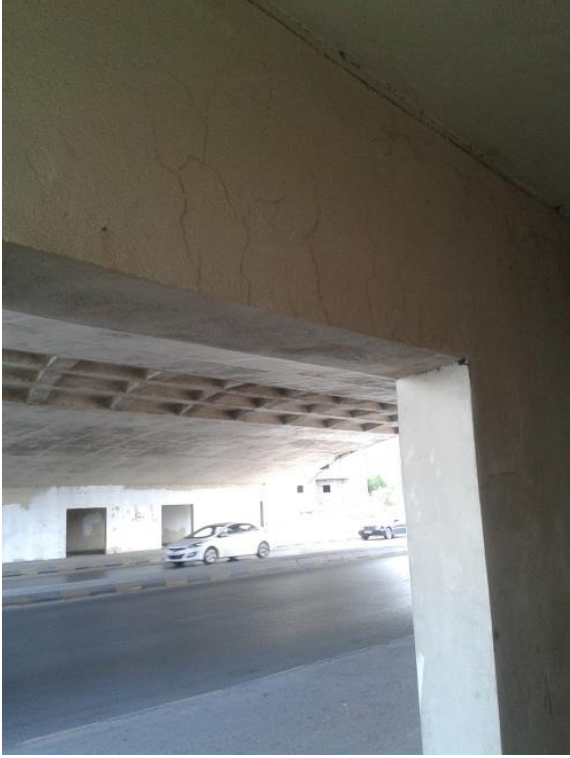
<p>Supporting wall:</p> <p>Net like cracks in (the part above the openings)</p>	<p>Drying shrinkage of repair mortar</p>

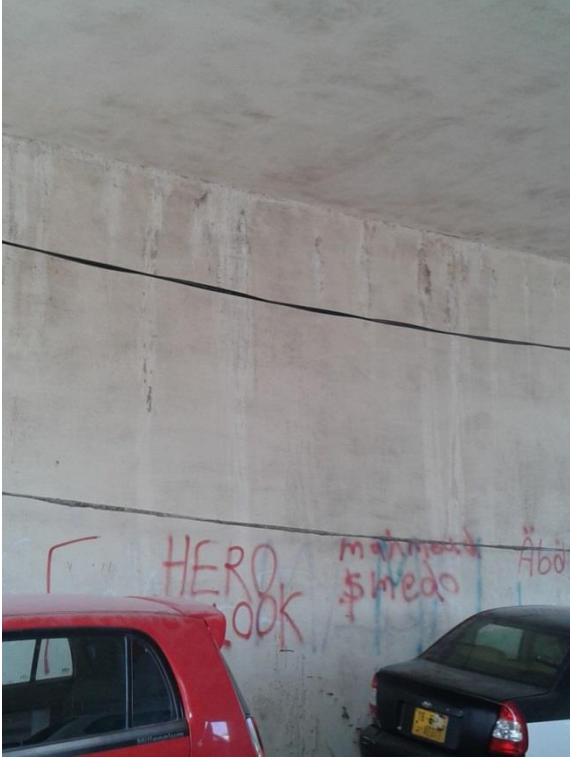
<p>Abutment:</p> <p>Leakage through the joint between abutment and deck slab</p>	<p>Poor bridge drainage system</p>
---	---	------------------------------------
